**Vulnerability of Hawaii Commercial Port and Harbor Facilities to
Tsunamis and Hurricane Storm Surge and Wave Action**

**PROJECT REPORT
for
Hawaii Department of Transportation, Harbors Division**

Research Report UHM/CEE/15-01

February 19, 2015

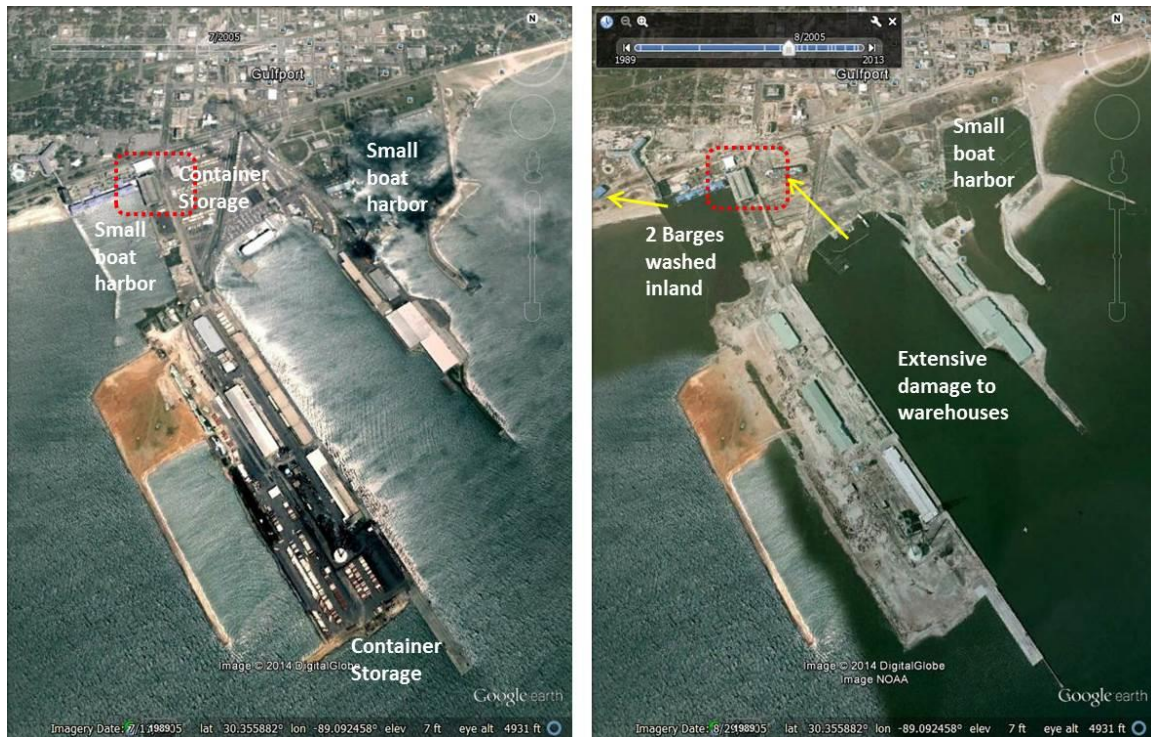
storm surge exceeded 25 feet in some locations. Wind-driven waves on top of this storm surge added to the considerable damage caused to coastal buildings and other structures by hydrodynamic effects (Robertson, *et al.* 2006, 2007; FEMA 549, 2006; Mosqueda and Porter, 2007). In addition to considerable damage to communities all along the affected coastline, Gulfport Harbor suffered major damage due to hydrodynamic loading (Figure 2-1).

Figure 2-1: Google Earth images of Gulfport Harbor before (left) and after (right) Hurricane Katrina

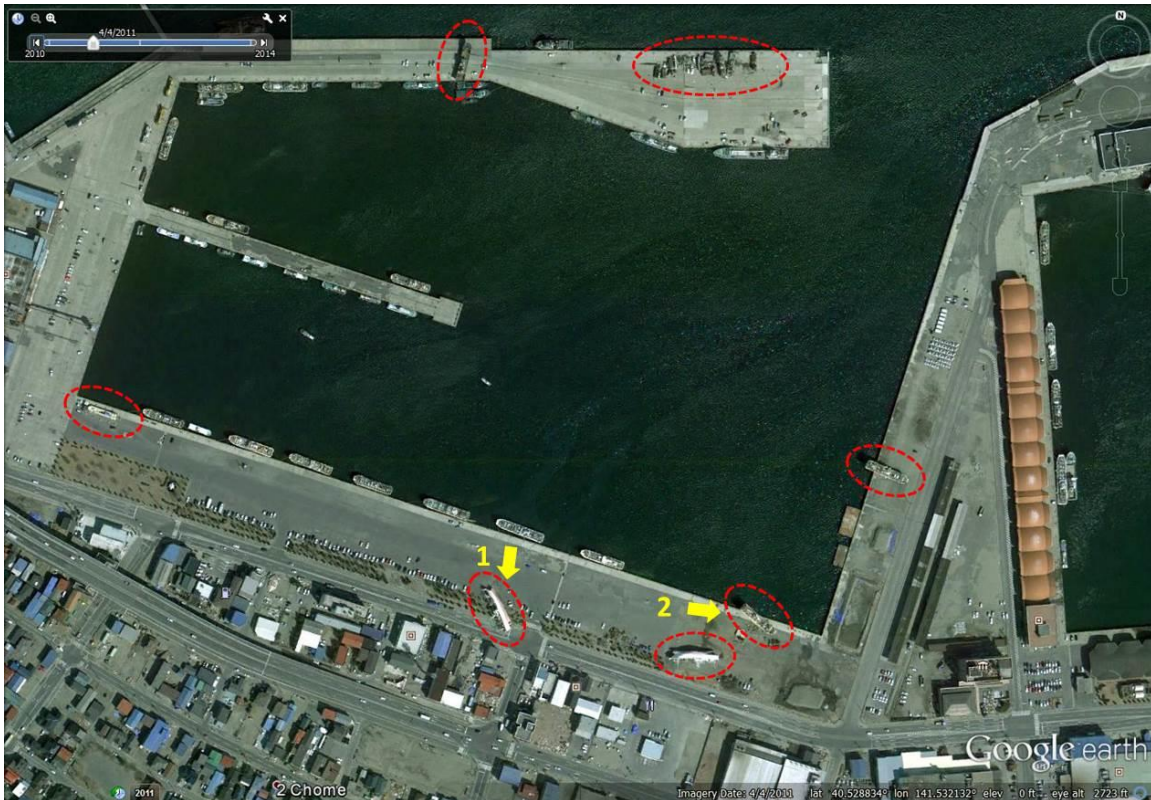
This port experienced tsunami flow depths on the order of 4-5 meters (12 – 16 feet), which are similar to what is anticipated for a major tsunami in Hawaii. This was sufficient to separate ships from their moorings and float them onto the adjacent piers, resulting in considerable disruption to port operations. Other ports in Japan experienced flow depths of up to 20 meters (60+ feet) but such extreme conditions are not anticipated at ports in Hawaii.

Figure 2-5: Hachinohe Harbor after the Tohoku Tsunami showing ships washed onshore (circled) and others that evacuated during the tsunami and have now returned.

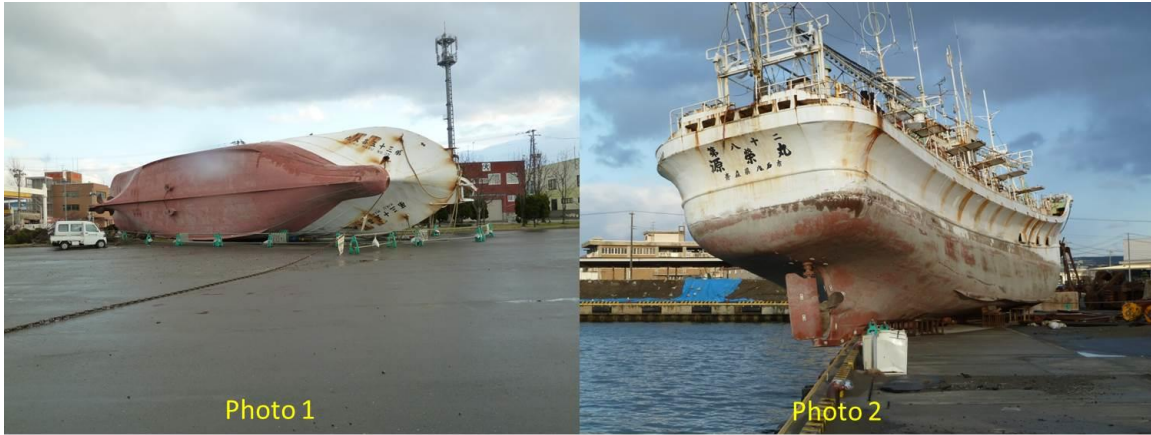
Figure 2-6: Large fishing vessels washed onto the pier at Hachinohe Harbor, Japan.

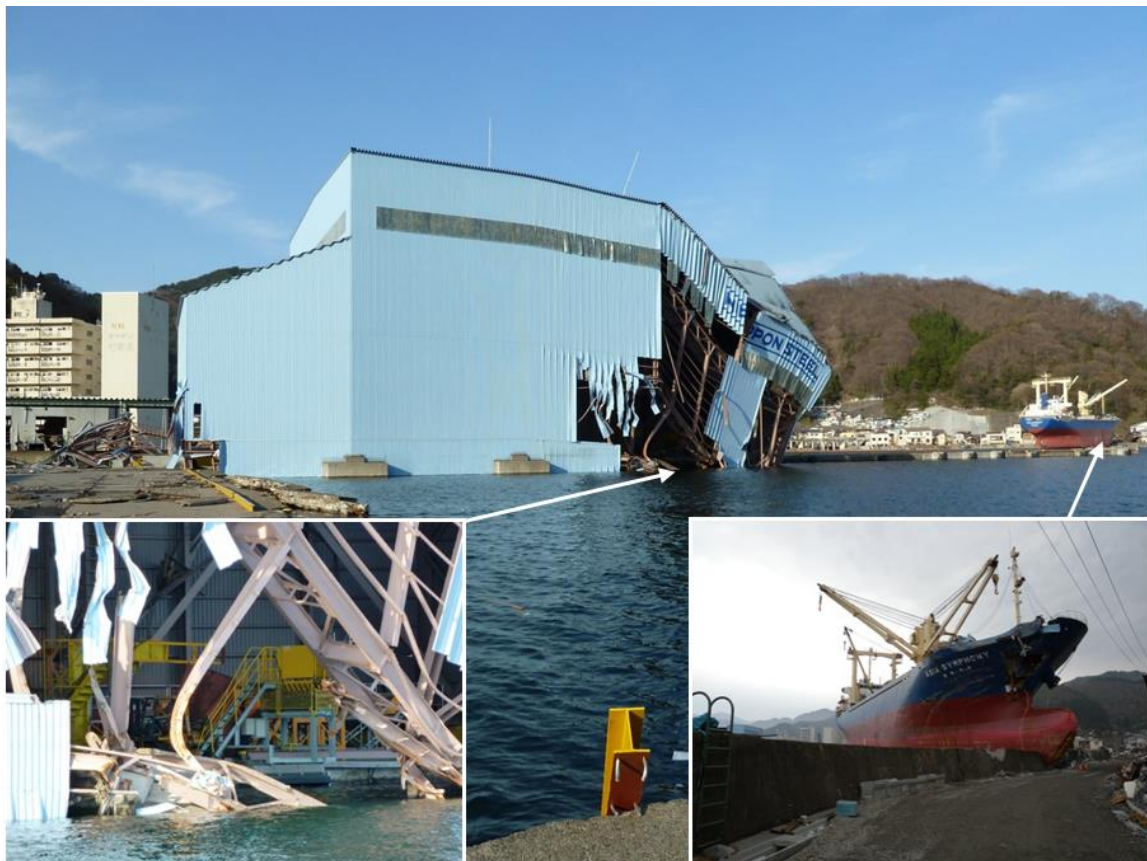
A large fishing vessel in Kamaishi Harbor, Japan, broke free of its moorings during the Tohoku Tsunami and impacted a steel framed port building, causing considerable structural damage to the building and piled foundation (Figure 2-7). Based on video footage from an adjacent building, the ship was travelling at approximately 16 mph prior to impact. In Sendai Harbor, a cargo ship floated over the pier to impact a large cargo crane and adjacent warehouse causing considerable damage (Figure 2-8).

Figure 2-7: Ship impact damage to port building in Kamaishi, Japan.

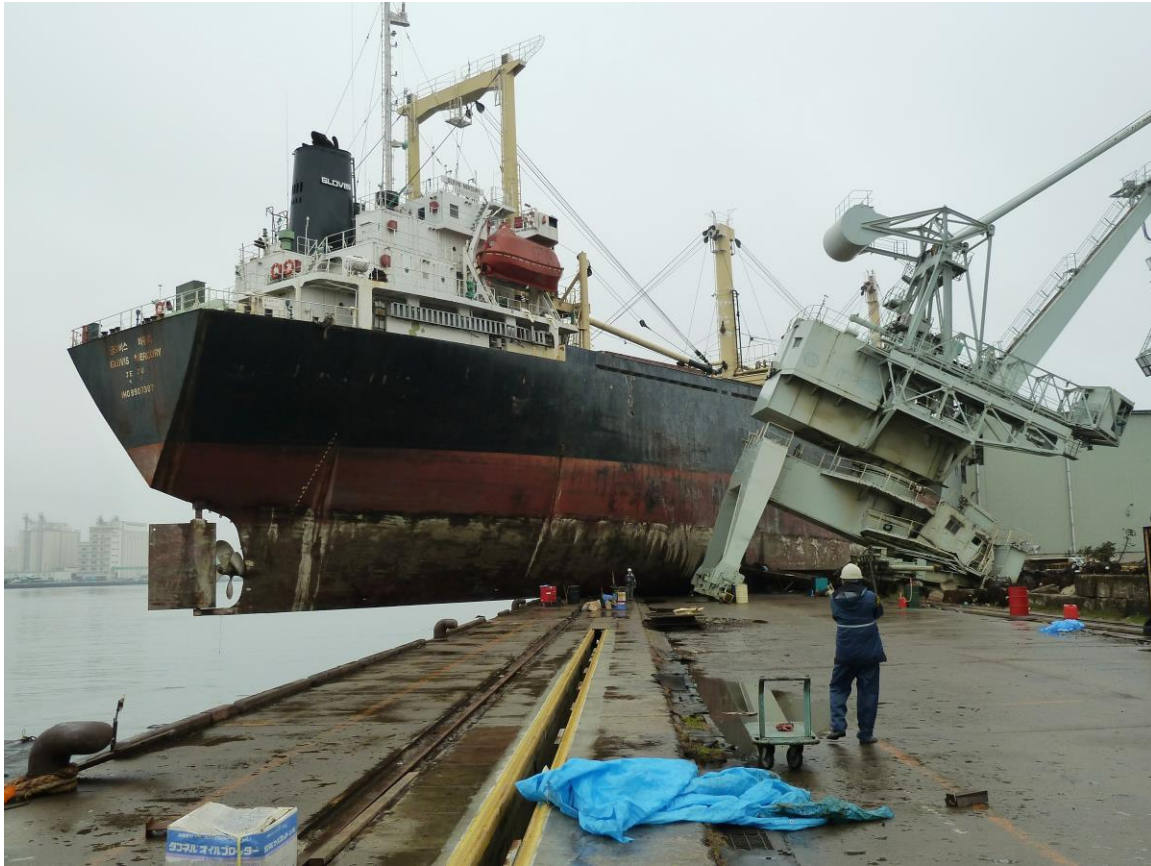
Figure 2-8: Ship impact damage to cargo crane in Sendai Harbor, Japan

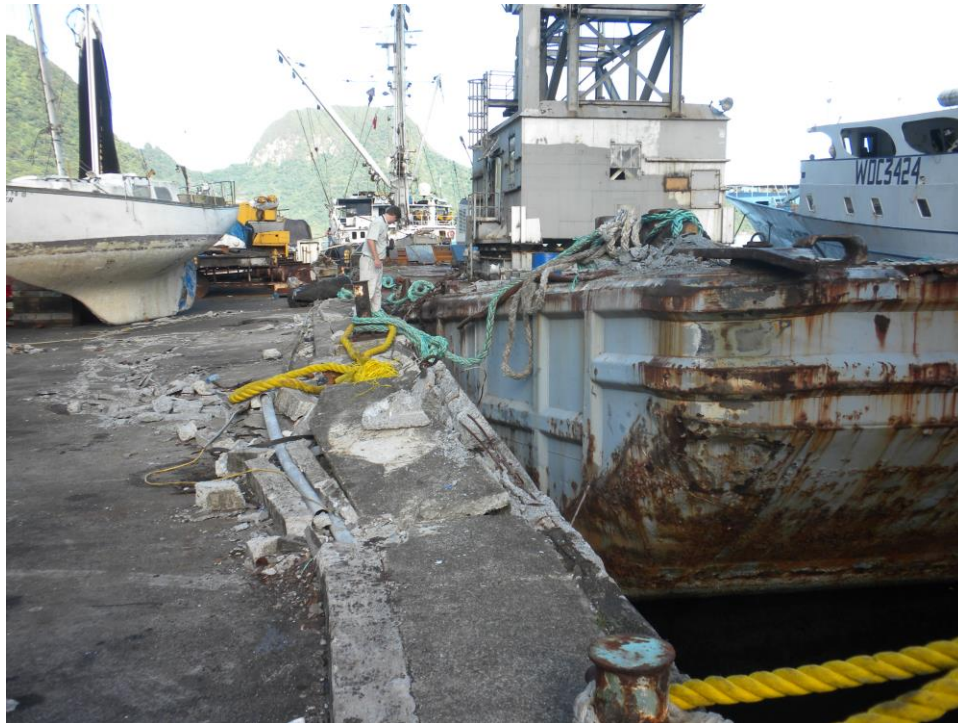
Similar barge damage to a harbor pier also occurred during the Samoa Tsunami, even though flow depths were relatively low. Figure 2-11 shows the damage caused to a pier in Pago Pago harbor due to uplift as the moored barge got caught below the pier during drawdown, and then rose with the incoming tsunami wave.

Figure 2-11: Barge uplift damage to concrete pier in Pago Pago Harbor, Samoa

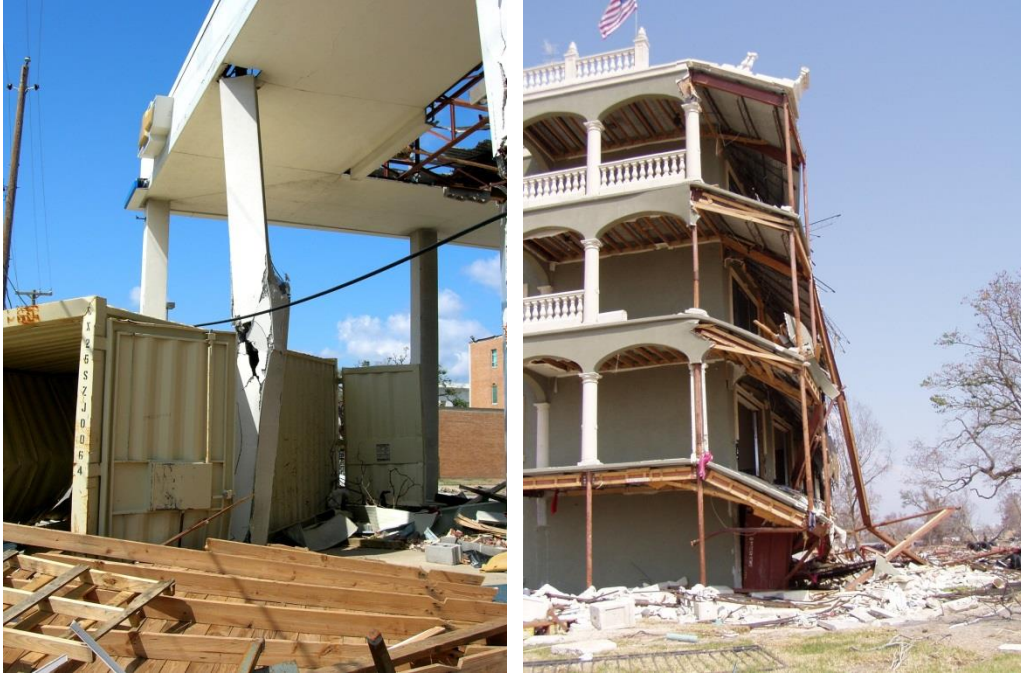
Figure 2-12: Structural damage to steel columns due to shipping container impact

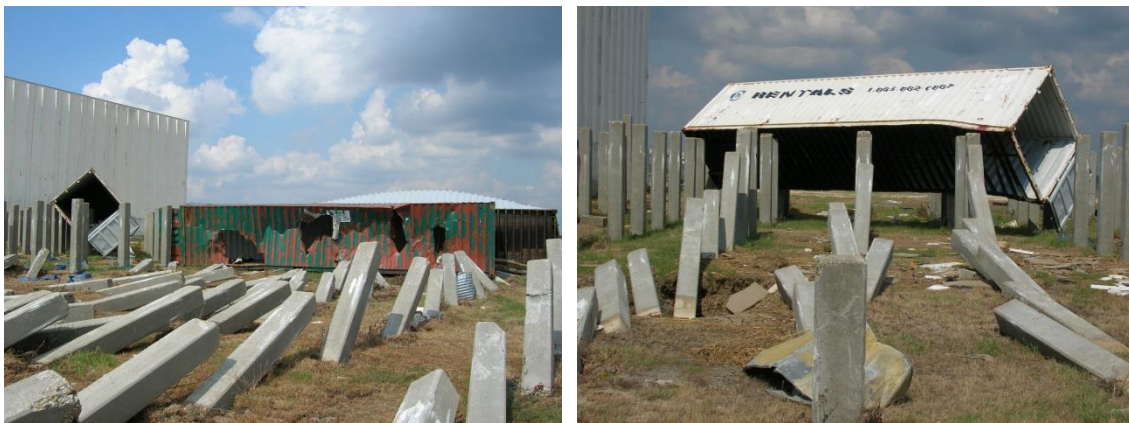
Figure 2-13: Damage to precast piles due to impact and damming effects of floating shipping containers in Biloxi, Mississippi

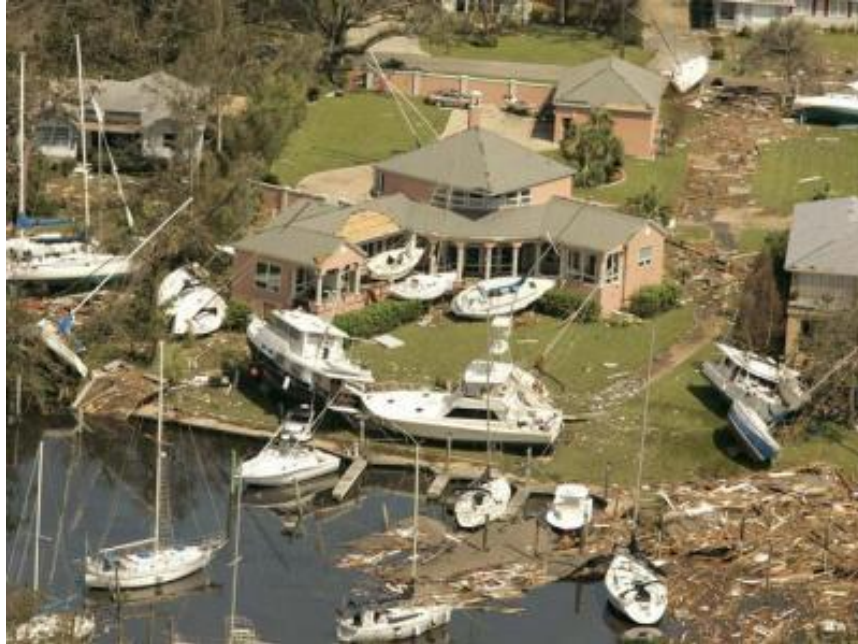
Small boat harbors also pose a danger to nearby buildings due to impact from floating vessels (Figure 2-14).

Figure 2-14: Small boat harbor debris in Ocean Springs, Mississippi

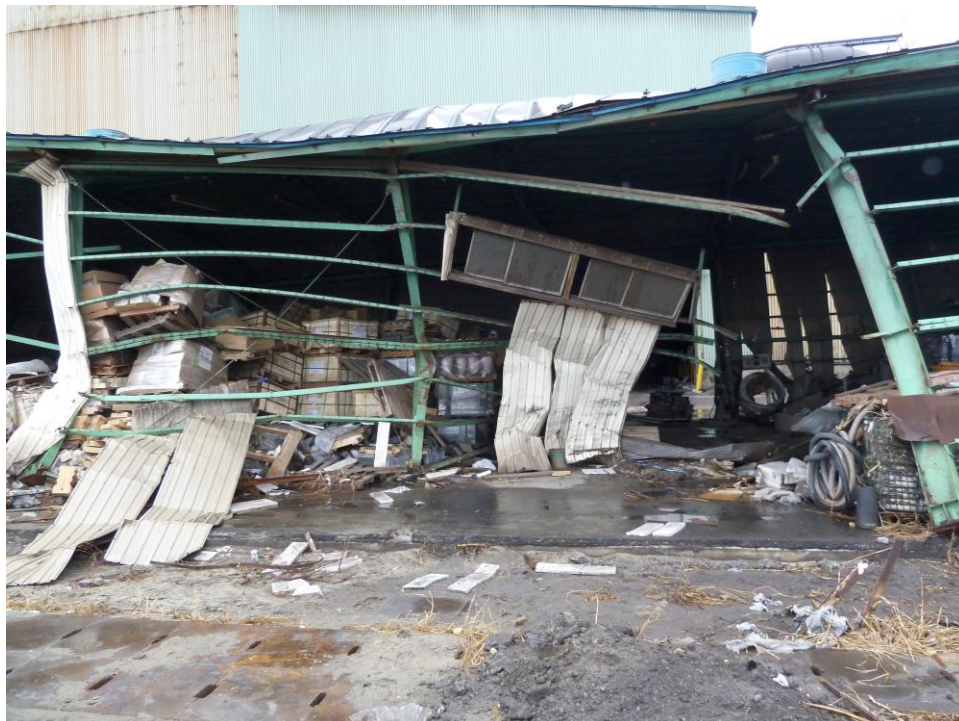
Figure 2-17: Damage to steel-framed warehouse in Sendai Harbor due to shipping container impact and damming effects

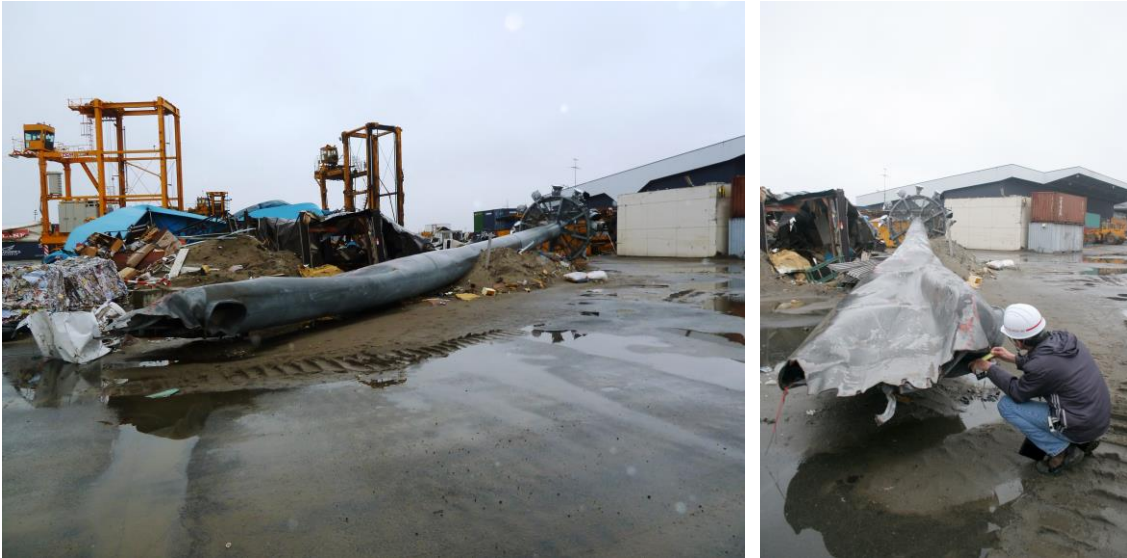
Figure 2-18 shows damage to a large light standard at the Sendai Harbor shipping container storage yard due to numerous shipping container impacts and damming effects.

Figure 2-18: Impact damage to large light standard in the Sendai Harbor shipping container yard.

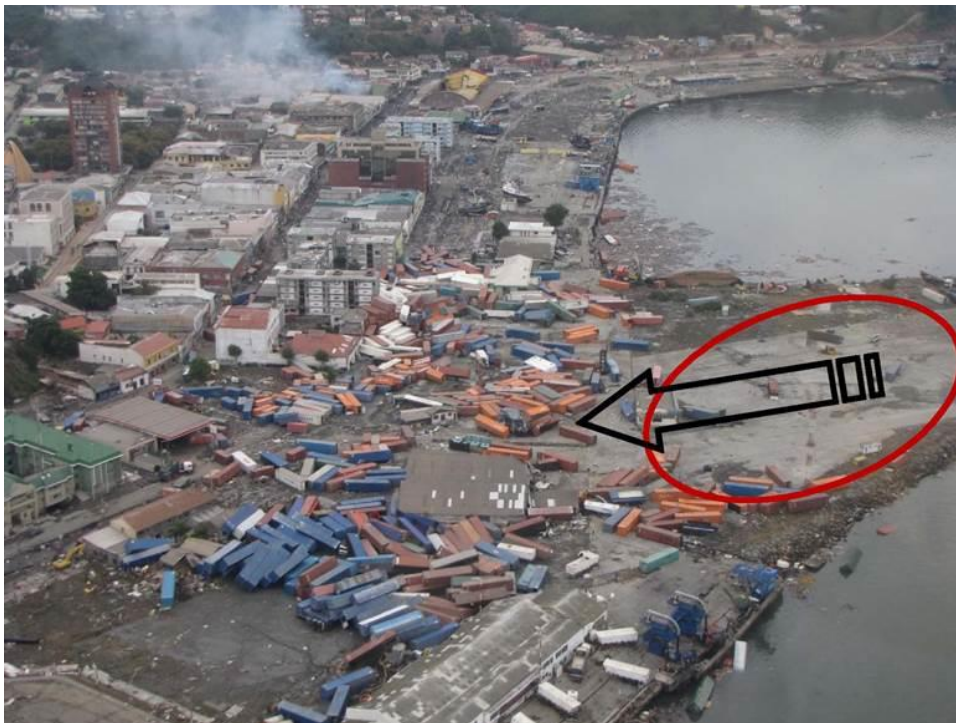
Similar damage due to shipping container impact and damming effects was observed after the Chile Tsunami. Figure 2-19 and Figure 2-20 show shipping containers displaced by the Chile Tsunami in Talcahuano Harbor. Figure 2-21 shows the resulting damage to a steel-framed warehouse adjacent to the container storage yard.

Figure 2-19: Shipping containers at Talcahuano Harbor, Chile, displaced by the tsunami

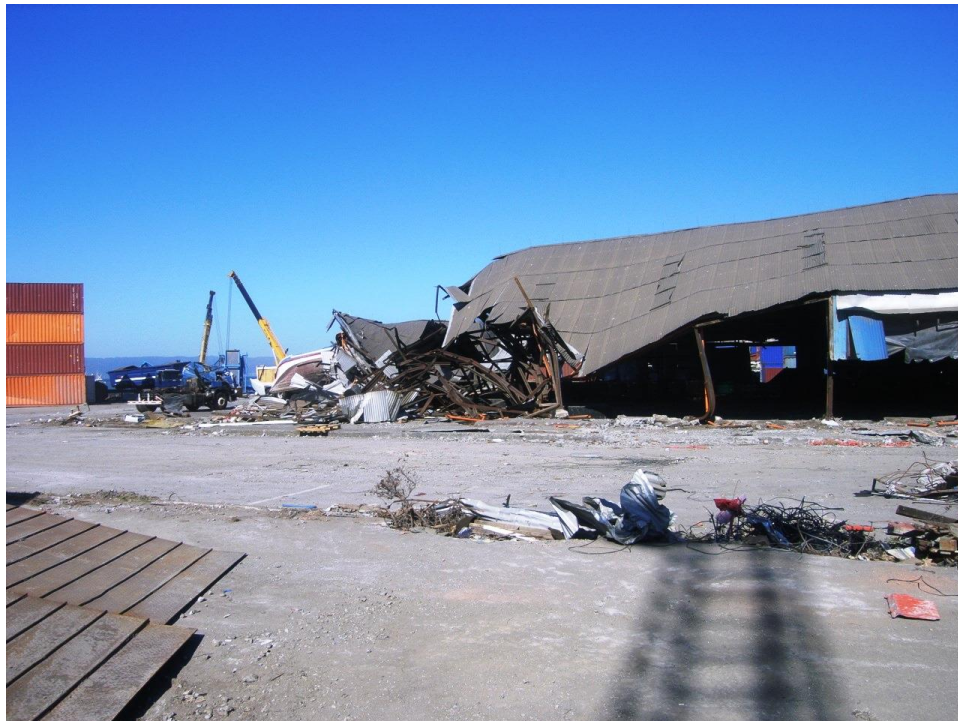
Figure 2-21: Damage to steel-framed warehouse due to shipping container impact and damming effects in Talcahuano Harbor, Chile.

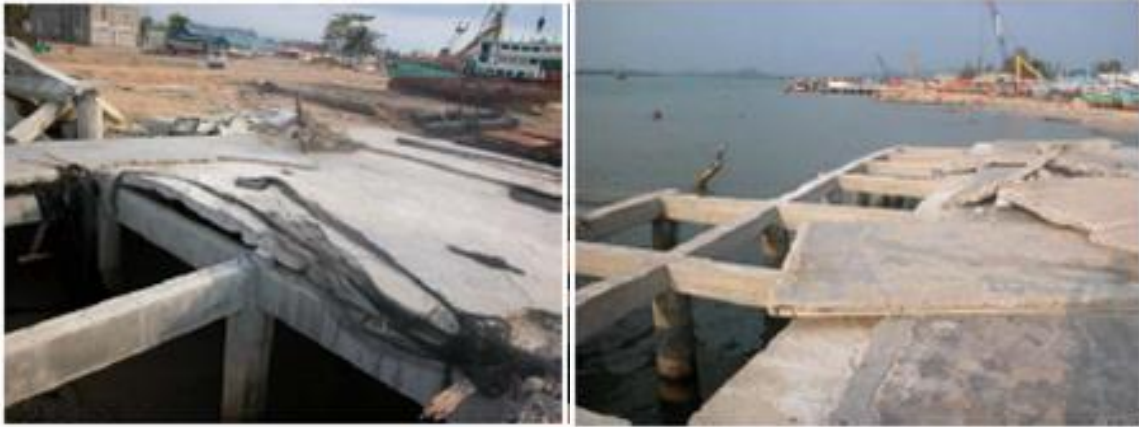
Figure 2-24: Tsunami uplift damage to precast harbor piers in Kao Lak, Thailand

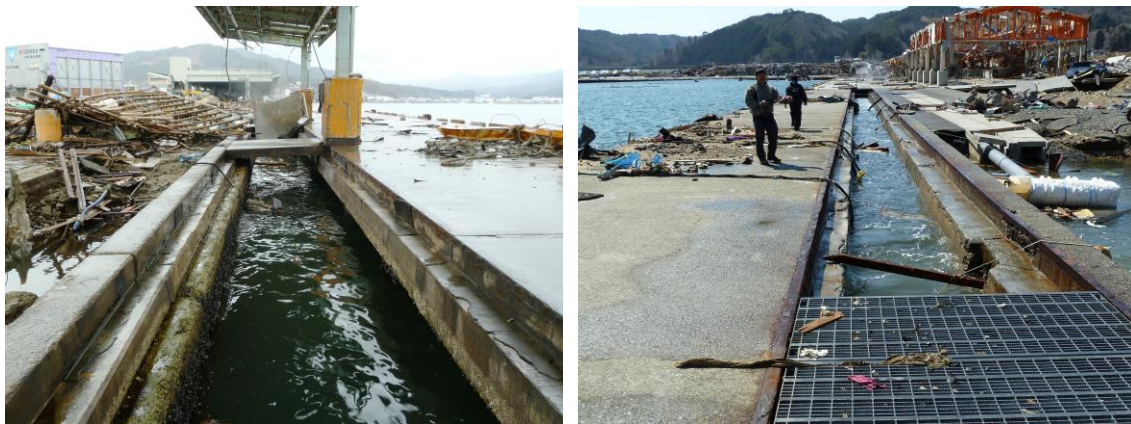
During the Tohoku Tsunami, similar hydrodynamic uplift loads developed below piers at a number of harbors. The resulting pressure was sufficient to lift the concrete or steel grating panels placed between the pile-supported piers and the adjacent soil-supported wharf (Figure 2-25 and Figure 2-26). Analysis of these “breakaway panels” indicates that the tsunami-induced hydrodynamic uplift pressure required to lift these panels ranged from 150 to 250 psf.

Figure 2-25: Concrete and steel grating “breakaway” panels uplifted by the Tohoku Tsunami in Kesennuma harbor (left) and Taro harbor (right)

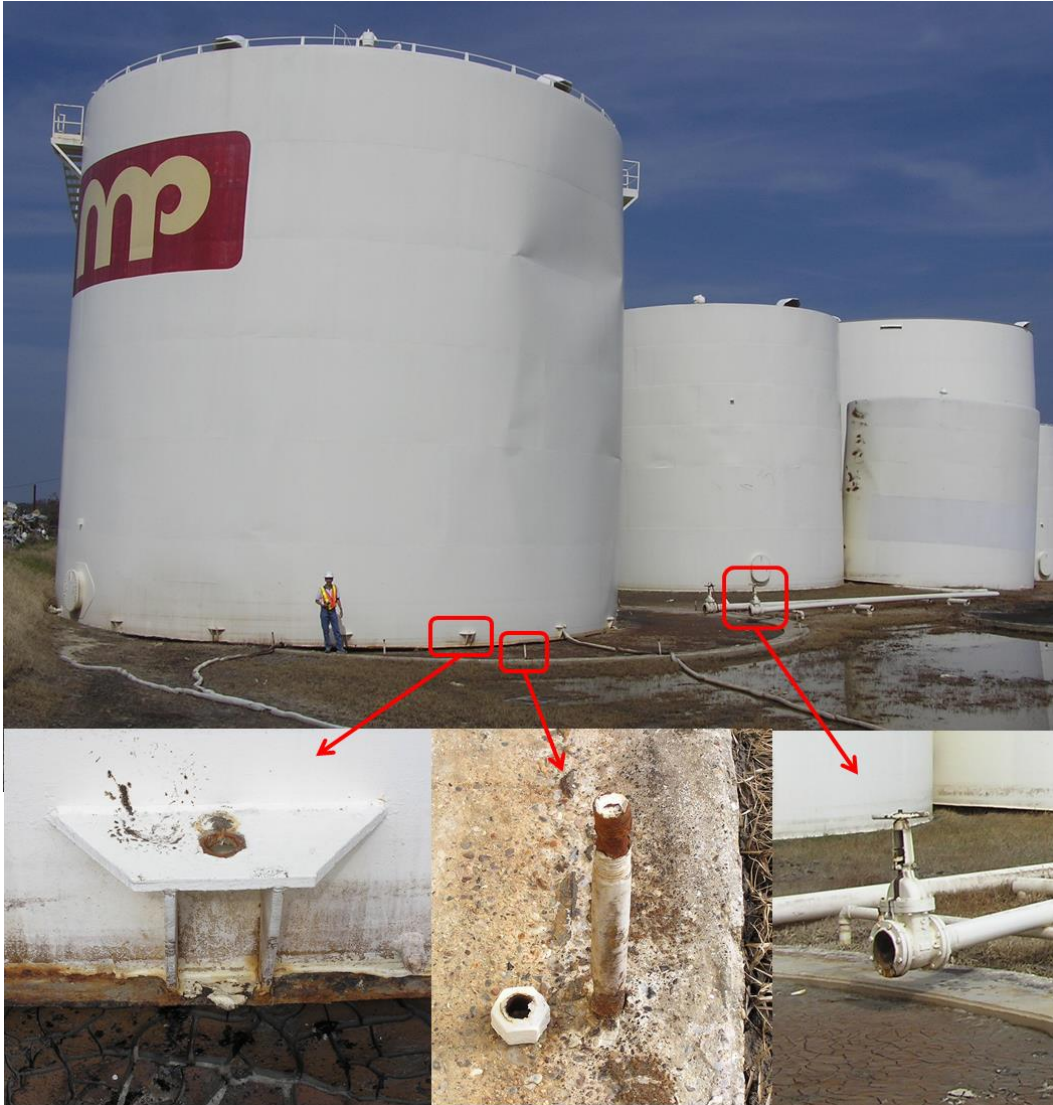
Figure 2-28 shows details of one of the tanks that moved off its foundations. It appears that the tank floated vertically by shearing the nuts from the top of the rusted anchor bolts. This relocation of the tank resulted in rupture of the pipes leading from the tank. Impact between the tanks also appears to have caused damage to the thin steel walls of this tank.

Figure 2-28: Fuel storage tanks floated off their foundations in Biloxi Back Bay, Mississippi

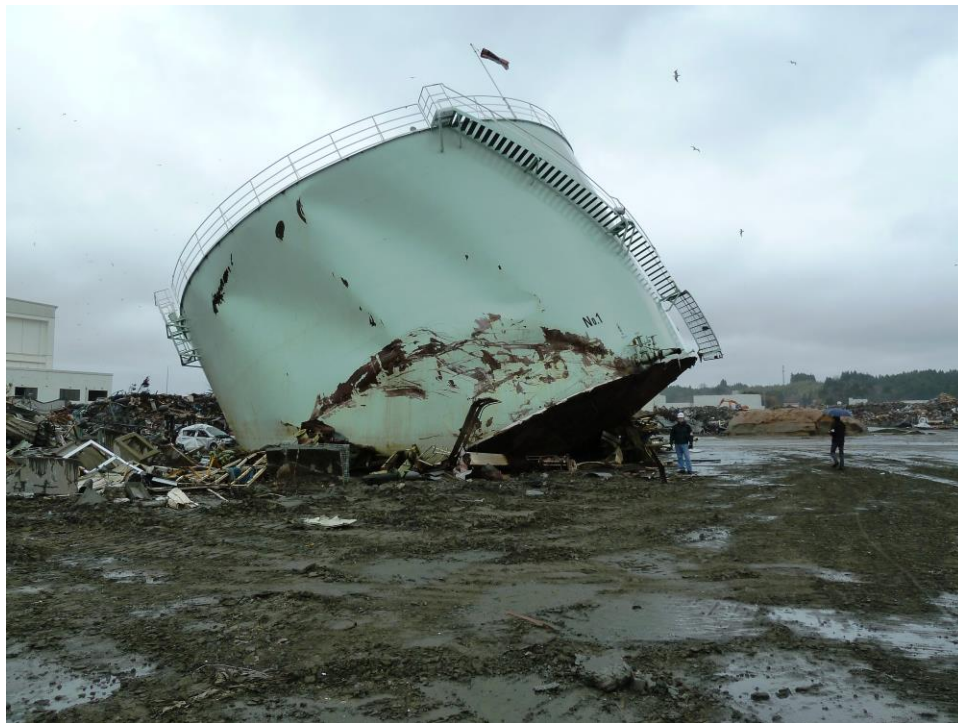
Figure 2-30: One of many large fuel storage tanks in Kesennuma Harbor damaged during the Tohoku Tsunami

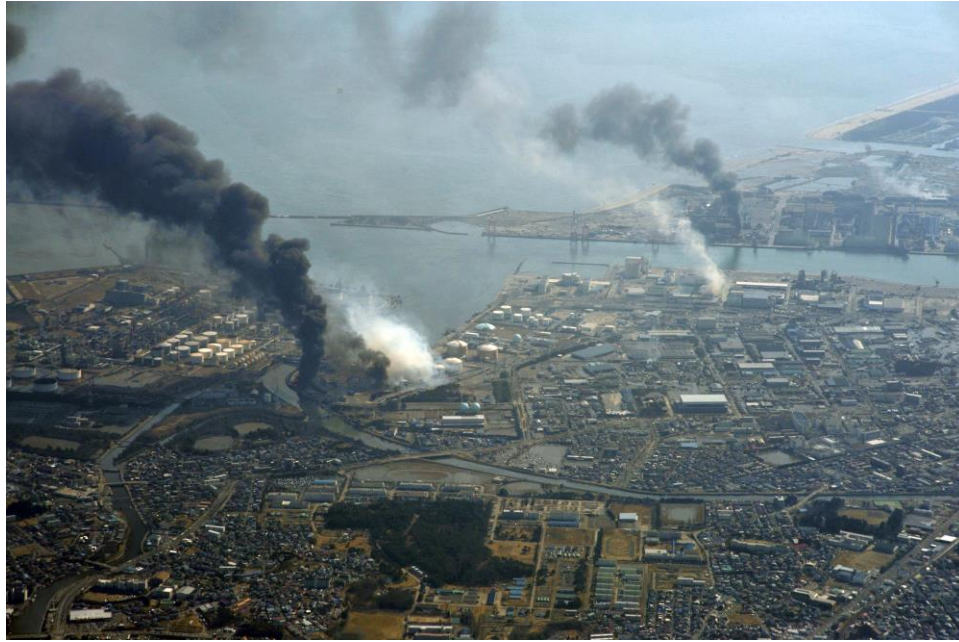
Figure 2-31: Fires in and around the fuel storage locations at Sendai Harbor immediately after the Tohoku Tsunami

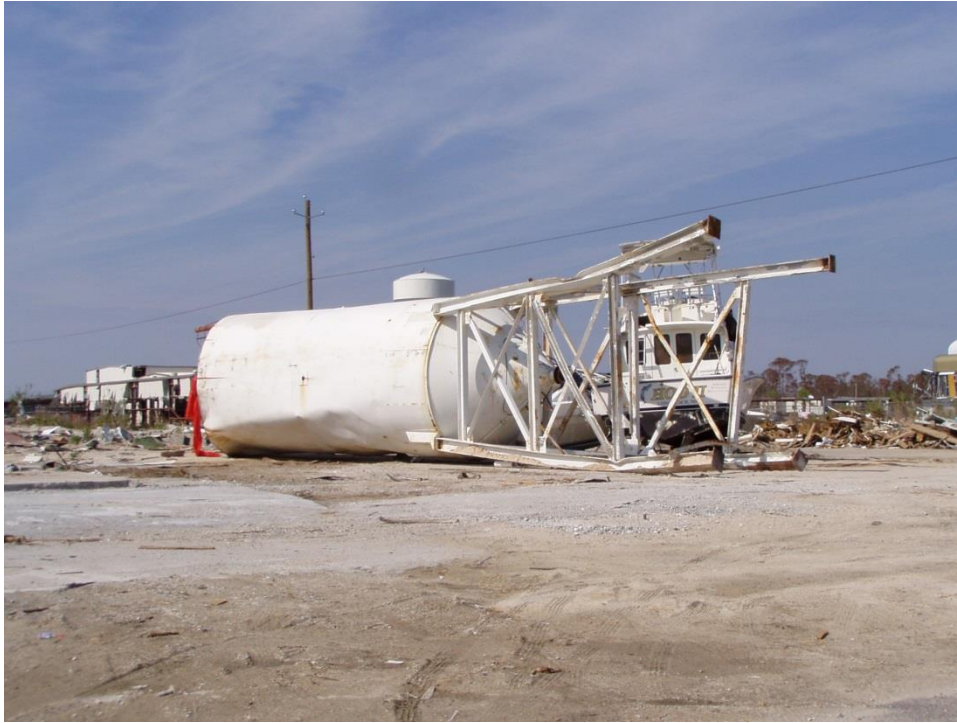
Figure 2-33: Collapsed cement silo in Ocean Springs, Mississippi

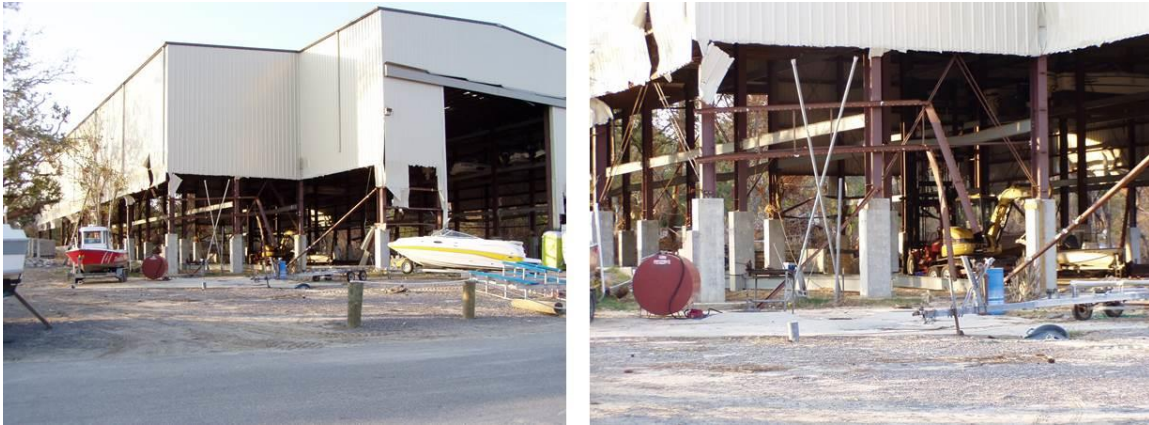
Coastal buildings suffered varying degrees of damage during Hurricane Katrina. Figure 2-35 shows damage to the light sheet metal cladding on a warehouse due to hydrodynamic and debris impact loading. The structural steel frame with columns encased in concrete at the lower level survived intact. Some damaged girts, roller doors and cladding would need to be replaced to restore this warehouse to its original condition.

Figure 2-35: Damage to light sheet metal cladding on steel framed warehouse in Ocean Springs, Mississippi

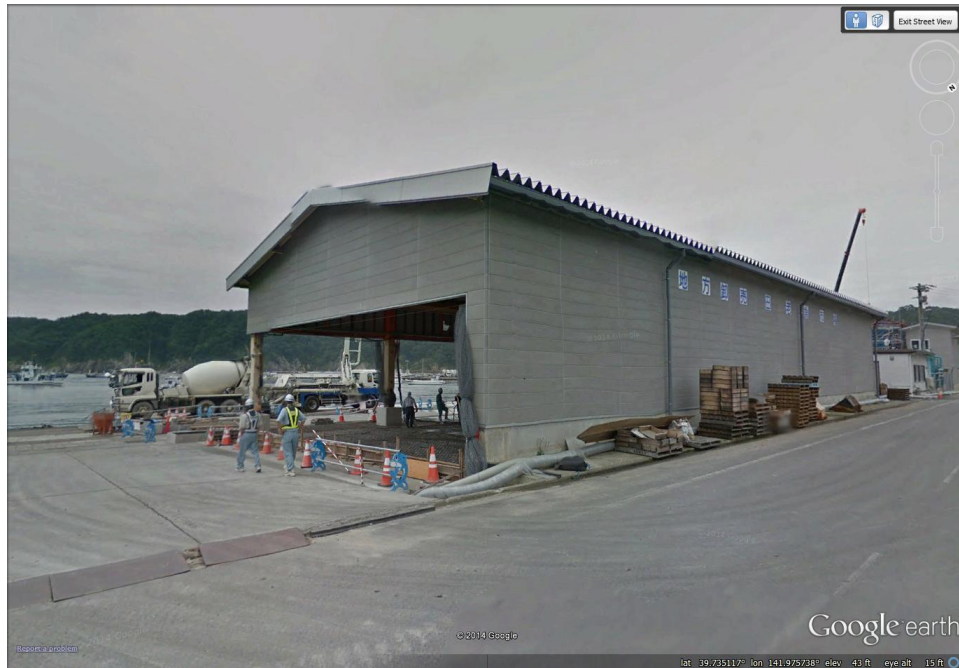
Figure 2-37: Restoration of cladding on badly damaged warehouse building in Taro, Japan.

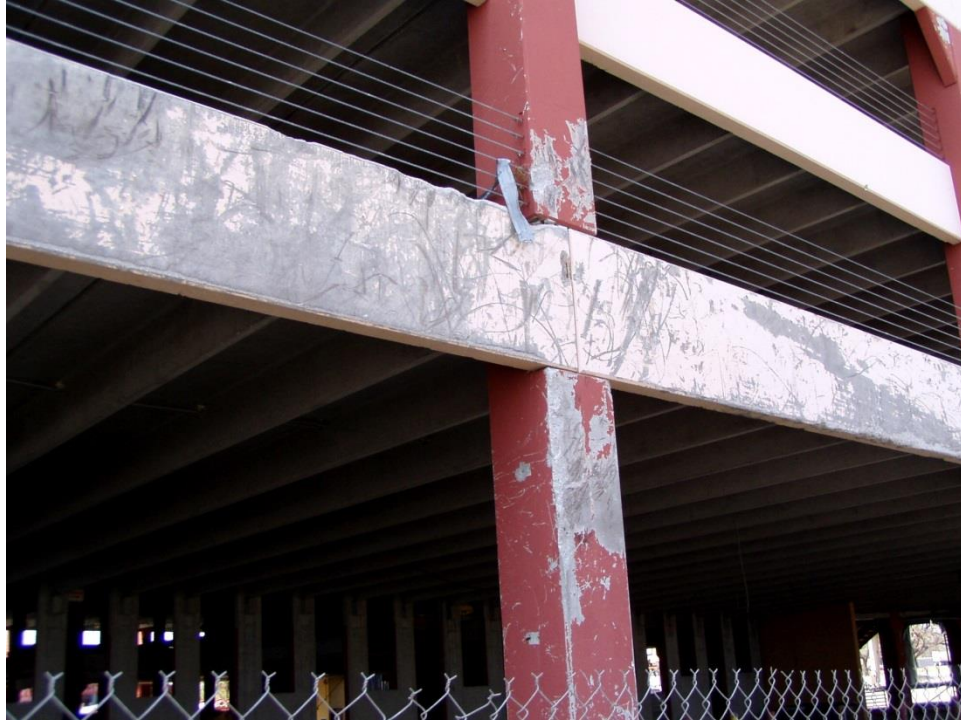
Figure 2-42 shows a portion of Gulfport Harbor with a concrete parking garage adjacent to a shipping container storage yard. Figure 2-43 shows damage to the lower levels of the precast concrete parking structure due to impacts from floating containers from the storage yard. Because of the relatively substantial nature of these columns and spandrel beams, most of the impact damage is superficial. The precast double-tee floor system supported by these spandrel beams collapsed due to buoyancy and hydrodynamic uplift (Figure 2-23, left).

Figure 2-43: Superficial impact damage to parking garage beams and columns at Gulfport Harbor, Mississippi

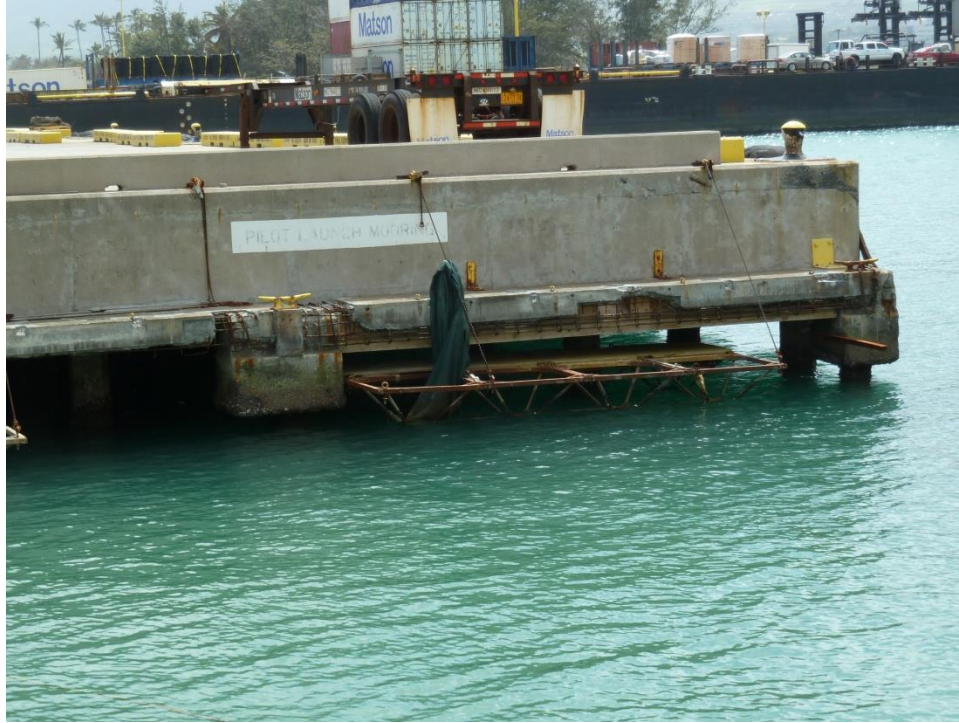
Figure 4-82: View of Pier 3 showing ongoing repair work
