**Vulnerability of Hawaii Commercial Port and Harbor Facilities to
Tsunamis and Hurricane Storm Surge and Wave Action**

**PROJECT REPORT
for
Hawaii Department of Transportation, Harbors Division**

Research Report UHM/CEE/15-01

February 19, 2015

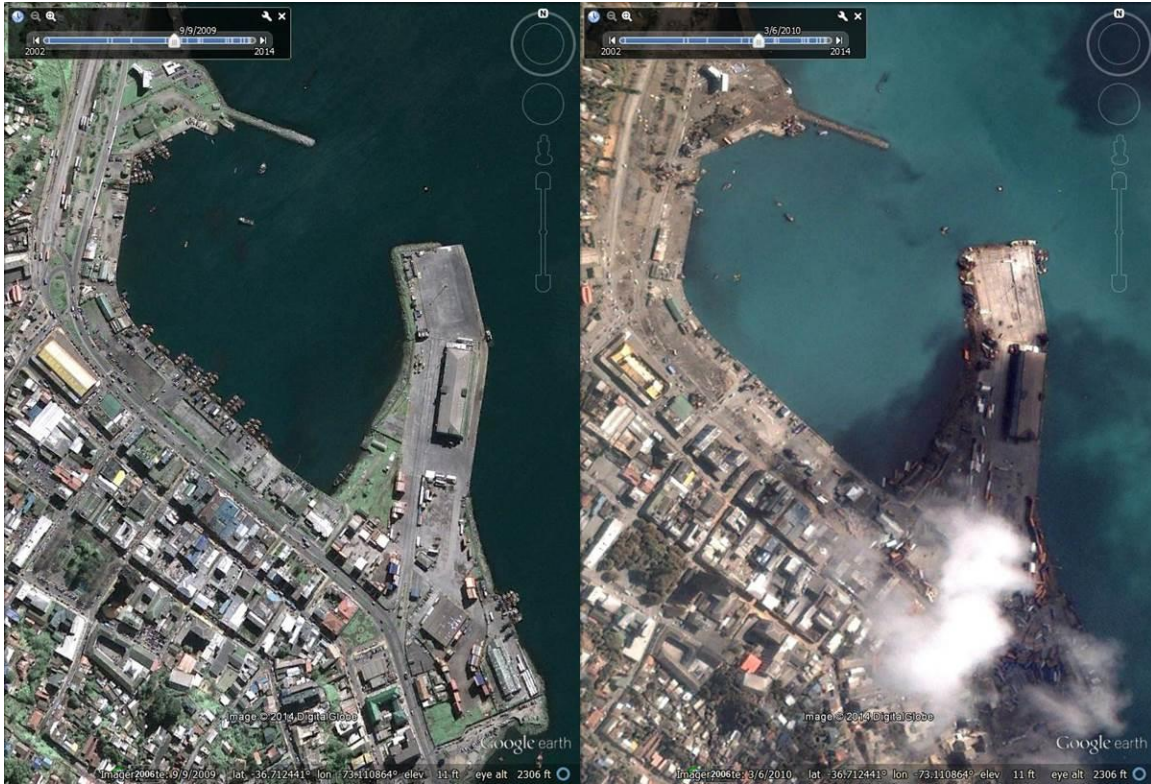
On February 27th, 2010 a magnitude 8.8 earthquake off the central coast of Chile caused a near source tsunami that resulted in considerable damage to the port of Talcahuano (EERI, 2010; Olsen, *et al.* 2012; Robertson, *et al.* 2012). Numerous coastal towns were also severely damaged by tsunami inundation. Figure 2-2 and Figure 2-3 show Google Earth images before and after the Chile Tsunami. Because the earthquake that caused the tsunami occurred at 3:34AM local time, very few of the ships in these harbors were able to evacuate. This resulted in numerous ships damaged, washed onshore, or sunk in the harbor basins.

Figure 2-2: Talcahuano Harbor before (left) and after (right) the Chile Tsunami

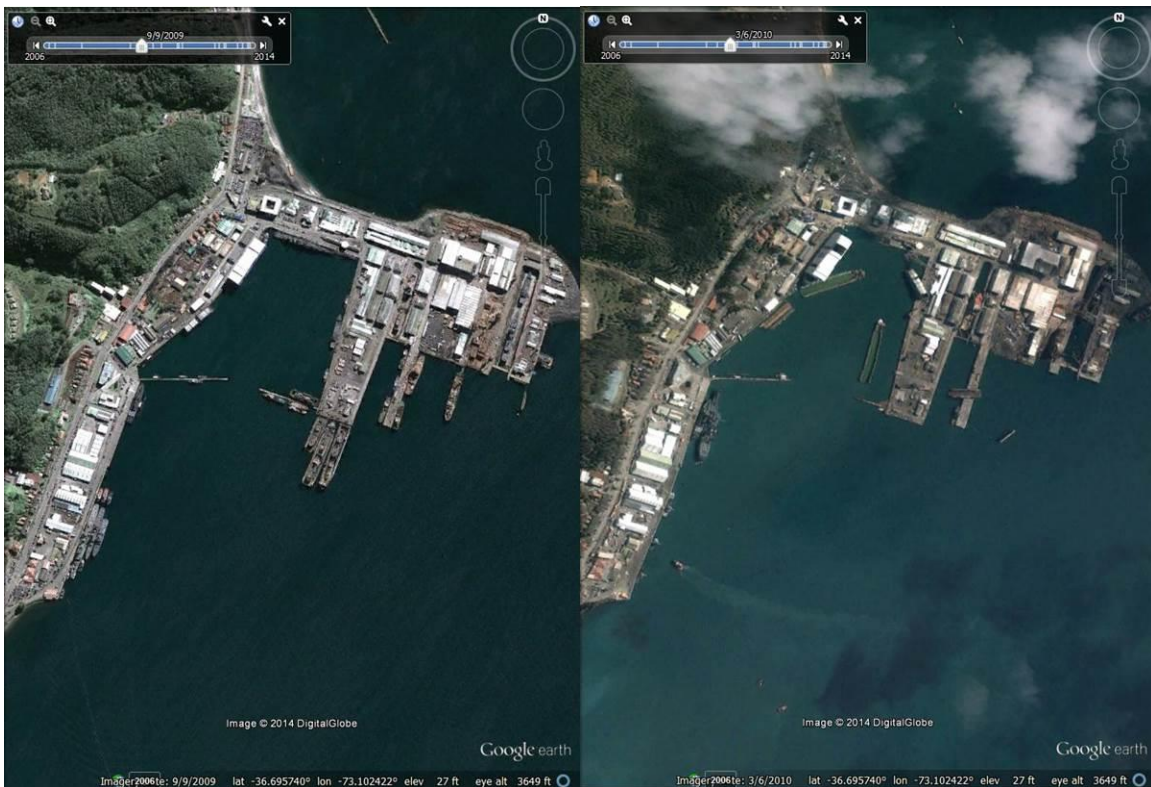
Figure 2-3: Talcahuano Naval Harbor before (left) and after (right) the Chile Tsunami

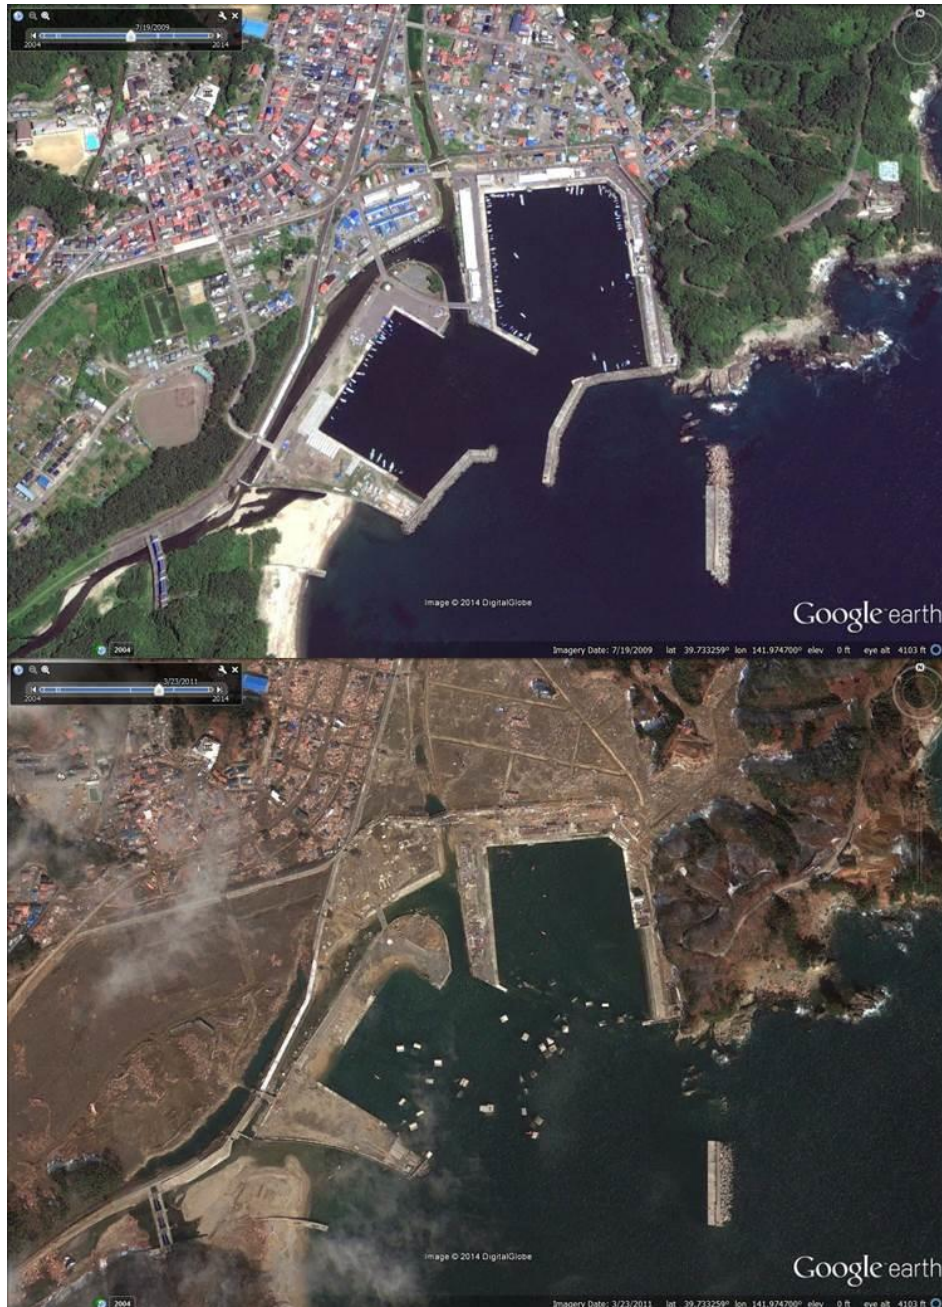
Figure 2-4: Google Earth images of Taro harbor before (top) and after (bottom) the Tohoku Tsunami

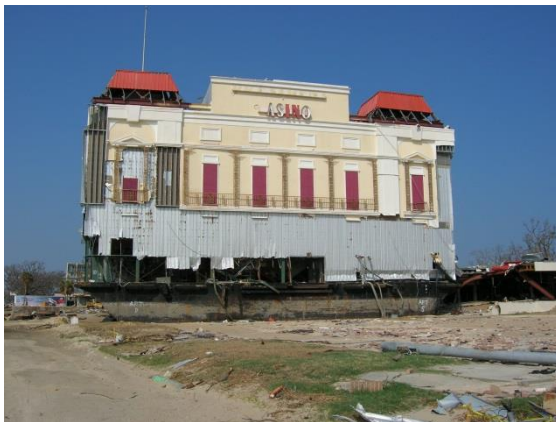
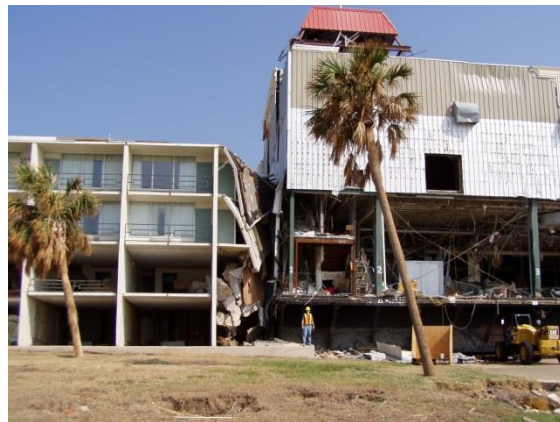
During Hurricane Katrina, a large amount of structural damage resulted from impact by large barge-mounted casinos. These barges broke free from their moorings and caused almost total destruction along their path. Figure 2-9 shows a barge-mounted casino in Biloxi, Mississippi, that broke its moorings, drifted inland and damaged a number of structures along the way. Figure 2-10 shows partial collapse of a prestressed concrete parking structure in Biloxi, Mississippi due to impact damage from a barge moored next to the structure.

Figure 2-9: Barge-mounted casino that drifted over Highway US90 in Biloxi, Mississippi, destroying a number of structures.

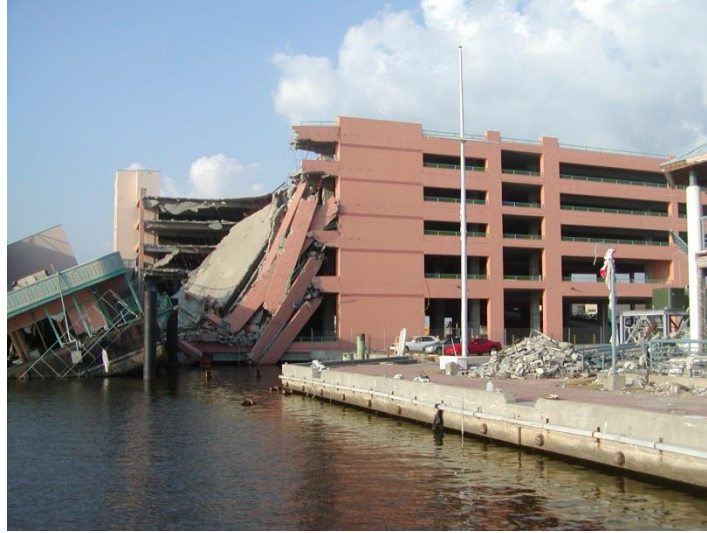
Figure 2-10: Partial collapse of prestressed concrete parking structure due to impact from barge moored adjacent to the structure

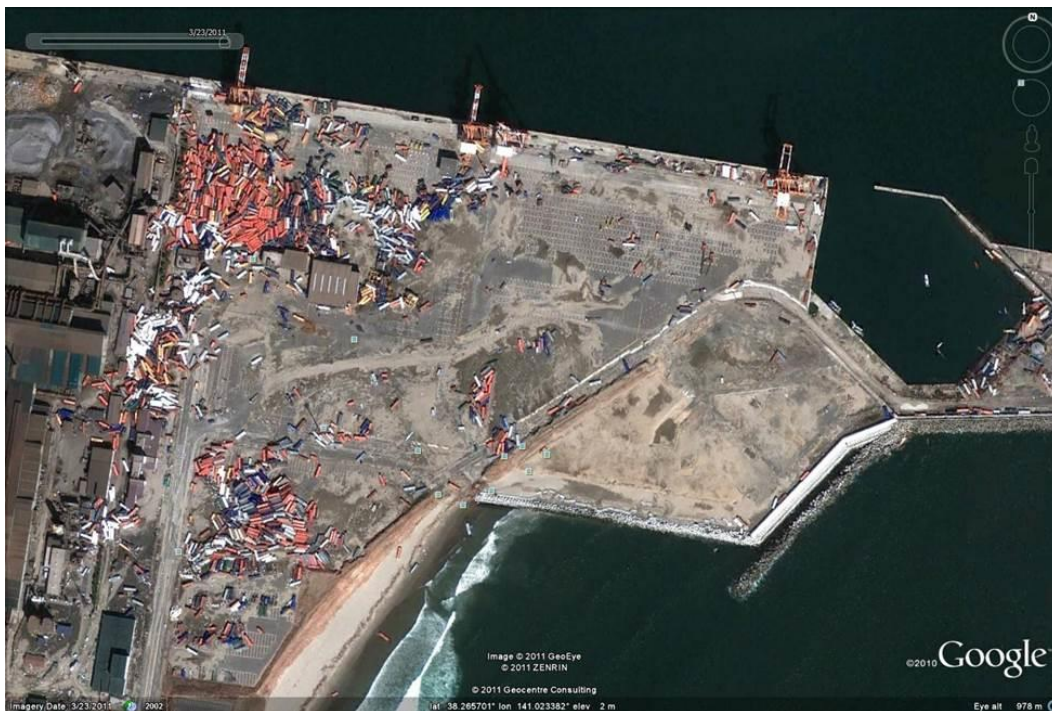
Shipping containers have also resulted in considerable damage to port facilities during recent tsunamis. Figure 2-15 and Figure 2-16 show the movement of shipping containers in the Sendai Harbor from their storage locations into the side of warehouse and other structures along the perimeter of the shipping container yard. Figure 2-17 shows the damage caused to a steel-framed warehouse impacted by these shipping containers.

Figure 2-15: Google Earth image of the shipping container storage area at Sendai Harbor after the Tohoku Tsunami

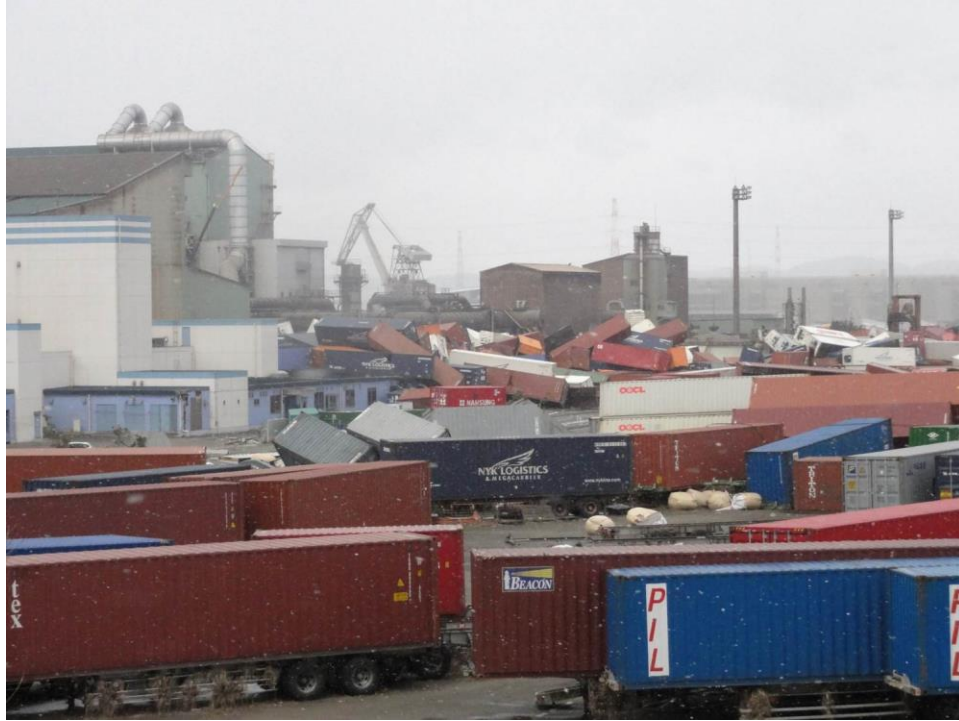
Figure 2-16: Shipping containers impacting port buildings in the Sendai Harbor after the Tohoku Tsunami

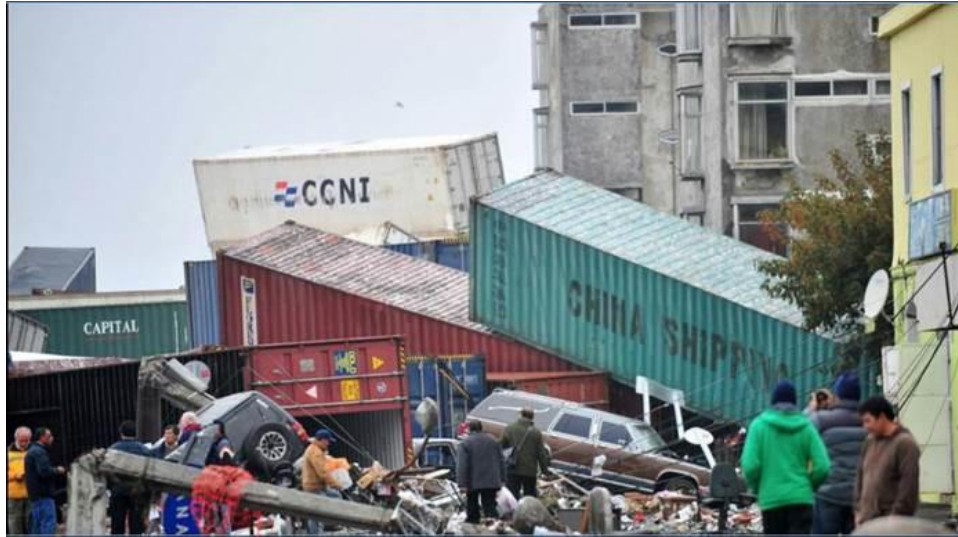
Similar damage due to shipping container impact and damming effects was observed after the Chile Tsunami. Figure 2-19 and Figure 2-20 show shipping containers displaced by the Chile Tsunami in Talcahuano Harbor. Figure 2-21 shows the resulting damage to a steel-framed warehouse adjacent to the container storage yard.

Figure 2-20: Shipping containers washed up against buildings adjacent to Talcahuano Harbor, Chile

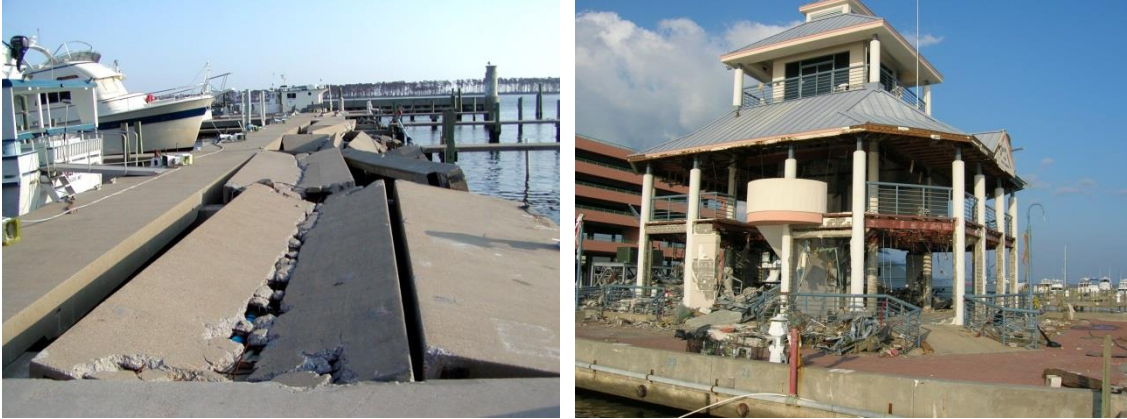
Hydrodynamic loading caused considerable structural and non-structural damage to port facilities during Hurricane Katrina. Figure 2-22 shows damage to precast concrete deck slabs and the control tower at the Joint Cadet Marina in Biloxi, Mississippi. The precast concrete deck panels appear to have been lifted by storm surge and wave action, similar to numerous bridge failures along the same coastline. Figure 2-23 shows damage to

Figure 2-22: Hydrodynamic loading damage to concrete pier and steel harbor building at Joint Cadet Marina in Biloxi, Mississippi

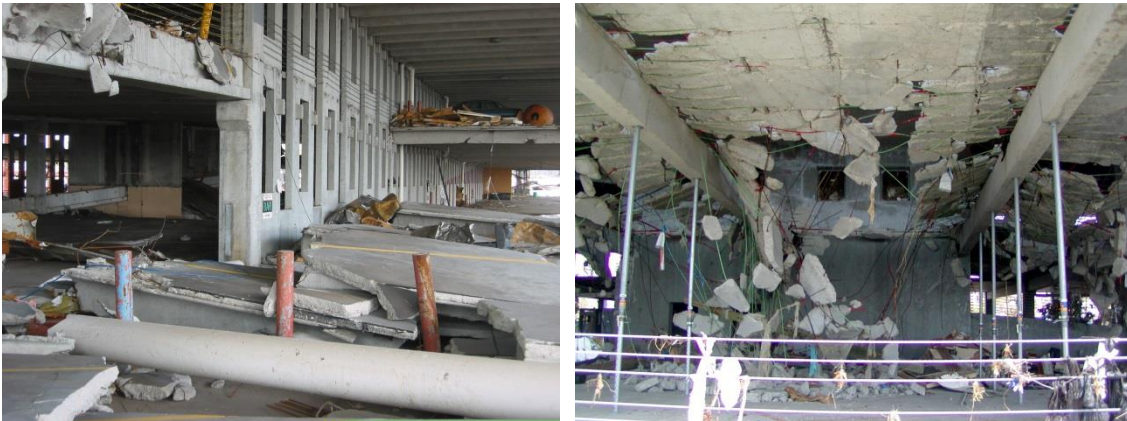
concrete parking structures located adjacent to port facilities in Gulfport and Biloxi, Mississippi. The double-tee floor system in the precast concrete parking structure (Figure 2-23, left) failed due to buoyancy as air was trapped between the webs of the double-tees. The posttensioned cast-in-place concrete slabs in another parking structure (Figure 2-23, right) were damaged by uplift due to storm surge and wave action.

Figure 2-23: Damage to precast parking structure in Gulfport (left) and prestressed cast-in-place parking structure in Biloxi due to hydrostatic and hydrodynamic uplift

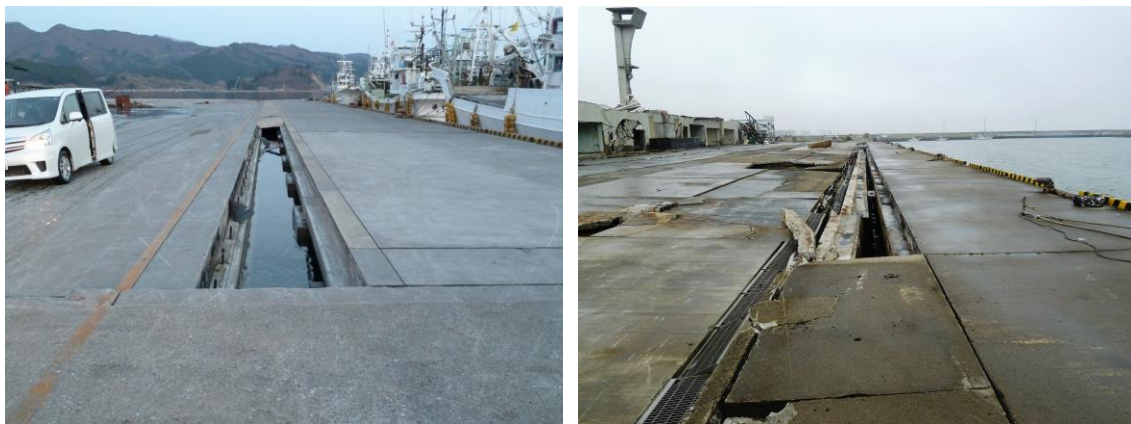
During the Tohoku Tsunami, similar hydrodynamic uplift loads developed below piers at a number of harbors. The resulting pressure was sufficient to lift the concrete or steel grating panels placed between the pile-supported piers and the adjacent soil-supported wharf (Figure 2-25 and Figure 2-26). Analysis of these “breakaway panels” indicates that the tsunami-induced hydrodynamic uplift pressure required to lift these panels ranged from 150 to 250 psf.

Figure 2-26: Concrete “breakaway” panels uplifted by the Tohoku Tsunami in Ofunato harbor (left) and Yuriagi harbor (right)

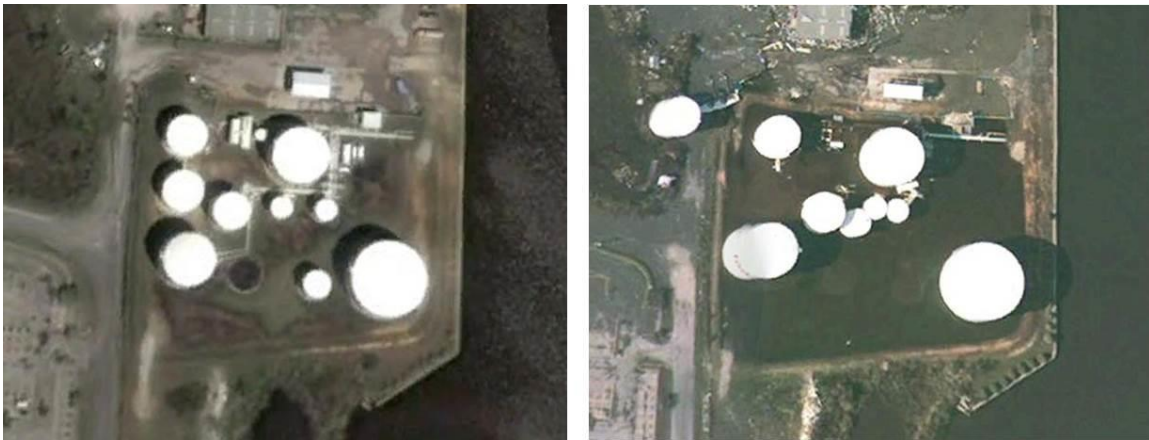
Damage to fuel storage tanks was observed at a number of locations along the Gulf Coast. Figure 2-27 shows before and after satellite images of a tank farm on the shores of Back Bay behind Biloxi, Mississippi. The inundation depth exceeded the earthen berm around the tank farm and caused flotation of a number of the storage tanks, including one tank that moved out of the containment area. The level of contents in each tank is unknown, but it is presumed that the tanks that floated may have been empty while those that remained in place may have had sufficient contents to resist the buoyancy forces. It was estimated that 482,000 gallons of fuel was released at this location (Frye, 2005).

Figure 2-27: Google Earth images of tank farm in Biloxi Back Bay before (left) and after (right) Hurricane Katrina

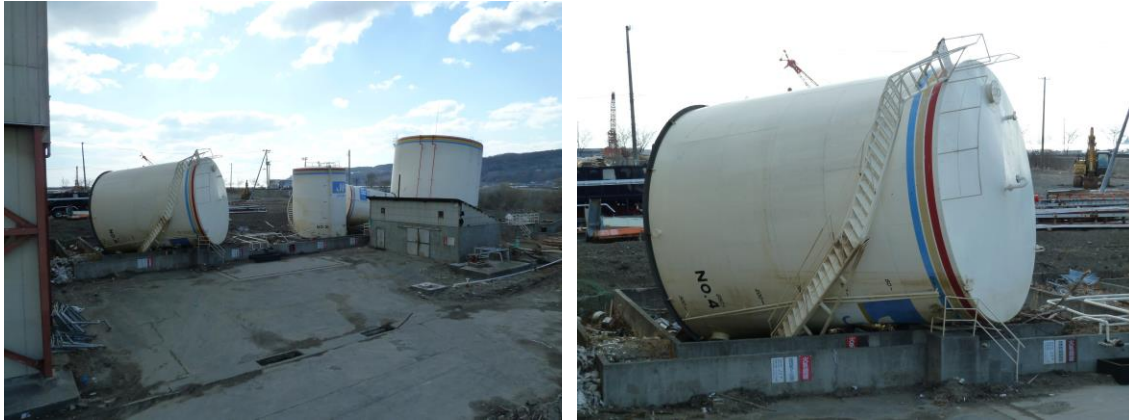
Even more severe damage to fuel storage tanks occurred during the Tohoku Tsunami (Figure 2-29 and Figure 2-30). Because these tanks generally have very thin steel walls, they are easily punctured, allowing the tank contents to spill. Depending on the fuel being stored, there may be a significant potential for fires to start, even in the wet conditions during a tsunami. Figure 2-31 shows a number of fires that developed in the Sendai Harbor during the Tohoku Tsunami. It is not known if fuel spills contributed to these fires, but some appear to be in or adjacent to fuel storage tank farms.

Figure 2-29: Damage to fuel storage tanks at Kuji Port during the Tohoku Tsunami

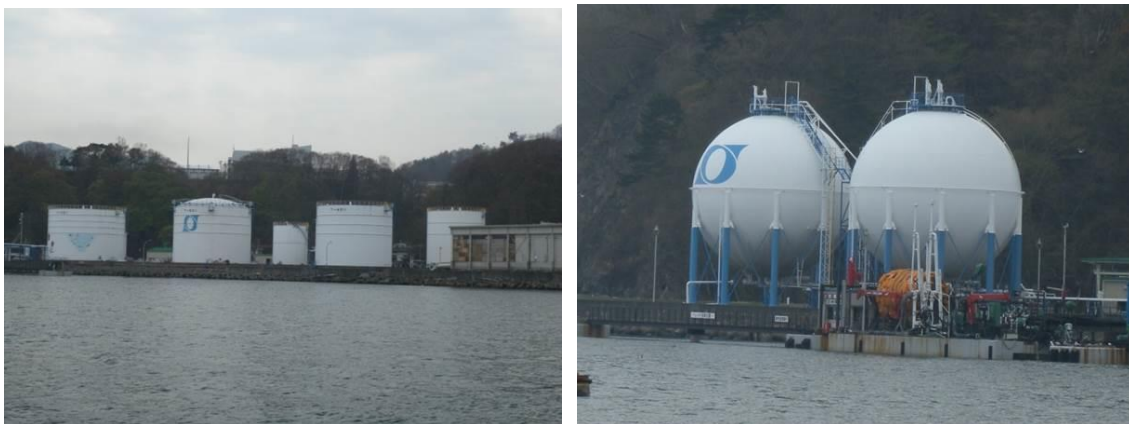
Some fuel storage tanks were able to survive the Tohoku Tsunami. Figure 2-32 shows two fuel storage locations in Kamaishi where the tanks were undamaged during the Tohoku Tsunami. The Liquid Natural Gas tanks are spherical and have relatively thick steel shells to withstand the high pressure of the contents. They are also generally elevated as shown in Figure 2-32 (right) thereby giving them increased protection from tsunami loads. It is not known if any piping, pumps, or other equipment at these locations was damaged by the tsunami.

Figure 2-32: Undamaged fuel tanks (left) and LNG tanks (right) at Kamaishi Harbor after the Tohoku Tsunami

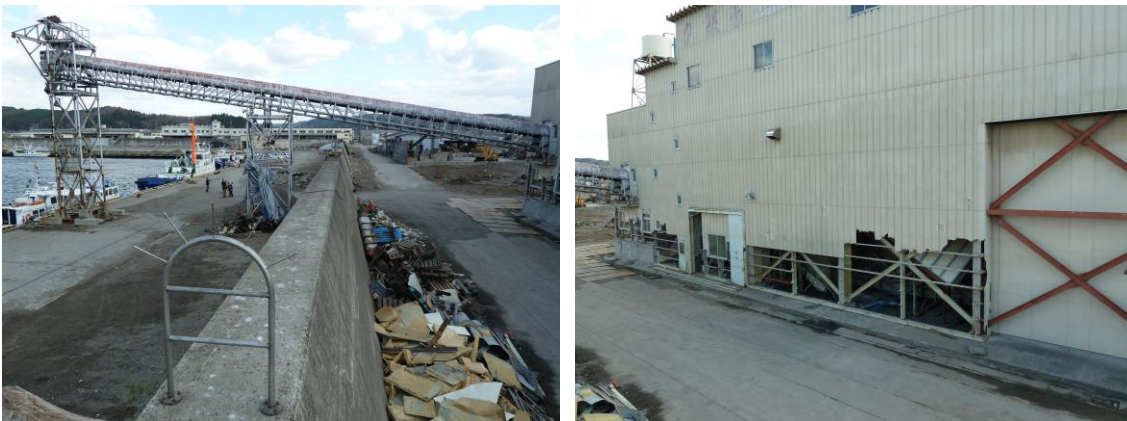
During the Tohoku Tsunami, a number of bulk handling facilities were damaged by the inundation. However, some facilities were relatively undamaged, such as the elevated conveyor system at Kuji Port in Japan (Figure 2-34, left). However, damage to the associated warehouse (Figure 2-34, right) probably still meant considerable downtime before bulk handling operations could resume.

Figure 2-34: Conveyor system (left) and associated warehouse (right) at Kuji Port, Japan.

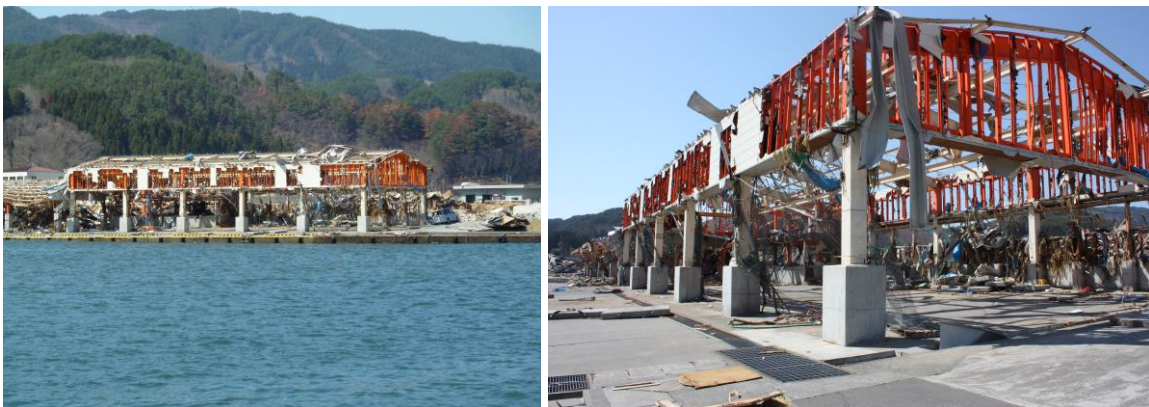
More extensive warehouse damage was observed after the Tohoku Tsunami, such as the steel-framed port-side building shown in Figure 2-36. However, because the structural frame remained intact, this warehouse could be restored by adding new cladding as seen in the July 2013 image from Google Earth street view in Figure 2-37.

Figure 2-36: Cladding stripped from steel-framed warehouse in Taro Harbor.

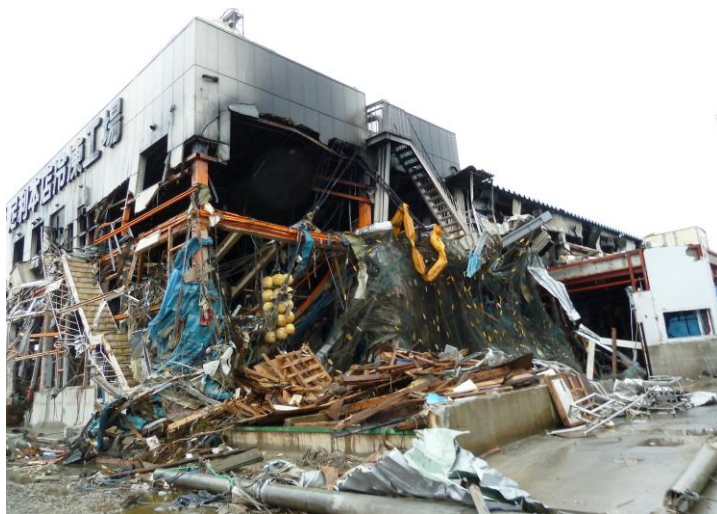
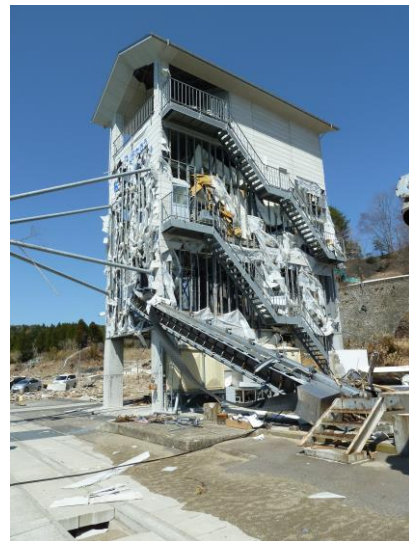
Similar cladding damage was observed at numerous other warehouses where the structural frame remained predominantly intact (Figure 2-38).

Figure 2-38: Port buildings with intact structural elements but extensive cladding damage; Kesennuma (left) and Taro (right)

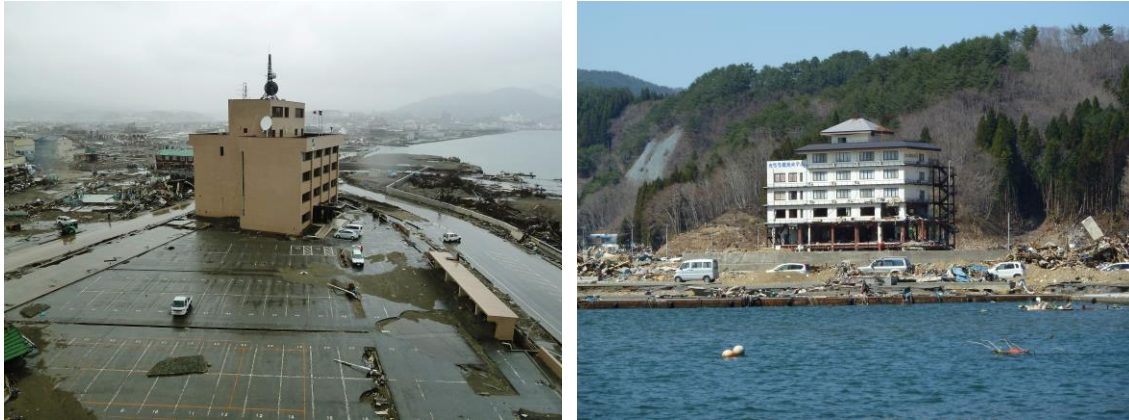
A number of multi-story concrete and steel buildings in or near harbors experienced considerable damage to non-structural elements, but survived structurally (Figure 2-39). These buildings would be relatively easy to repair and put back into service after the tsunami. Unfortunately the two buildings shown in Figure 2-39 have not fared that well. The vertical evacuation building in Kesennuma Harbor has been demolished while the Taro hotel remains unrepaired over 2 years after the tsunami (Figure 2-40).

Figure 2-39: Multi-story buildings that survived inundation to the third floor level; Reinforced concrete vertical evacuation building in Kesennuma Harbor (left) and steel-framed hotel adjacent to Taro Harbor (right).

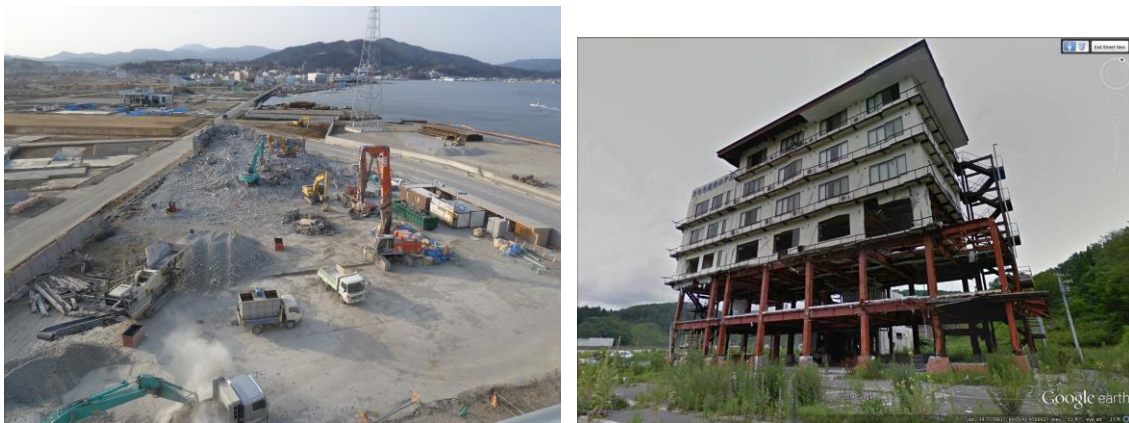
Figure 2-40: Demolition of Kesennuma vertical evacuation building in March 2013 (left) and unrepaired state of Taro Hotel from Google Earth street view July 2013 image (right).

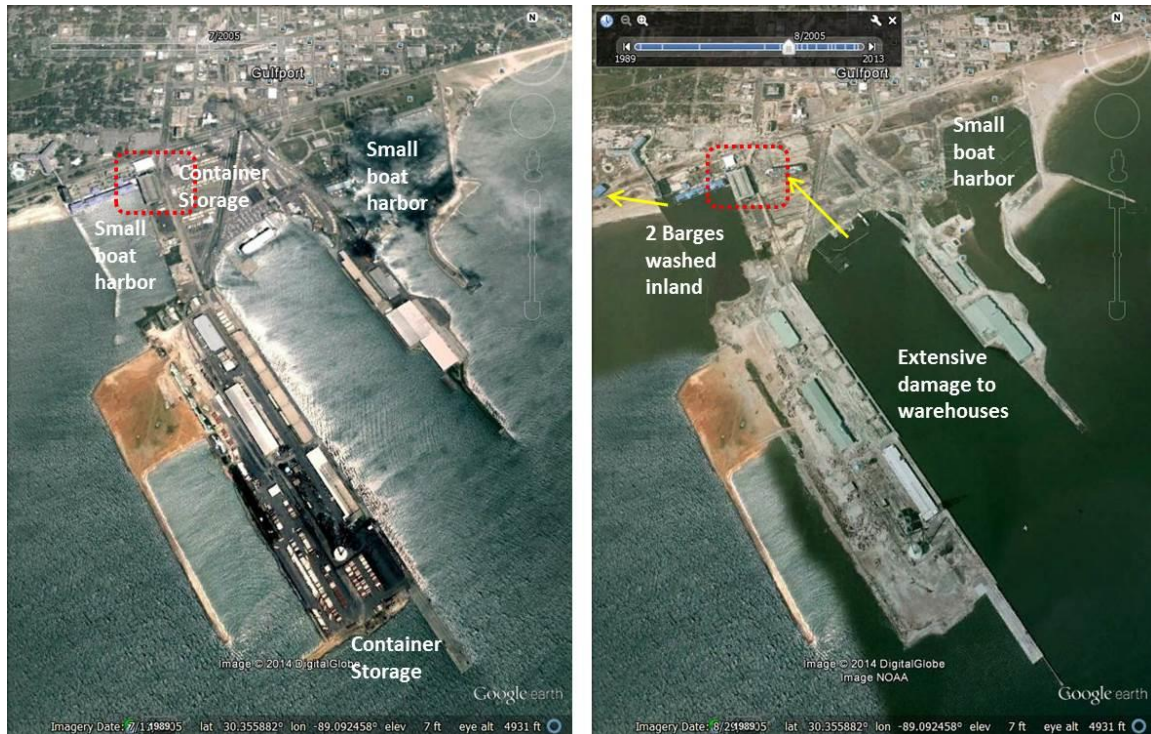
Gulfport harbor suffered considerable damage during Hurricane Katrina. Figure 2-41 shows Google Earth satellite images before and after the hurricane. Extensive damage occurred to the steel-framed warehouses on both piers. Two barges broke free from their moorings and washed inland. All boats in the two small boat harbors were washed away, along with extensive damage to the dock systems. All shipping containers at the two storage yards were washed away, becoming floating debris for nearby structures. The container handling cranes remained intact, only experiencing water damage to electrical and mechanical components below the inundation level (Fritz, et al., 2008).

Figure 2-41: Google Earth images of Gulfport Harbor, Mississippi, before (left) and after (right) Hurricane Katrina

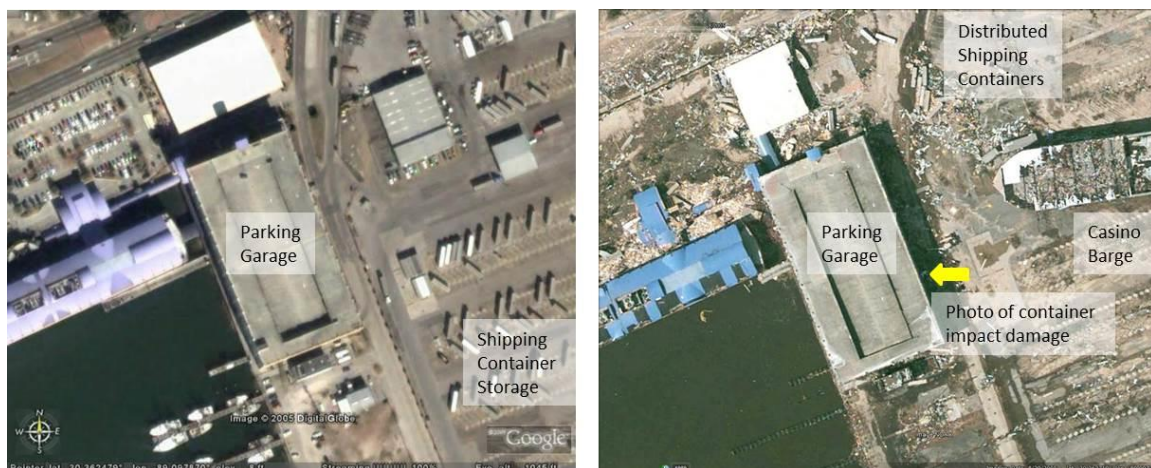
Figure 2-42: Google Earth images of portion of Gulfport Harbor before (left) and after (right) Hurricane Katrina showing shipping containers that impacted a parking garage

Figure 2-42 shows a portion of Gulfport Harbor with a concrete parking garage adjacent to a shipping container storage yard. Figure 2-43 shows damage to the lower levels of the precast concrete parking structure due to impacts from floating containers from the storage yard. Because of the relatively substantial nature of these columns and spandrel beams, most of the impact damage is superficial. The precast double-tee floor system supported by these spandrel beams collapsed due to buoyancy and hydrodynamic uplift (Figure 2-23, left).

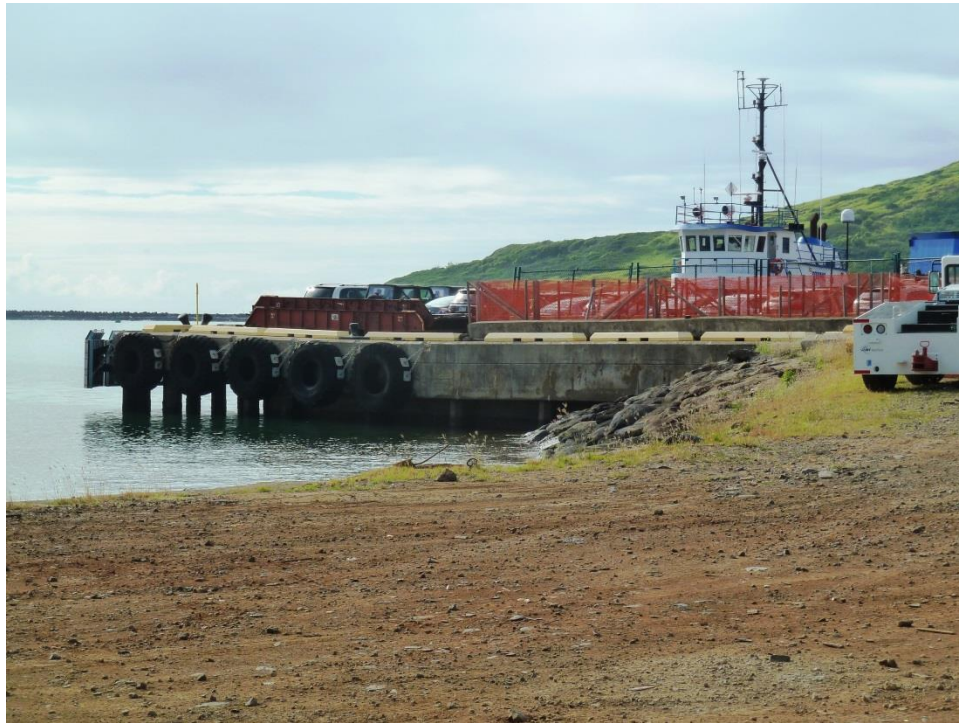
and wave action, and during tsunami inundation. In particular, the orientation of Pier 3 makes it most susceptible to incoming tsunami flow and hurricane wave action. Pier 3 was completed in 1994 and is constructed using closely spaced driven piles encased in large reinforced concrete beams supporting the reinforced concrete pier deck (Figure 4-7 and Figure 4-8). This integral construction provides superior resistance to the uplift forces and would be expected to survive anticipated hydrodynamic loading. However, drawings for the pier were not reviewed for this project, and no structural or hydrodynamic analysis was performed to verify the anticipated performance of this structure, or Piers 1 and 2, during future inundation events.

Figure 4-7: Edge of Pier 3 showing closely spaced driven pile supports

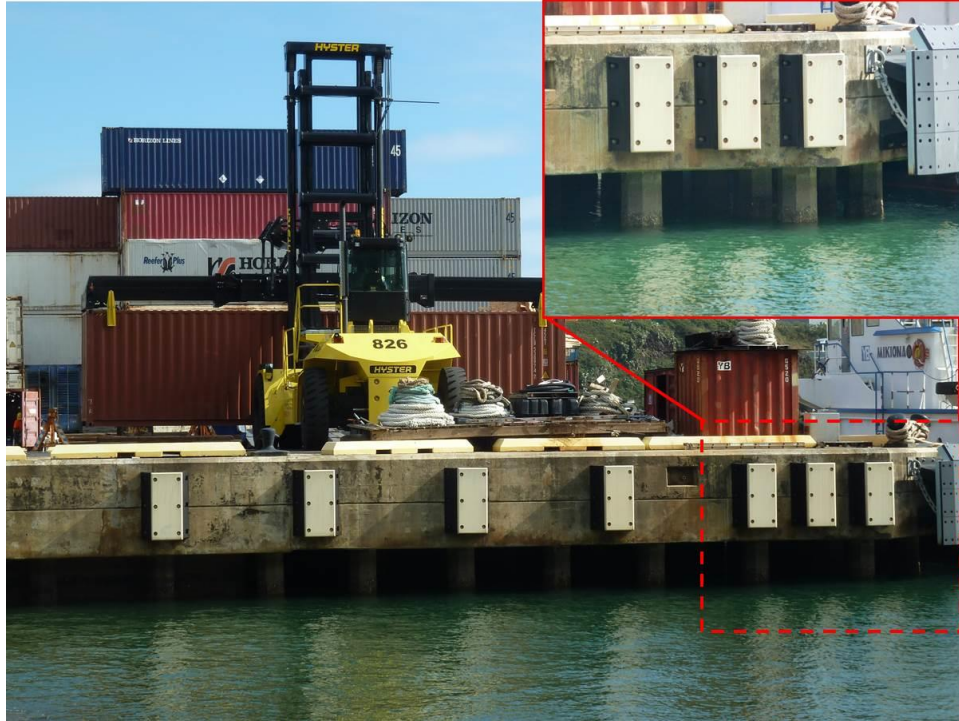
Figure 4-8: Pier 3 container handling and pile support detail

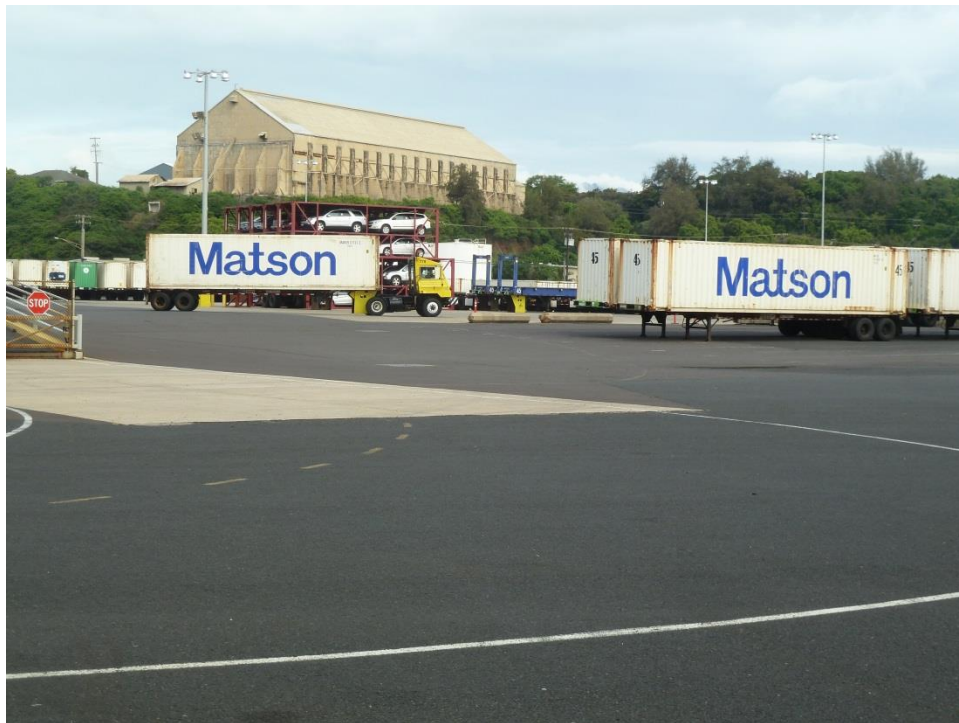
The main shipping container storage areas are on Pier 1 and Pier 3 (Figure 4-8 and Figure 4-9). Both areas are directly exposed to inundation due to storm surge or tsunamis (Figure 4-2 and Figure 4-6). Containers with hazardous contents are stored on chassis ready for removal to high ground in the event of a hurricane or tsunami warning (Figure 4-9). Others are stacked without restraint, so would be expected to float during a major inundation event. They will then become floating debris with the potential for striking structures and other harbor facilities and causing considerable damage. Many of the containers will be washed off the piers and potentially sink in the harbor basin or entry channel, reducing the available draft. This would be a major concern that needs to be resolved prior to allowing ships into the harbor after a hurricane or tsunami.

Figure 4-9: Chassis-mounted containers on Pier 1

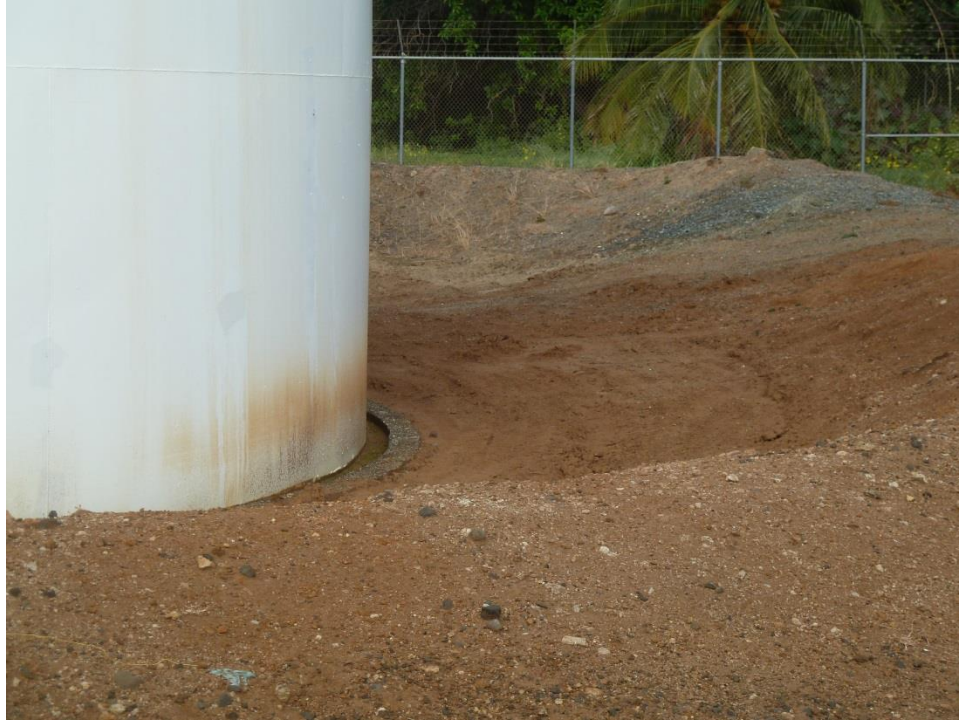
Pier 1 (Figure 4-10). The storage tanks do not appear to be secured to their foundations, and are surrounded by a small earthen berm for containment purposes (Figure 4-11). Other than self-weight, there does not appear to be any resistance to buoyancy of an empty or partially filled tank. In addition, the small earthen berm surrounding the tank farm will easily scour or be overtopped during storm surge or tsunami inundation, so it cannot be considered as protection for the tank farm. It is therefore highly likely that some or all of these tanks will be displaced during a major inundation event, potentially leading to fuel spills and fires.

Figure 4-11: Midpac fuel storage tank base and containment berm

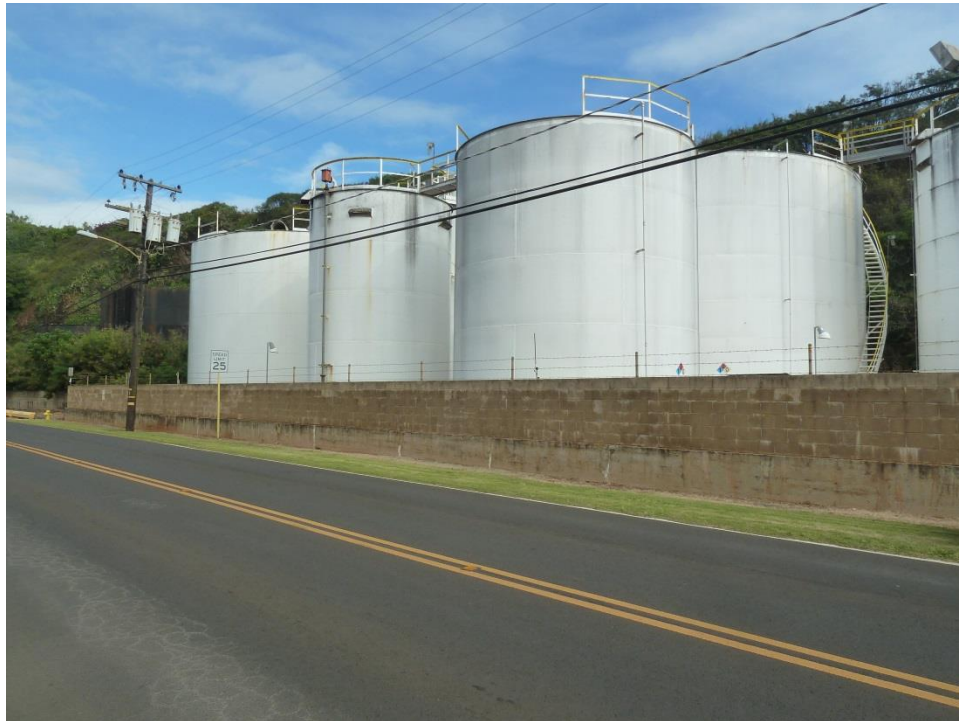
The second fuel storage facility is the Aloha tank farm adjacent to Pier 2 (Figure 4-2). This facility is surrounded by a 6 foot high concrete wall (Figure 4-12). The top of the wall is approximately 14 feet above MSL. This wall was presumably designed as a containment wall, so would be able to resist internal hydrostatic pressure, but may not be adequate for external hydrostatic pressure due to storm surge, and may not be adequate to resist high velocity tsunami flow. Figure 4-6 shows that flow depths could exceed 16.5 feet at this location during a Great Aleutian Tsunami event. If the wall is overtopped by tsunami inundation, the tanks will be subject to potential flotation, buckling, or impact from floating debris. Resulting fuel spills could lead to fires that can spread with the water flow. A portion of the fire suppression system is located on the outside of the containment wall (Figure 4-13) and appears to be vulnerable to debris impact damage. This is also the case for the numerous fuel pipes both inside and outside the containment wall.

Figure 4-12: Containment wall around Aloha fuel storage facility at Nawiliwili Harbor

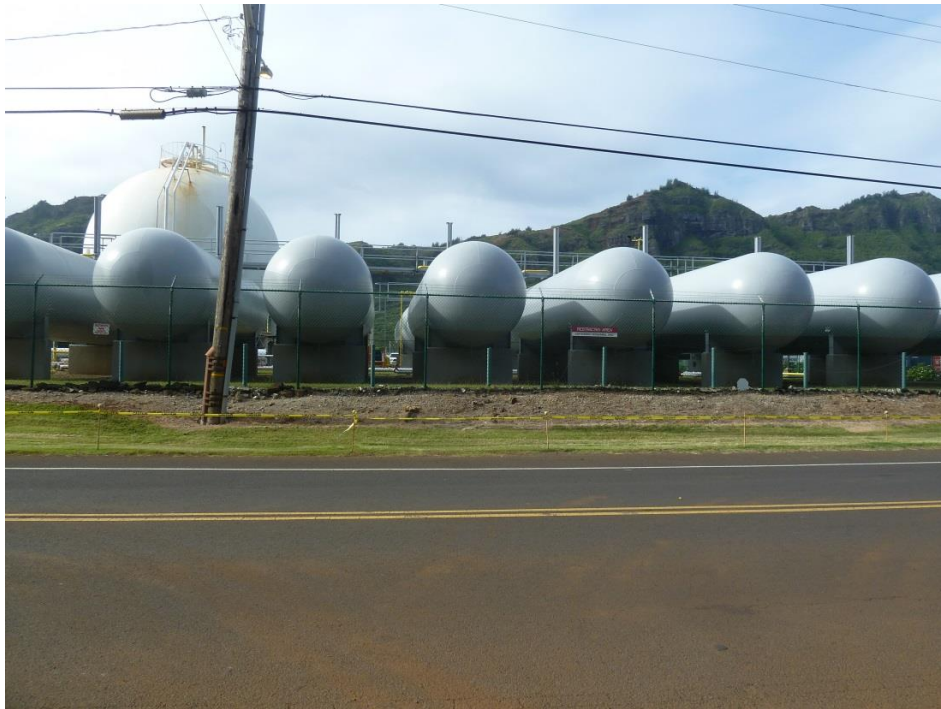
A Gasco Inc. propane storage facility is located adjacent to Pier 3 (Figure 4-2). This facility does not require a containment wall, so it is only surrounded by a security chain-link fence (Figure 4-14). This fence will not provide protection against floating shipping containers from Pier 3, or other debris impacts.

Figure 4-14: Gasco Inc. propane storage tanks adjacent to Pier 3 in Nawiliwili Harbor

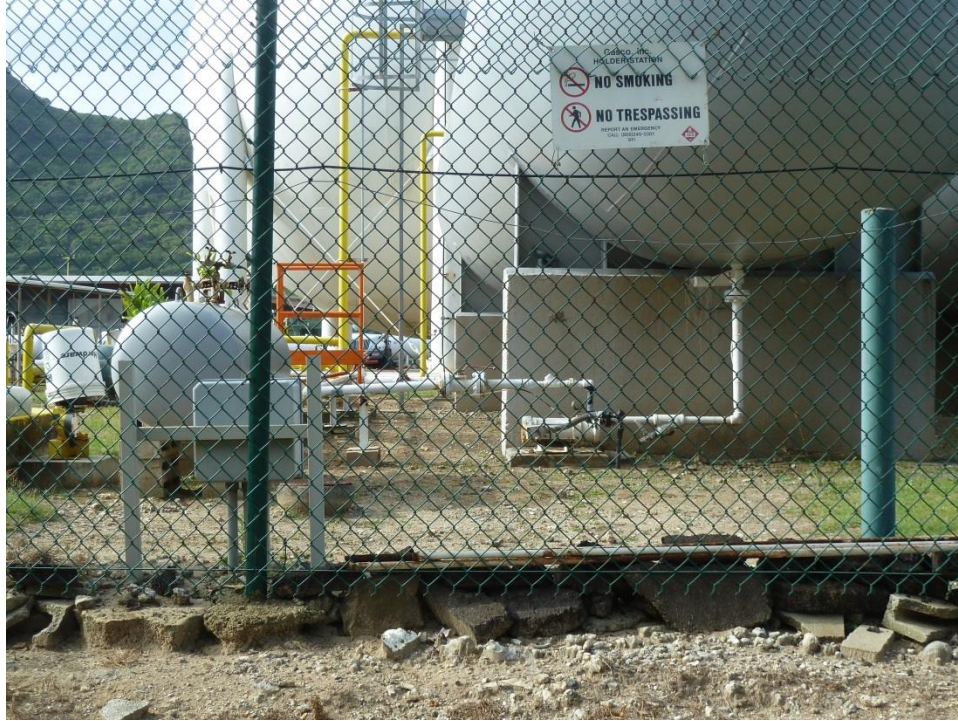
Figure 4-15: Gas tank connection to concrete foundation.

The cylindrical and spherical storage tanks appear to be anchored to their concrete foundations (Figure 4-15), which will assist in preventing displacement due to buoyancy. However, the strength of the anchor bolts and size of the concrete foundations is unknown, so a complete evaluation of buoyancy potential could not be performed for this study. There is also potential for breakage of the pipes leading from these tanks due to floating debris strikes. Shutoff valves and other safety measures already in place at a gas storage facility should help to mitigate the potential for a gas leak and potentially explosive fire.

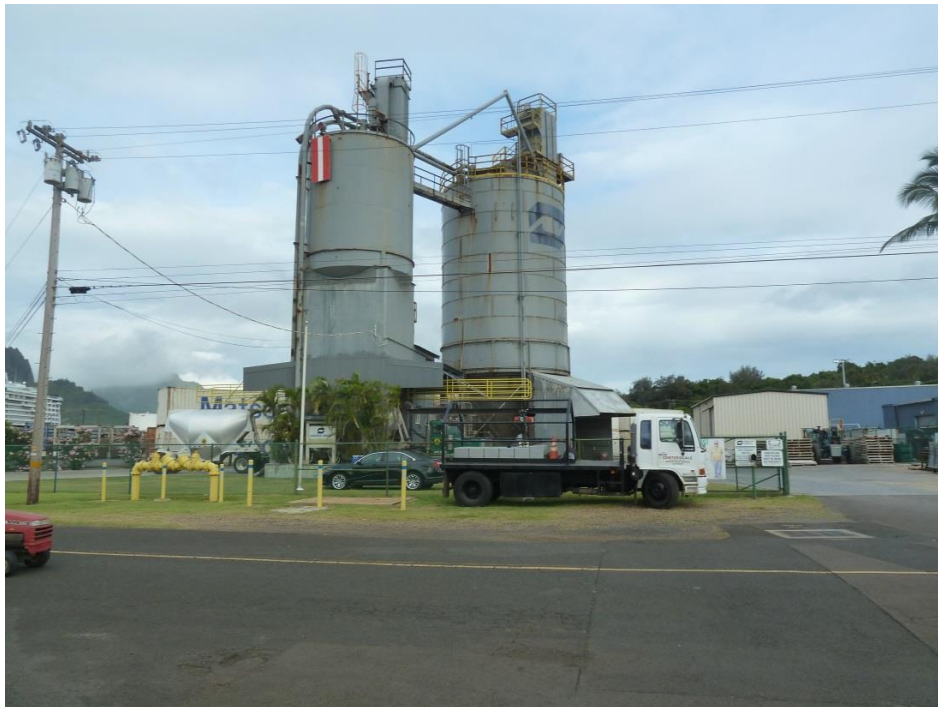
The only bulk handling facility at Nawiliwili Harbor is the cement storage silos adjacent to the container storage yard at Pier 1 (Figure 4-2 and Figure 4-16). These silos are elevated above ground level, but are supported by relatively slender steel columns and cross-bracing. Debris impact damage to these supports, or to the piping and machinery used to operate the silos, could affect the availability of cement for reconstruction work after a major inundation event. Only limited cement supplies are stored at the concrete ready-mix companies on Kauai.

Figure 4-16: Cement Storage Silos at Nawiliwili Harbor
