**Vulnerability of Hawaii Commercial Port and Harbor Facilities to
Tsunamis and Hurricane Storm Surge and Wave Action**

**PROJECT REPORT
for
Hawaii Department of Transportation, Harbors Division**

Research Report UHM/CEE/15-01

February 19, 2015

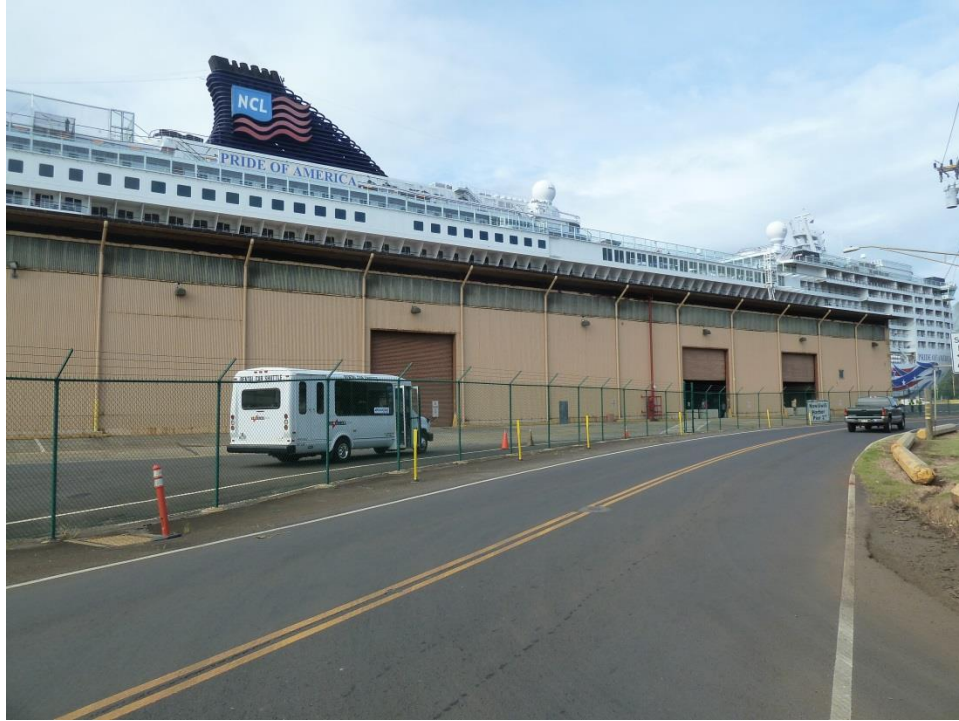
The only major buildings in Nawiliwili Harbor are metal frame warehouses on Pier 1 and Pier 3 (Figure 4-17 and Figure 4-18). It should be anticipated that the exterior roller doors and sheet metal cladding on these buildings will be damaged during an inundation event. It is suggested that the roller doors be left fully open during future warnings so as to reduce damage to the doors. It is also possible that floating debris strikes could damage some of the structural columns and bracing members, but it is unlikely that the entire warehouse structures will be destroyed. These buildings are used for equipment and other storage purposes, as well as cruise boat loading and offloading, but are not essential for restoring harbor operations after an event.

Figure 4-17: Warehouse on Pier 1

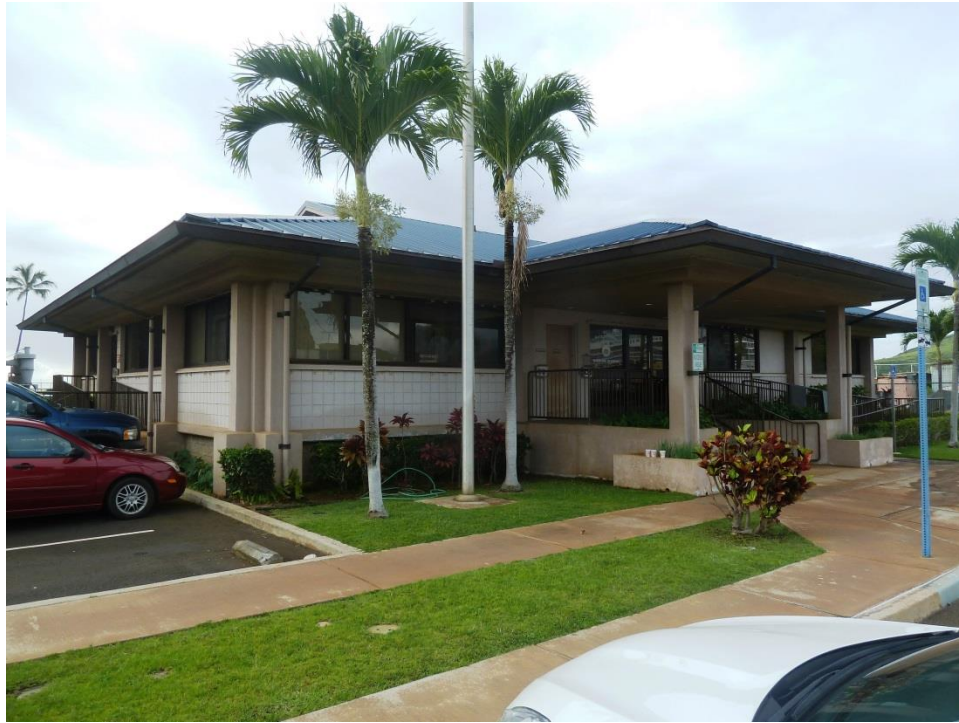
The Harbor Master office is a single-story building elevated a few feet above grade (Figure 4-19). It is located near the entrance to the harbor (Figure 4-2) and will likely be severely damaged during a major inundation event. The Coast Guard facility near the back of the harbor (Figure 4-2 and Figure 4-20) will also be severely damaged. No critical equipment or functions should be maintained at these facilities because they will likely not be available after a major inundation event.

Figure 4-19: Nawiliwili Harbor Master office

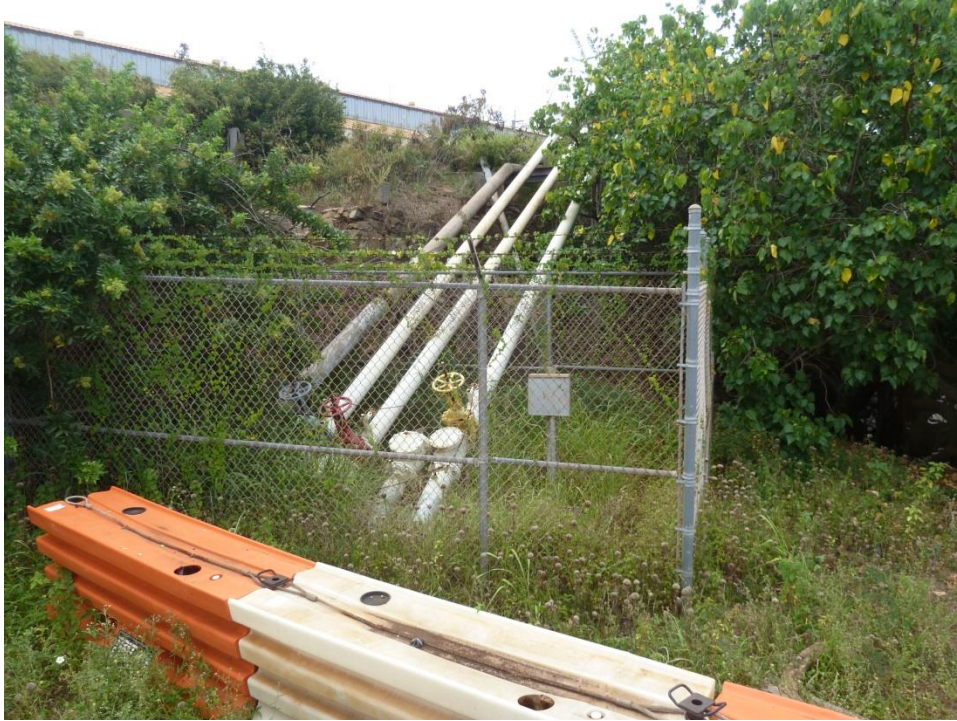
The only fuel storage tanks at Port Allen are in a Chevron facility located well above the anticipated inundation level (Figure 4-21 and Figure 4-26). No damage to these facilities or the adjacent power plant is anticipated because of their elevation above MSL. However, the pipes that lead from the harbor pier to the Chevron storage tanks may be damaged by debris impacts (Figure 4-27). Safety measures should be in place to prevent a fuel spill in case any of these pipes should be damaged during an inundation event.

Figure 4-27: Pipes carrying fuel from Port Allen pier 1 to Chevron storage facility

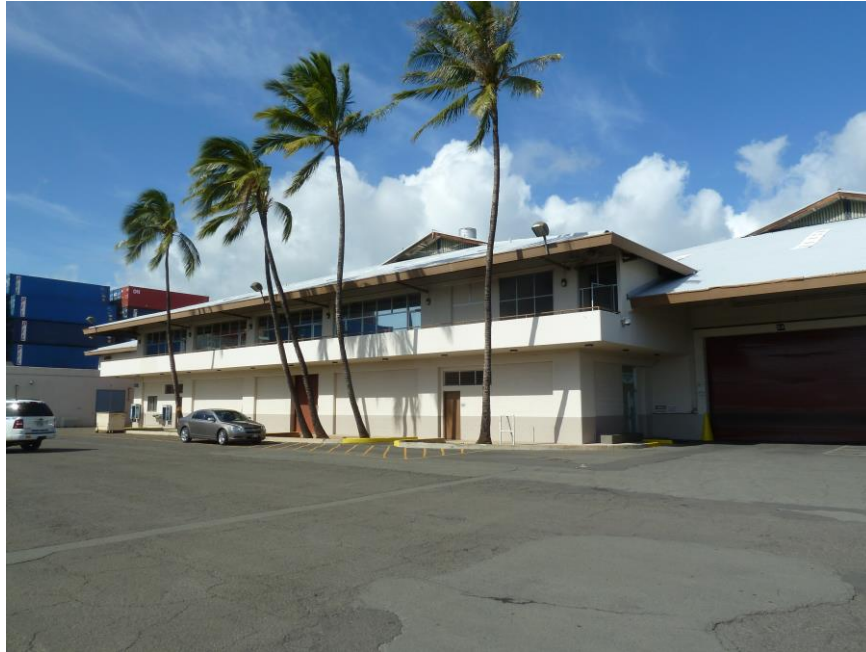
The harbor EOC is currently located on the second floor of the reinforced concrete warehouse on Pier 2 (Figure 4-37). This location is approximately 12 feet above Pier 2, which should be adequate to avoid inundation during even the GAT event (Figure 4-35). The building is a relatively sturdy reinforced concrete frame building with infill masonry walls (Figure 4-38). Although there may be localized damage to the building due to impact from floating shipping containers, it is likely that the building will survive the anticipated flow depths of less than 10 feet above Pier 2. No evaluation has been performed of the tsunami capacity of this structure.

Figure 4-37: Honolulu Harbor EOC on second floor of warehouse building on Pier 2

The emergency generator for this EOC is currently on the ground floor where it could be rendered inoperable by water damage. All emergency power generation and other critical equipment for this EOC should be located on the second level or roof to ensure continued functioning of the EOC during and after the event.

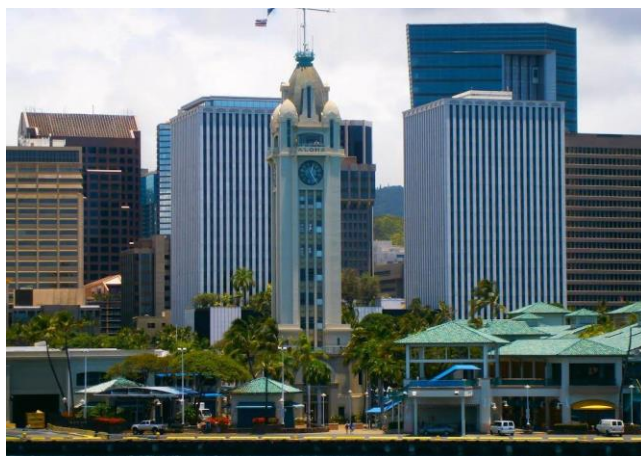
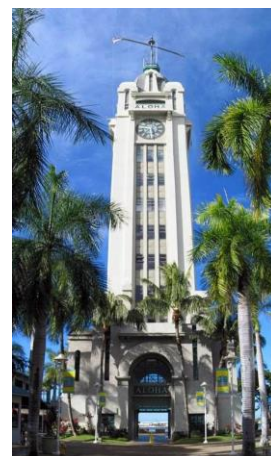
The Harbor Control Center on the 9th floor of Aloha Tower will also remain occupied and active during a hurricane or tsunami event (Figure 4-30). This tower is a sturdy reinforced concrete structure that should survive the anticipated flow depths of less than 10 feet (Figure 4-39). No structural evaluation has been performed of the Aloha Tower to evaluate its tsunami resistance. Again, all emergency power generation and other critical equipment for the Harbor Control Center should be located above the 2nd floor level of the Aloha Tower.

Figure 4-39: Aloha Tower with Harbor Control Center on 9th Floor level

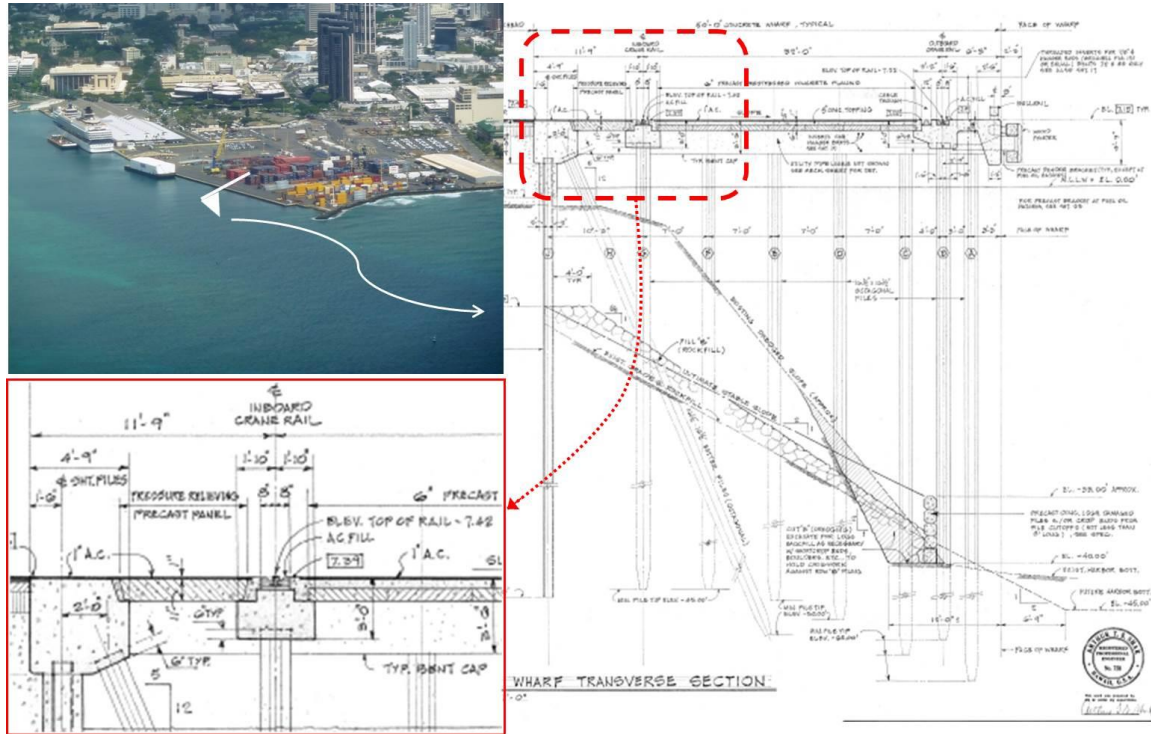
Pier 1 is currently used by Pasha Hawaii for roll-on roll-off container and vehicle shipping (Figure 4-30). Because of its proximity to the mouth of the harbor, and exposure to wave action during storms, this pier was constructed with a “pressure relieving precast panel” system (Figure 4-40). Based on the weight of the panels and the soffit area exposed to uplift pressure, these panels can be expected to lift when the pressure below the pier deck exceeds 175 psf. Once the relief panels have opened a gap at the back of the pier, the uplift pressure on the remaining pier deck will drop significantly, thereby reducing the potential for further damage to the pier.

Figure 4-40: Drawing details of Pier 1 showing “pressure relieving precast panels”

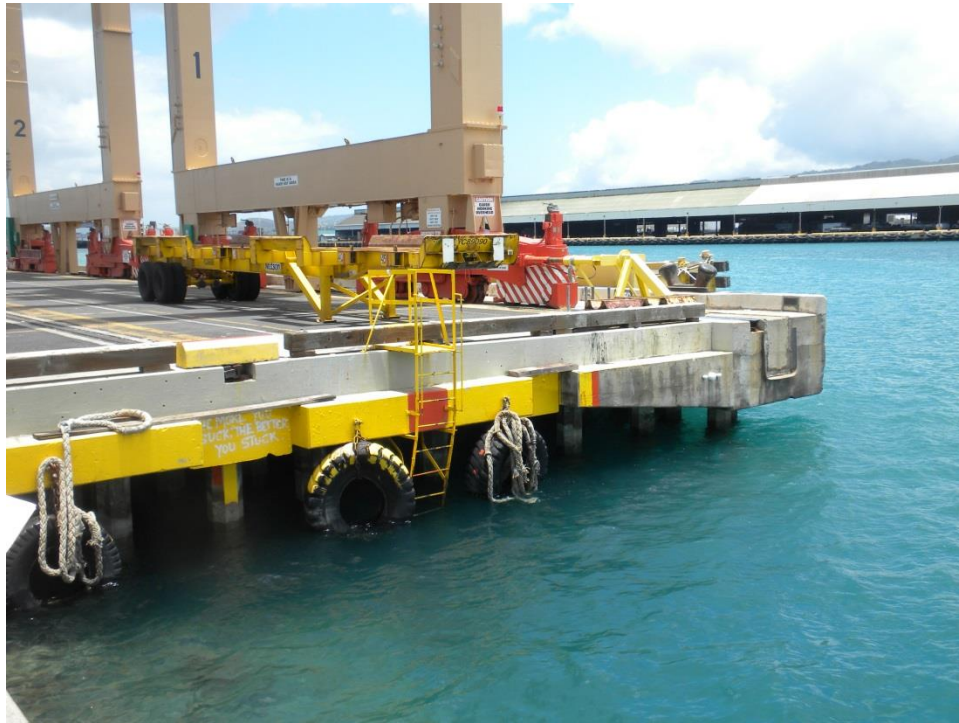
The majority of trans-oceanic shipping container handling currently takes place at Pier 51 (Horizon Lines) and Piers 52 and 53 (Matson Shipping) on Sand Island (Figure 4-32). Figure 4-41 shows an end view of Pier 53, with closely spaced driven piles integrally connected to the deck beams and slab. These piers are designed to support significant gravity loads, including the cranes used to load and offload shipping containers. They are therefore relatively substantial and would not be expected to suffer any damage during a hurricane or tsunami.

Figure 4-41: End view of Pier 53 with shipping container handling crane

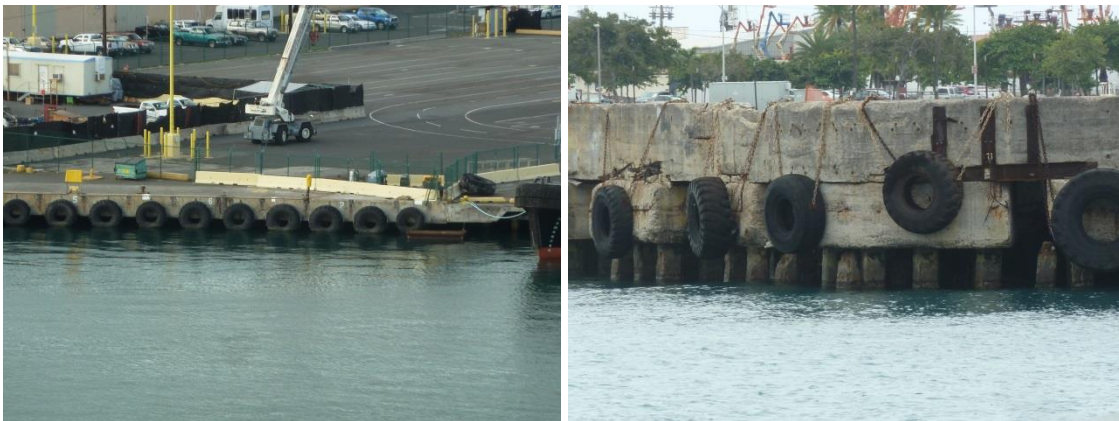
The majority of the active piers at Honolulu Harbor are relatively recent construction and in good condition. However, there are some older piers that may suffer damage during an extreme event (Figure 4-42). Provided the functions served by these older piers are not critical to harbor operations, there is no need to strengthen them for hurricane or tsunami loads.

Figure 4-42: Pier 21 (left) and Pier 27 (right) represent older pier construction in Honolulu Harbor

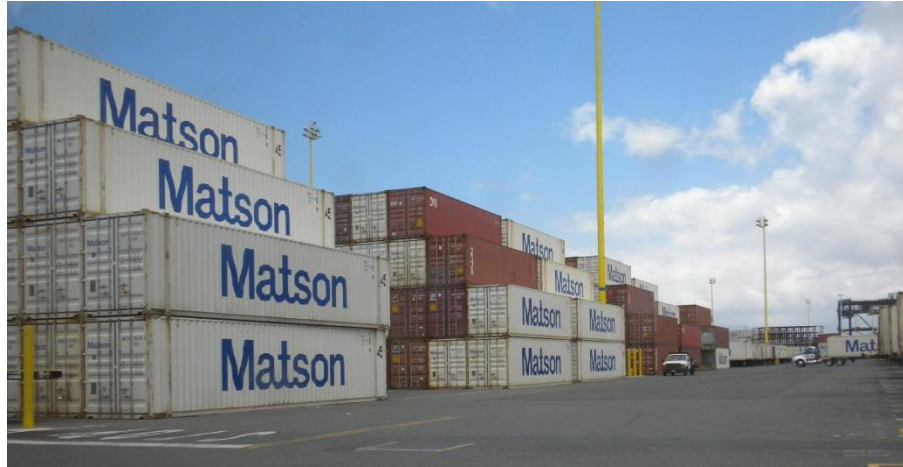
Shipping containers are generally stacked 3 to 4 high (Figure 4-43) without any restraint or interconnection between containers. With anticipated flow depths of 3 to 10 feet, all enclosed shipping containers would be anticipated to float and be displaced with the flow. A stack of four empty 40 foot containers requires less than 2 feet flow depth in order to float. A fully loaded 20ft container only requires 3 feet of inundation to float. A possible solution to this problem would be the use of open-sided containers at the bottom of container stacks to avoid buoyancy effects till the flow reaches the second layer of enclosed containers.

Figure 4-43: Container stacks at Matson facility on Sand Island

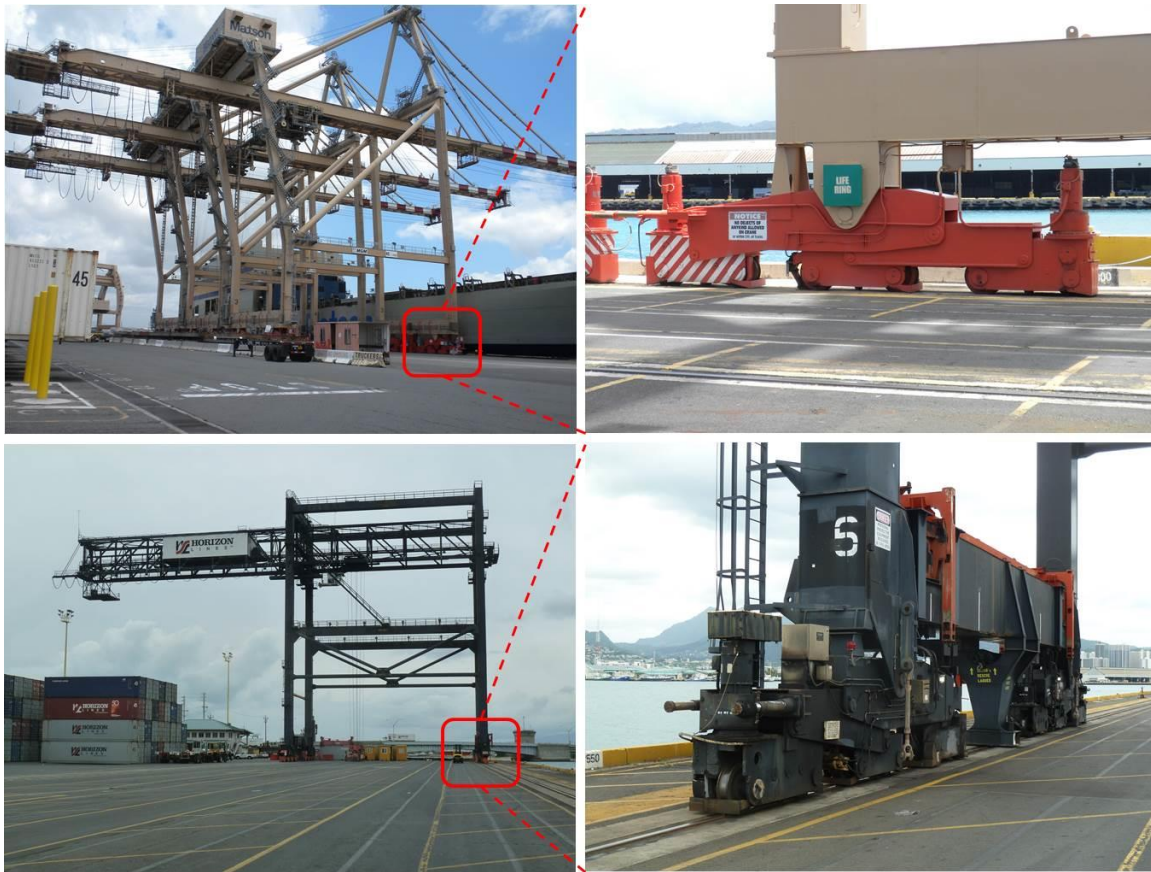
Shipping containers on Sand Island are offloaded using gantry cranes (Figure 4-45). These cranes will likely experience impact strikes from floating shipping containers during an inundation event. These impacts will only affect the lower sections of the crane legs, which are constructed as box columns using relatively thick steel plate. It is unlikely that the debris strikes will cause any structural damage to the crane framing elements. However, water and debris impact damage to electrical and other sensitive equipment located at the base of the cranes will likely make the cranes inoperable after an event (Figure 4-45).

Figure 4-45: Container Cranes at Matson (top) and Horizon (bottom) on Sand Island

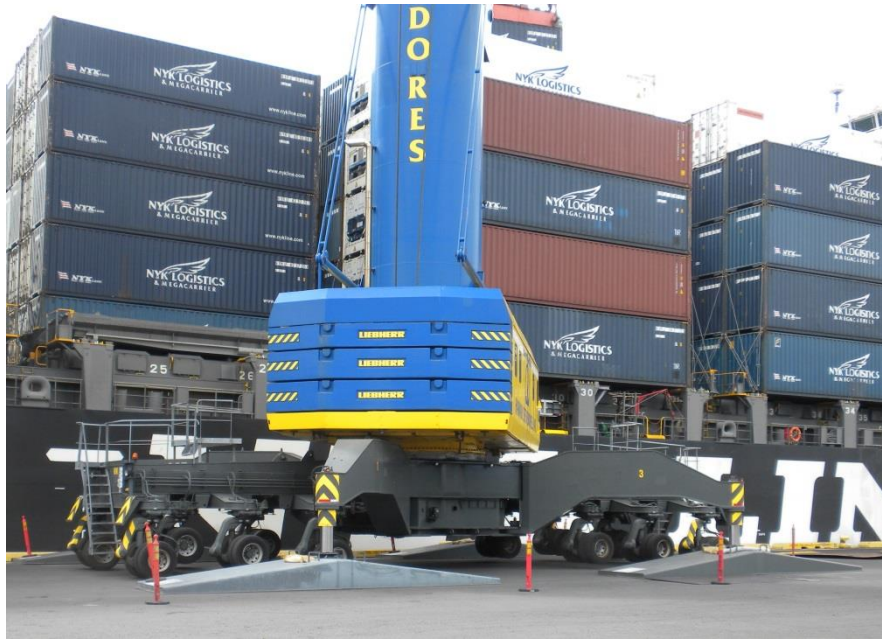
On Pier 1, a mobile crane is used by Hawaii Stevedores Inc. to offload shipping containers (Figure 4-46). Although it is mobile, the crane cannot be moved from the pier because of its size and weight. It will likely suffer damage to electrical and mechanical equipment below the inundation level.

Figure 4-46: Hawaii Stevedores Inc. mobile crane at Pier 1

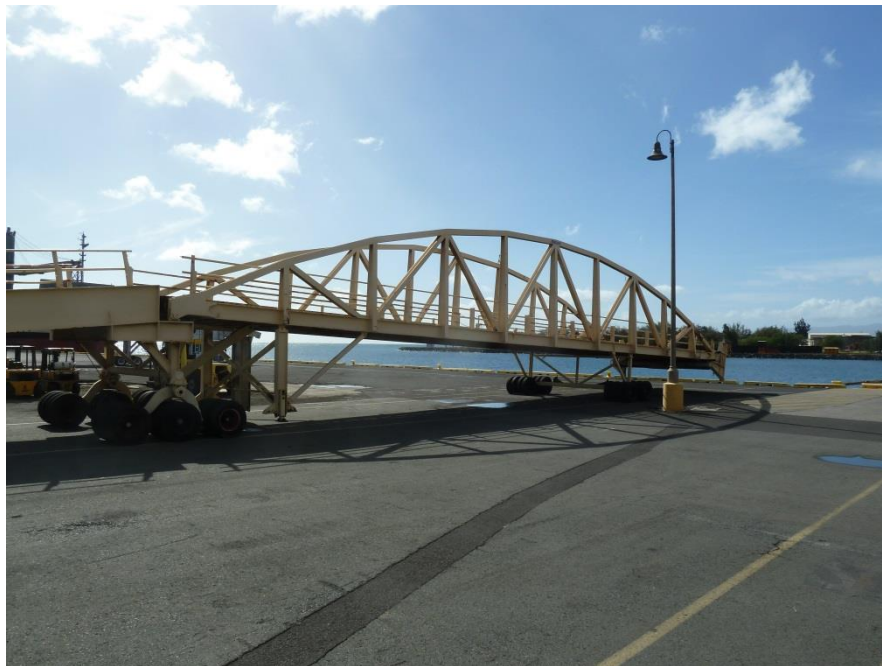
Matson has in the past used a roll-on roll-off facility at Pier 1, with no crane equipment. The ramp structures used in this operation could be damaged by impact from floating shipping containers, and may need repair after an inundation event (Figure 4-47).

Figure 4-47: Ramp used for roll-on roll-off loading operations at Pier 1

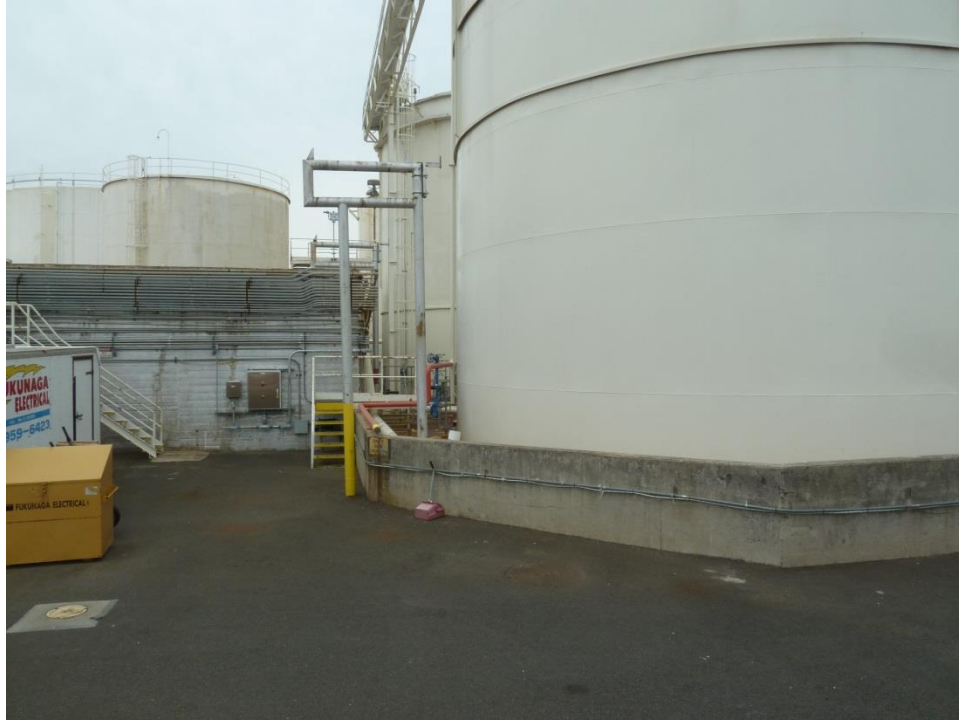
There are two primary fuel storage locations within or near Honolulu Harbor. The first is a tank farm adjacent to Pier 30 where Chevron stores fuel for ships (Figure 4-31). This tank farm consists of three adjoining containment areas surrounded by reinforced concrete walls with heights of 3, 6 and 10 feet above the pier (Figure 4-49). With flow depths for the Great Aleutian Tsunami estimated at 3.3 to 6.6 ft. in this location (Figure 4-35), it is likely that the 10 ft. high wall will be sufficient to prevent inundation of the tanks in that enclosure. The 6 ft. high may also be adequate, but the 3 ft. high wall will likely be overtopped. This could lead to flotation of the tanks and damage to electrical and mechanical equipment in the tank enclosure. Because of the shipping container storage area adjacent to the tank farm, there is also a high potential for debris strikes on the tanks, piping and other equipment associated with the tank farm (Figure 4-50).

Figure 4-49: Chevron ship fuel storage tanks with 3 ft. and 10 ft. high containment walls

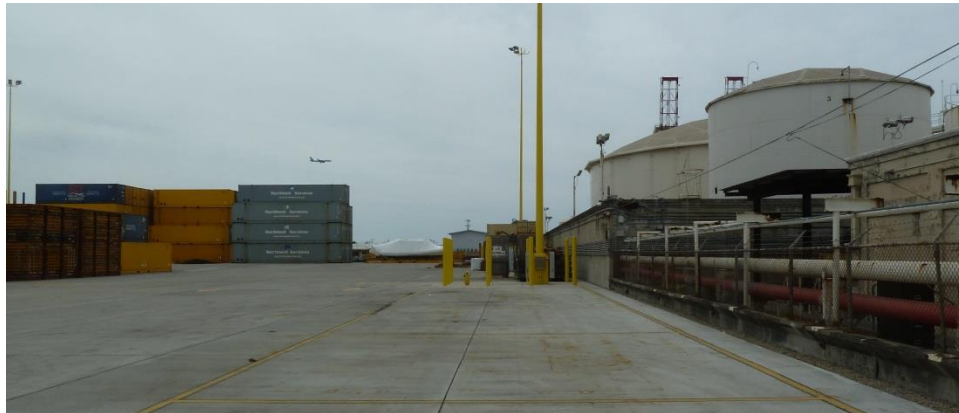
Figure 4-50: Proximity of Chevron tank farm to shipping containers on Piers 29 and 30

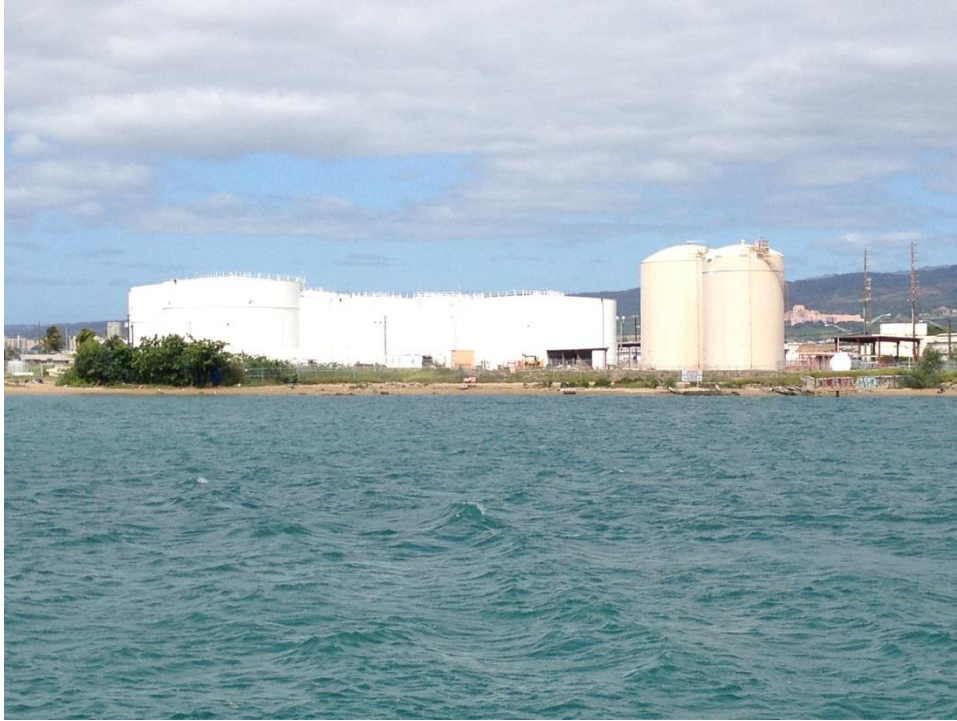
The second major fuel facility is the aviation fuel storage tank farm adjacent to Sand Island Access Road (Figure 4-32). This facility is on the shoreline of Keehi Lagoon and is surrounded by only a 3 ft. high containment wall (Figure 4-51 and Figure 4-52). Flow depths at this location during the GAT event are anticipated to exceed 6 ft. (Figure 4-35), meaning that these walls will be overtopped. The tank farm is also exposed to debris impact from the Keehi Lagoon Small Boat Harbor to the West (Figure 4-53), and shipping containers at the proposed new shipping container storage facility at Kapalama Military Reservation to the East (Figure 4-54).

Figure 4-51: Aviation Fuel Storage tank farm between Sand Island Access Road and Keehi Lagoon

Because of the critical nature of both fuel storage locations for ship and airplane refueling operations, it is important that these facilities be protected from damage during a major inundation event. Alternatively, fuel storage outside of the inundation zone might be able to serve as an emergency reserve. For example, fuel storage at the Red Hill underground tank farm for Joint Base Pearl Harbor Hickam could be used as a reserve location for both ship and aviation fuel. This would require a Memorandum of Understanding between the State and US Navy for shared use of this facility after a disaster.

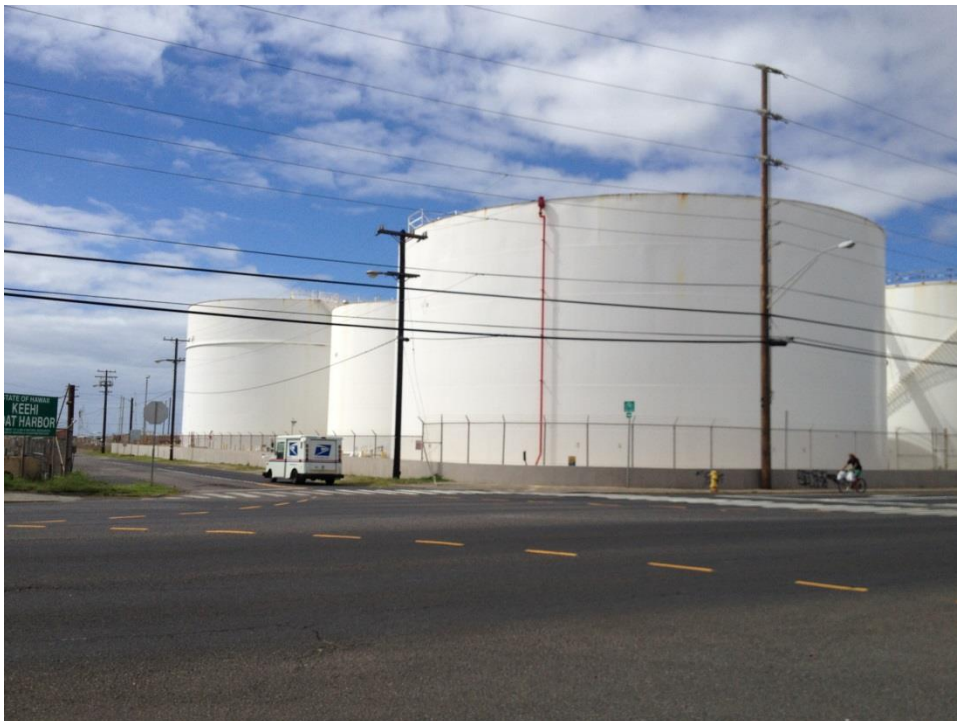
Figure 4-52: Aviation Fuel Storage tank farm with 3 ft. high containment wall

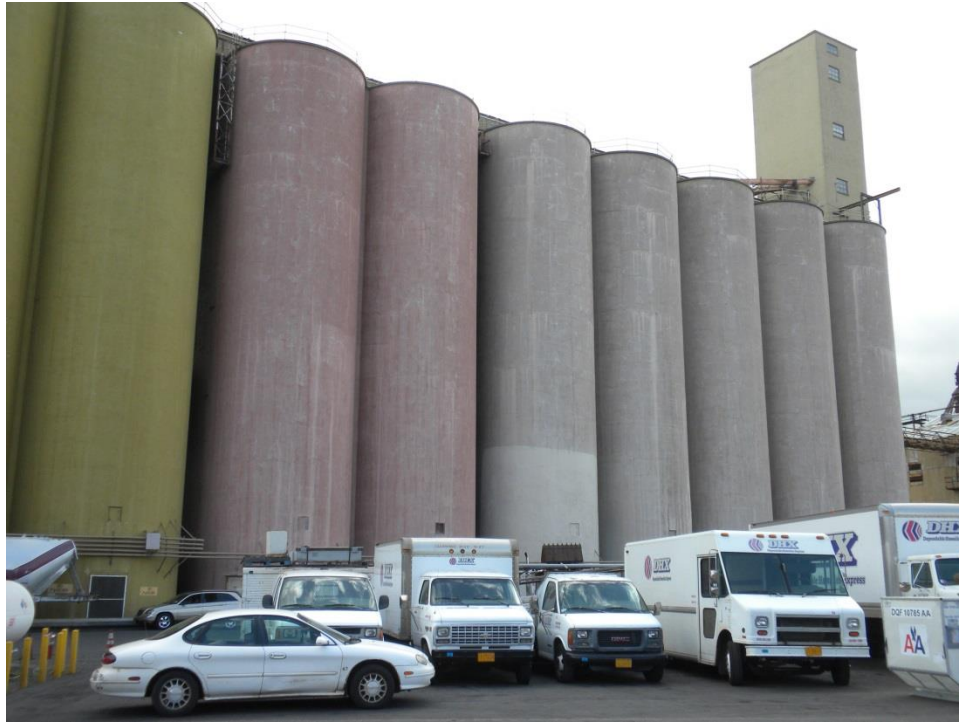
The majority of bulk handling facilities on the Island of Oahu are located at Kalaeloa Barbers Point Harbor (See Section 4.5.5). However, bulk importation and storage of wheat is performed at the grain silos adjacent to Pier 23 in Honolulu Harbor (Figure 4-31 and Figure 4-55). Although it is unlikely that the reinforced concrete silos will be damaged by inundation, associated electrical and mechanical equipment will likely be inoperable due to submersion in salt water or impact from floating debris.

Figure 4-55: Grain Silos adjacent to Pier 23 in Honolulu Harbor

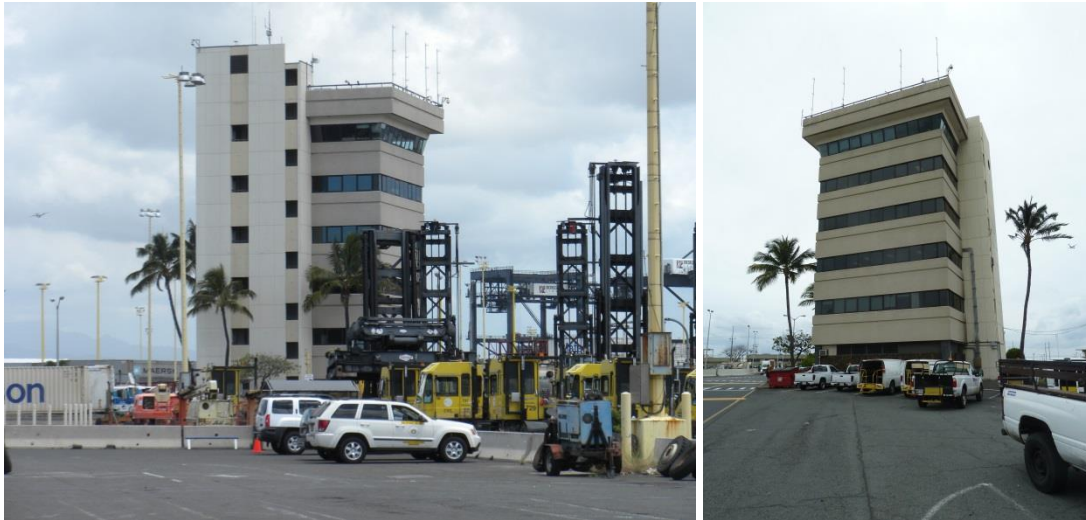
The Matson container storage facility on Sand Island is controlled from a 6 story control tower (Figure 4-56). With anticipated flow depths less than 10 feet at this location, it is unlikely that this tower will be structurally compromised during an inundation event, even though it will be exposed to impact from floating shipping containers. No structural evaluation was performed to verify this assumption. It is anticipated that the control tower will remain occupied by a skeleton staff during an inundation event so as to speed cleanup and recovery operations.

Figure 4-56: Control tower at Matson Shipping Container facility on Sand Island.

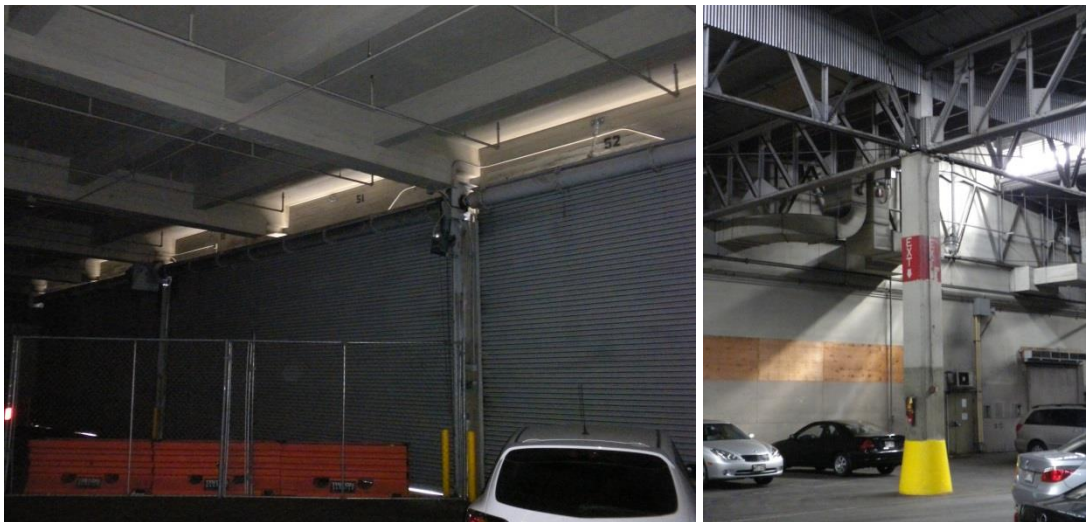
A large reinforced concrete warehouse at Piers 10 and 11 is used for cruise ship loading and unloading, as well as housing the harbor operations offices (Figure 4-31). A portion of this structure is a reinforced concrete beam-slab elevated floor supported by concrete columns (Figure 4-57, left), while the rest of the structure consist of steel roof trusses

supported on reinforced concrete columns (Figure 4-57, right). The flow depths at this location are not anticipated to reach the second level or roof framing, so would only affect the column and wall elements.

Figure 4-57: Structural framing members in warehouse on Piers 10 and 11.

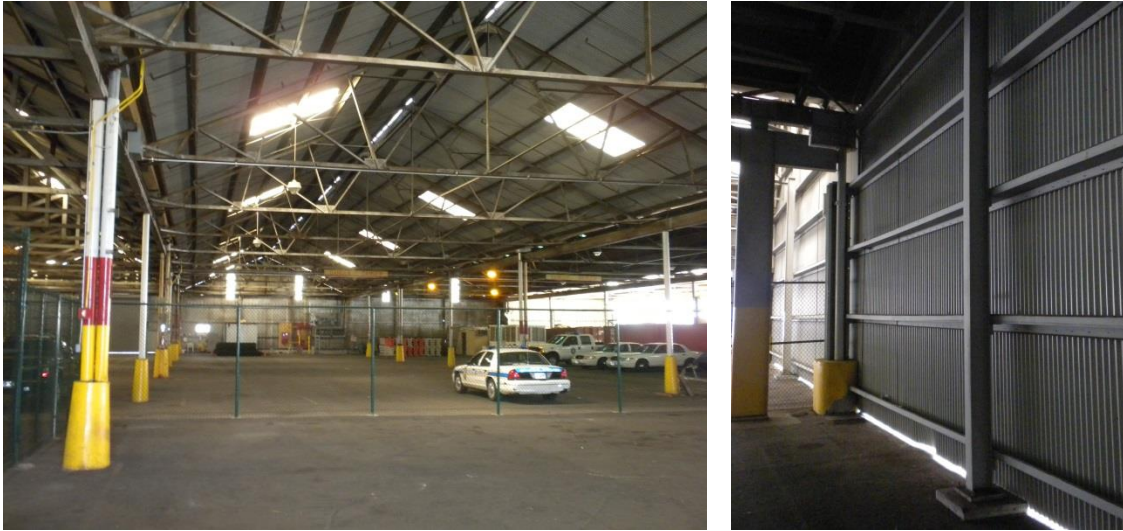
A warehouse structure on Pier 19 was used in conjunction with the interisland ferry during its tenure (Figure 4-58). This steel framed building is clad with sheet metal, which is expected to suffer considerable damage during an inundation event. The steel columns are also susceptible to impact damage, even though they have been encased in concrete for the lower 3 feet. This warehouse currently has limited use and is probably not critical to harbor operations.

Figure 4-58: Interior views of warehouse on Pier 19

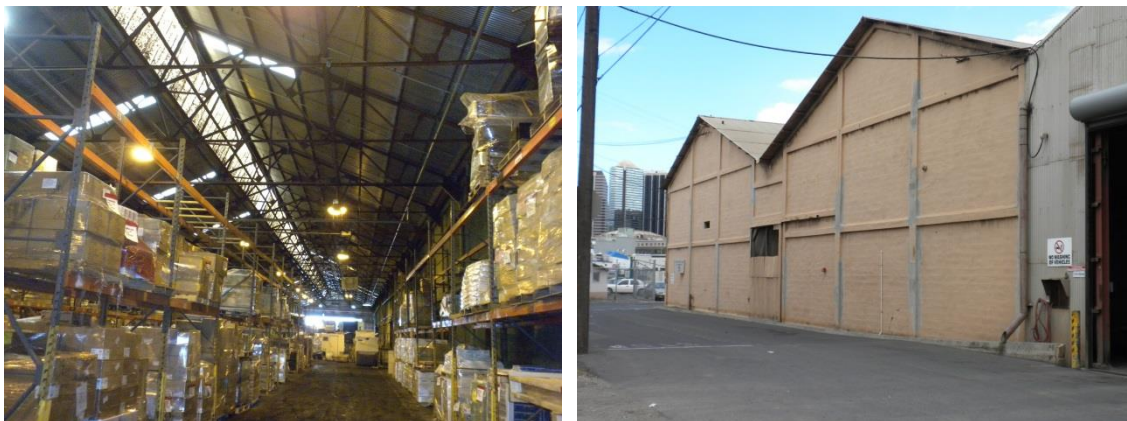
A large warehouse on Pier 22 is used for handling and storing pallet cargo and other non-containerized items (Figure 4-59). The building has a steel truss roof system supported on exterior walls consisting of reinforced concrete frames with infill masonry panels. These exterior masonry walls and relatively slender columns may be vulnerable to high velocity

flow loading and debris impact damage. The contents of the building will also be exposed to water damage during an inundation event.

Figure 4-59: Interior and exterior views of warehouse on Pier 22

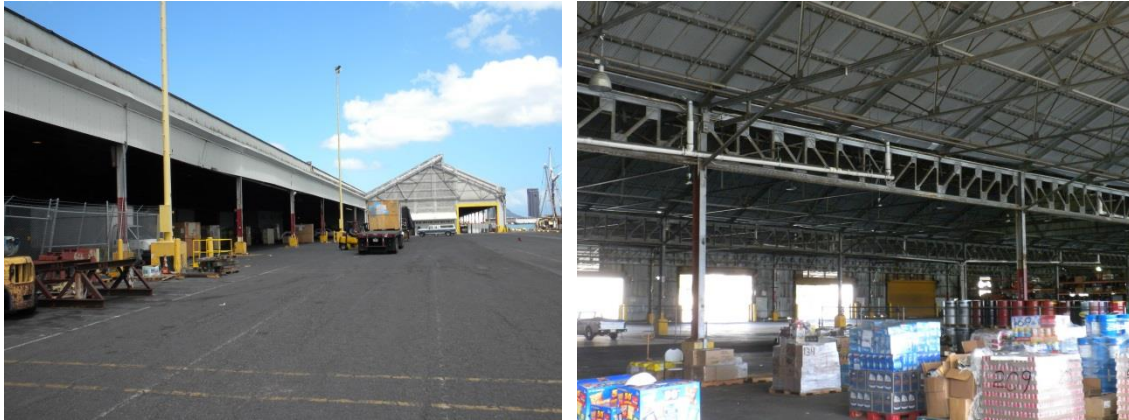
A large warehouse on Piers 31 to 33 is currently used for handling and storage of non-containerized cargo (Figure 4-60). Inundation will only affect the walls and columns of this structure. The steel columns are supported on concrete pedestals (Figure 4-61, left). The exterior wall is either sheet metal on girts (Figure 4-61, center) or concrete frame with infill masonry walls (Figure 4-61, right). All of these elements, including the cross-bracing, could be damaged by hydrodynamic flow and debris impacts.

Figure 4-60: Steel framed warehouse on Piers 31 to 33

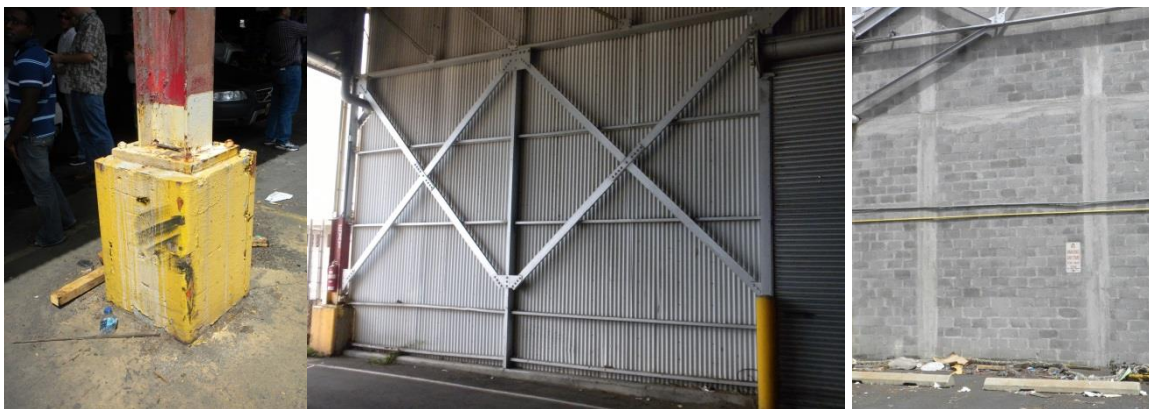
Figure 4-61: Details of framing members in warehouse on Piers 31 to 33

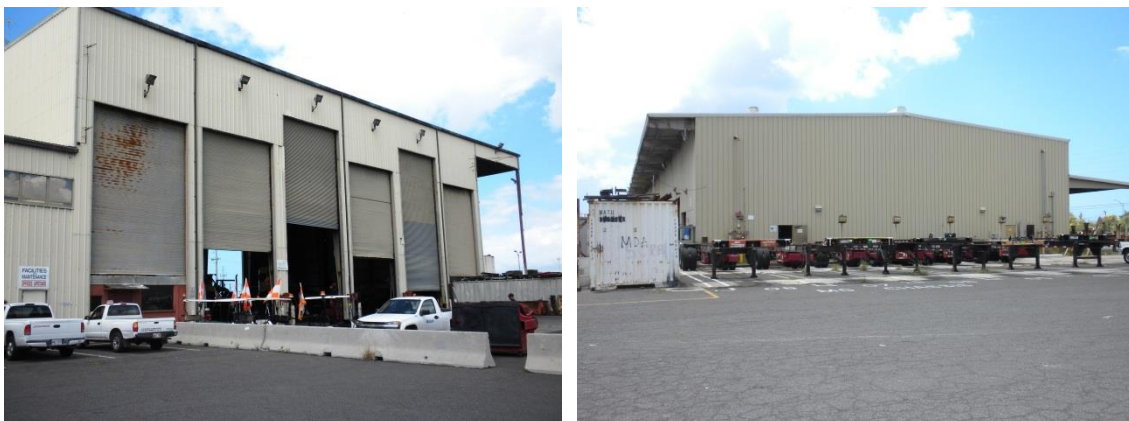
Two large warehouses in the Matson shipping container facility on Sand Island also consist of steel framed buildings with sheet metal cladding (Figure 4-62). Damage to the sheet metal and localized impact damage to the lower extents of the columns can be anticipated during an inundation event.

Figure 4-62: Pre-manufactured steel framed warehouses on Sand Island

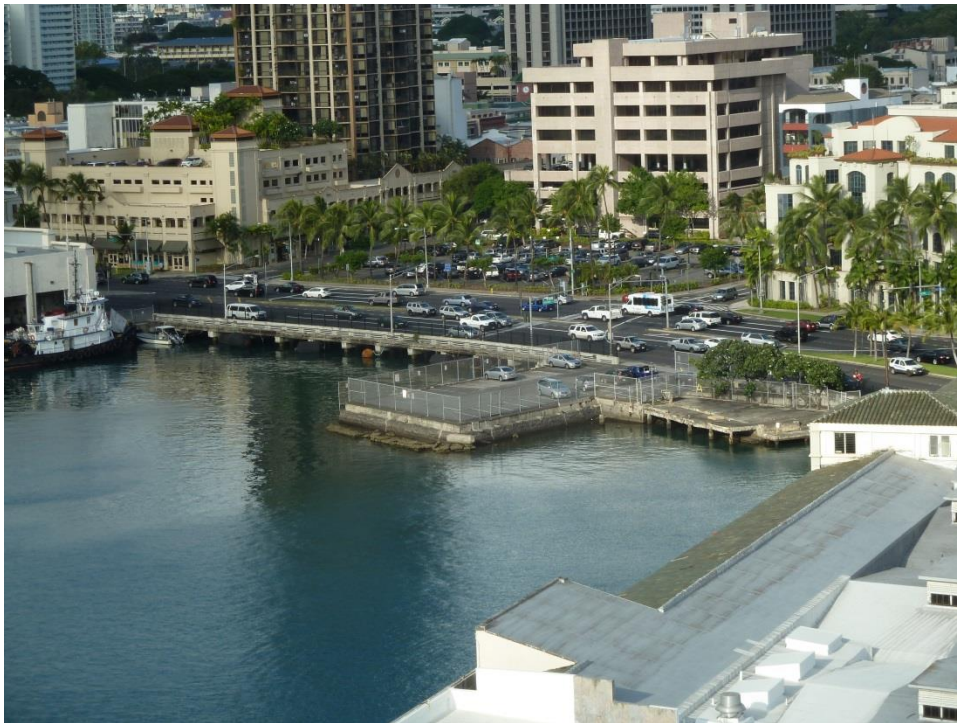
boats and fishing vessels. Nimitz highway, a major artery that runs along the North edge of the harbor, is also exposed to potential impact loads and debris accumulation during an inundation event (Figure 4-64).

Figure 4-64: Nimitz highway running around the North side of Honolulu Harbor

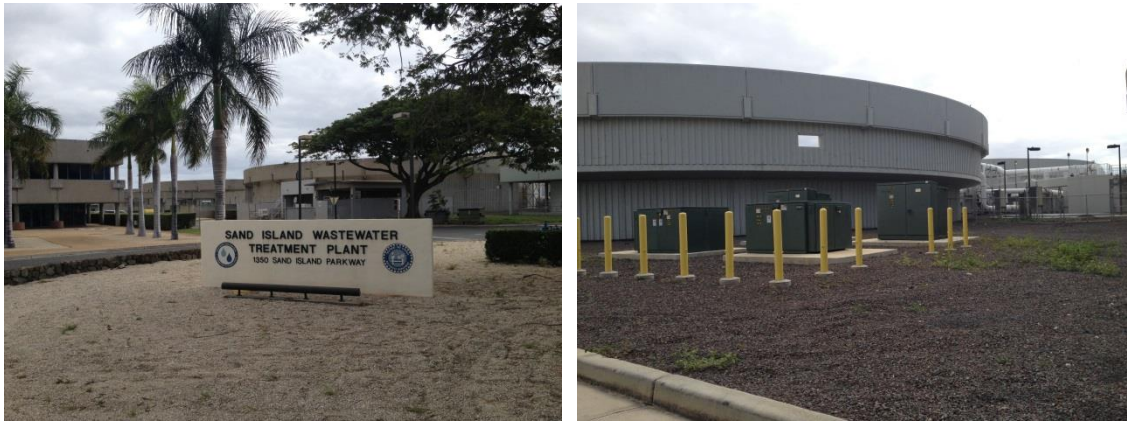
The main wastewater treatment plant for Honolulu is located adjacent to the port facilities on Sand Island (Figure 4-31). During a major inundation event, much of the electrical and mechanical equipment at this facility will be damaged and rendered inoperable (Figure 4-65). There is potential for large sewage spills that affect Sand Island and the harbor basin. This will create hazardous conditions for first responders and early recovery efforts in and around the harbor. This plant treats the majority of wastewater from Honolulu. Extended downtime will result in discharge of untreated sewage directly into the ocean with serious health and environmental consequences.

Figure 4-65: Sand Island Wastewater Treatment Plant

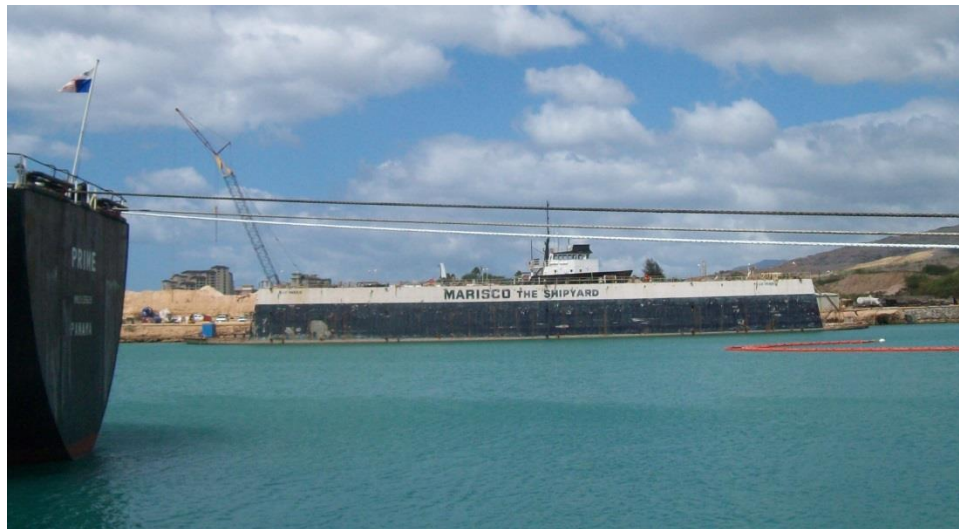
- If three or more large ships are in port at the time of a warning, there is not sufficient time and personnel to evacuate them all to deep water. Stevedores and pilots are required for ships to cast-off and leave the harbor.
- Marisco Shipyard maintains a floating dry dock opposite Pier P-7 (Figure 4-70). This dry dock will not be evacuated during a warning, so may break loose from its moorings and present a large debris impact hazard during the event.
- The two resident tugs, and any inter-island barges in the harbor, will be evacuated to deep water when a warning is announced.

Figure 4-70: Marisco Shipyard floating dry dock opposite Pier P-7

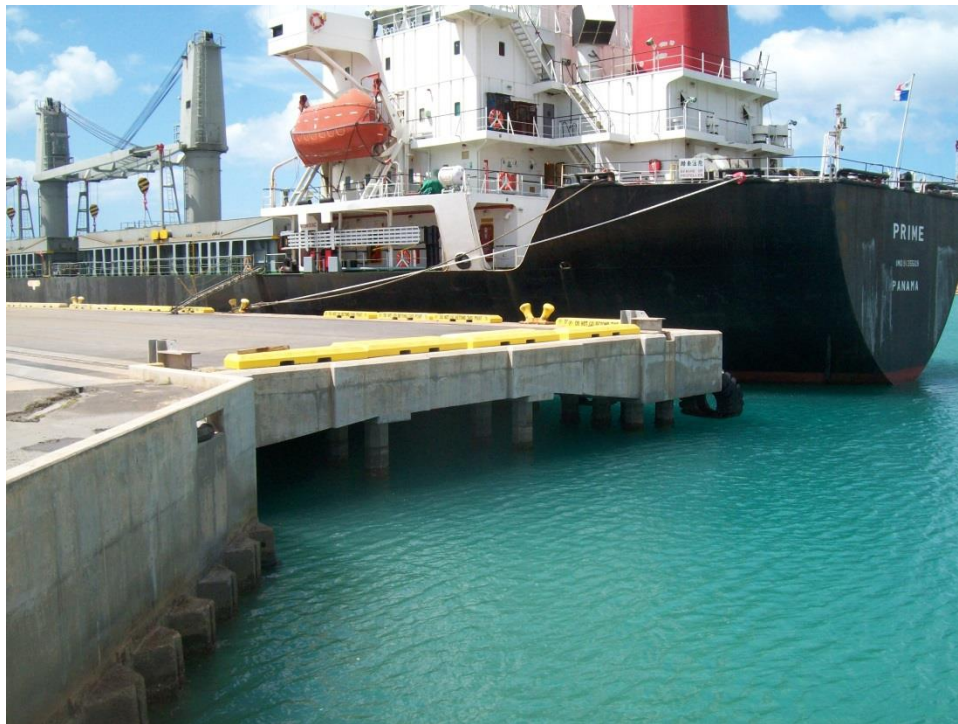
All piers at Kalaeloa Barbers Point harbor are relatively new construction (Figure 4-71). They consist of pile supported reinforced concrete beams and deck, with integral connections between the piles and deck. The closely spaced piles provide significant resistance to uplift of the pier during storm surge and wave action, or tsunami inundation. It is not anticipated that the piers will be damaged by hydrodynamic loading. However, damage due to impact from large ships is possible, particularly if the ships cannot be evacuated to deep water prior to inundation.

Figure 4-71: Ship berthed at Pier P7 at Kalaeloa Barbers Point Harbor

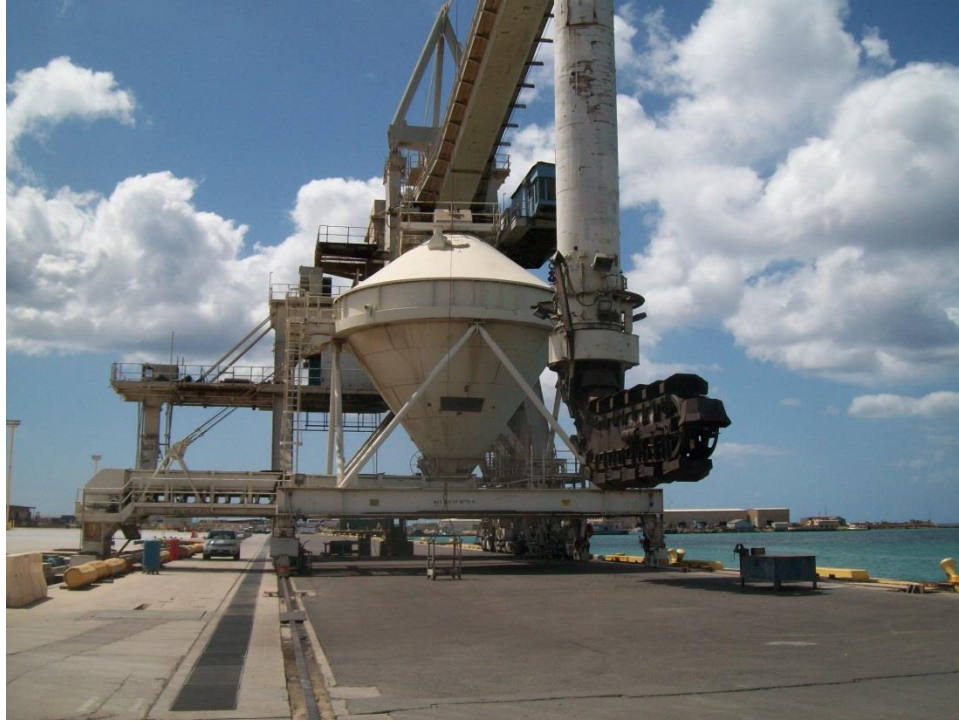
Approximately 650,000 tons of coal is offloaded annually using the bucket/screw lift shown in Figure 4-72. It is then transported by a 1.6 mile long conveyor belt system to the AES power plant in Campbell Industrial Park. Both the offloading equipment and conveyor belt are exposed to potential floating debris impacts. Electronic components of the equipment will also be damaged if submerged in seawater during the event. It is likely that a major inundation event will result in an extended breakdown on this coal bulk handling equipment, leading to downtime for the AES power plant. This power plant generates about 11% of Oahu's commercial electricity supply (Wikipedia, 2014), so provided other power generation facilities are still operational, the island electrical grid could likely be maintained without power from the AES plant.

Figure 4-72: Bulk coal handling equipment at Pier P-6
