**Vulnerability of Hawaii Commercial Port and Harbor Facilities to
Tsunamis and Hurricane Storm Surge and Wave Action**

**PROJECT REPORT
for
Hawaii Department of Transportation, Harbors Division**

Research Report UHM/CEE/15-01

February 19, 2015

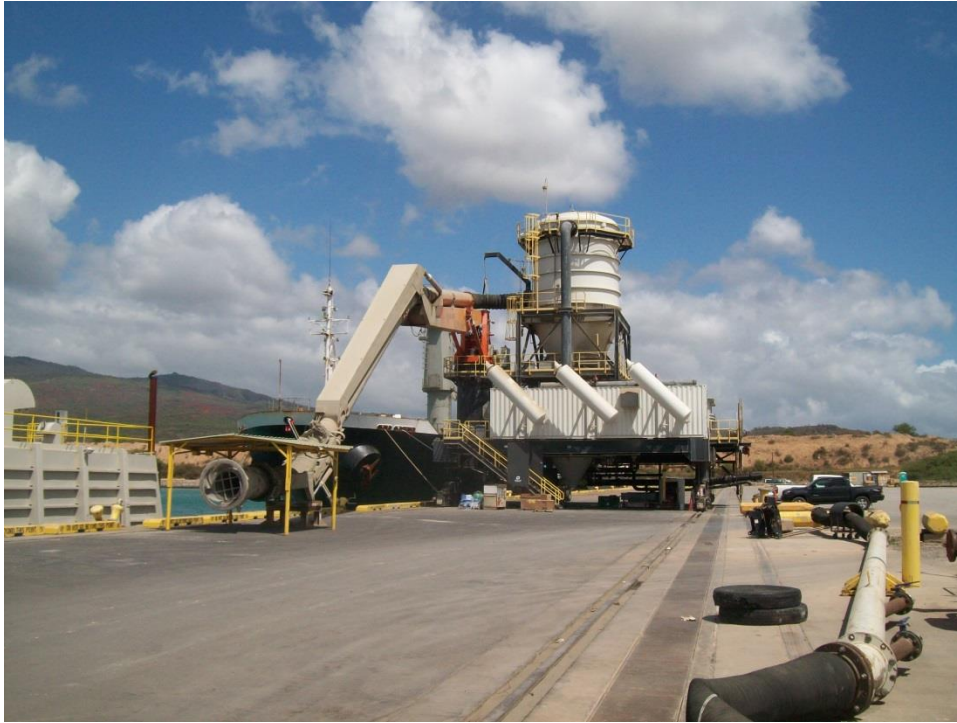
Kalaeloa Barbers Point Harbor is the only harbor in Hawaii that can accept bulk deliveries of cement in ocean-going ships. Equipment at Pier P-6 is dedicated to this task (Figure 4-73). The cement is transported pneumatically to large storage domes adjacent to Pier P-6 (Figure 4-74). It is then either transported to the Hawaii Cement facility in Campbell Industrial Park for use on Oahu, or transported by barge to the other Hawaiian Islands.

Water damage to the electronics or motors operating the offloading and pneumatic transport equipment could potentially lead to extended downtime for this bulk cement handling capability. An interim solution would be the importation of cement in super-sacks until the bulk handling equipment could be repaired. A large earthen berm

Figure 4-73: Bulk cement handling equipment at Pier P-6

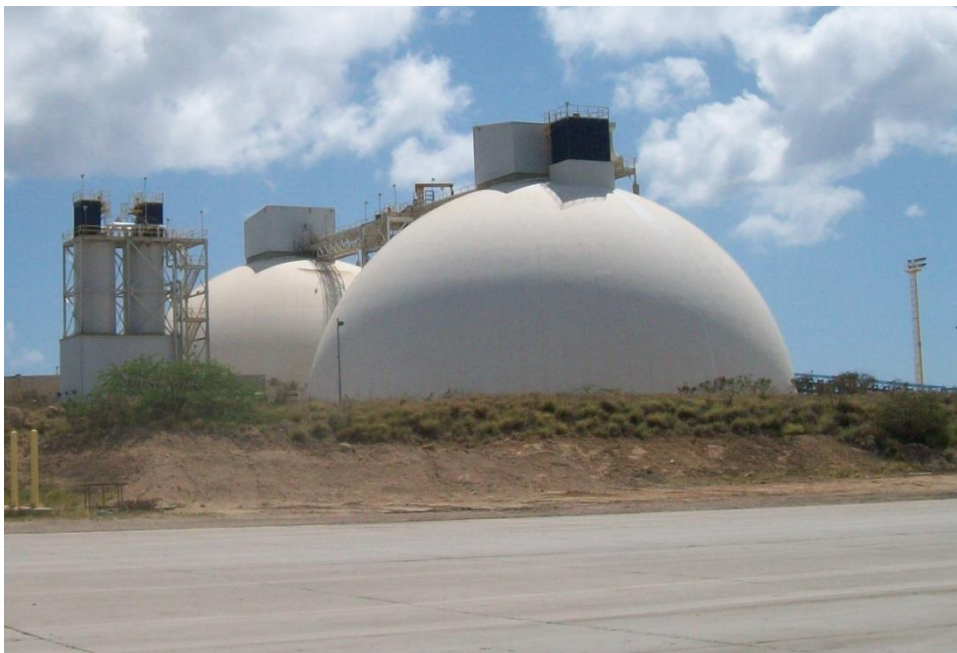
surrounding the cement storage domes will help to prevent water damage to the stored cement and any ground level equipment at this storage site (Figure 4-74).

Figure 4-74: Cement storage facility adjacent to Pier P-6

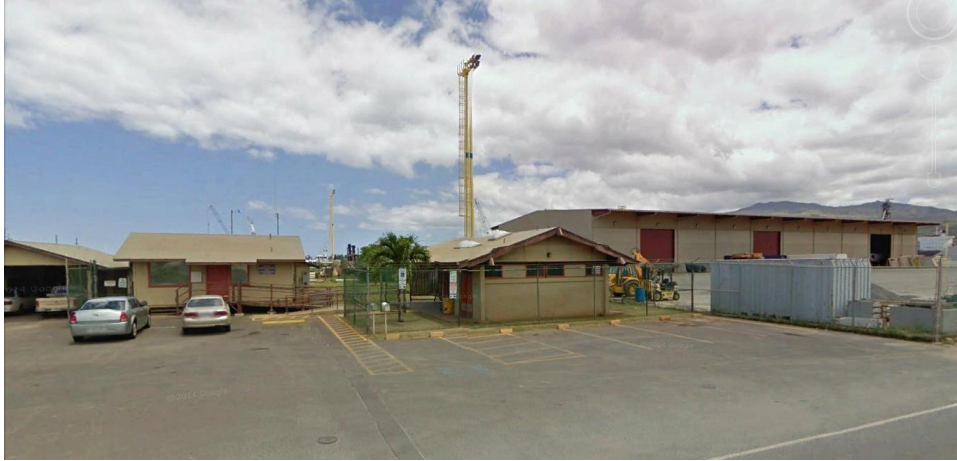
The harbor administrators office is a simple timber framed office that will likely be severely damaged during a major hurricane or tsunami event (Figure 4-75). All personnel and important equipment should be evacuated from this office during a warning. The nearby steel-framed warehouse on Pier P-5A (Figure 4-75) is only used to store equipment and is not critical to port functionality after an inundation event. It is likely to experience damage to the sheet metal siding and roller doors, and possibly debris impact damage to steel columns and bracing members. Keeping the roller doors open during an inundation event would help to protect them from damage.

Figure 4-75: Harbor administration building and Pier P-5A warehouse

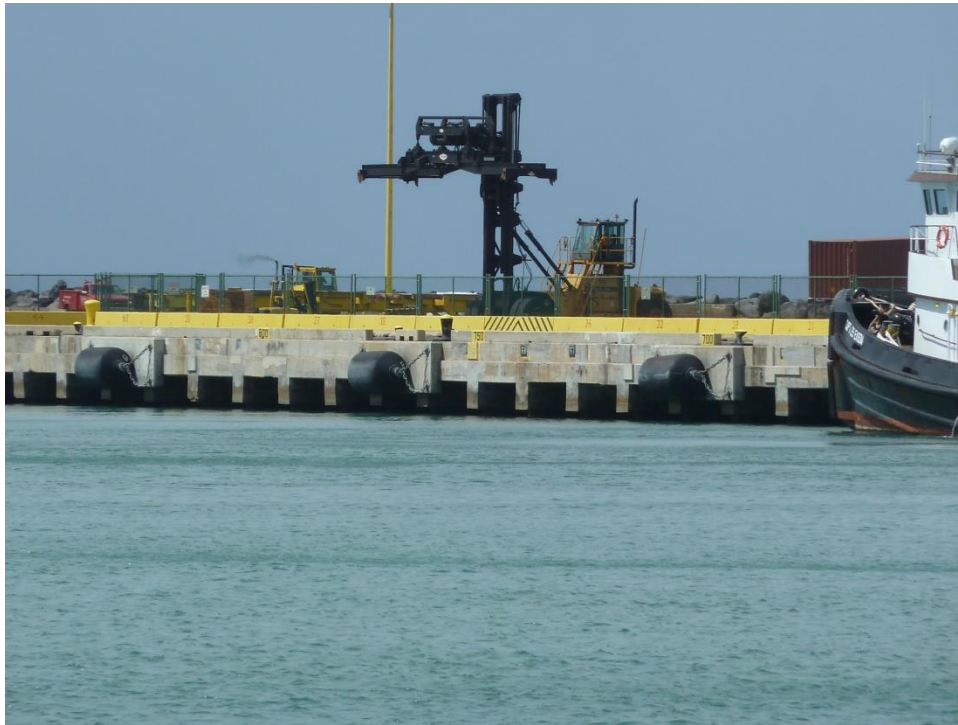
All three piers at Kahului Harbor have both pile supported and soil supported sections. The pile supported sections are susceptible to hydrodynamic uplift during storm surge and wave action, and during tsunami inundation. The main pier (Pier 1) is constructed using driven piles encased in large reinforced concrete beams supporting the reinforced concrete pier deck (Figure 4-81). This integral construction provides superior resistance to the uplift forces and would be expected to survive anticipated hydrodynamic loading. However, drawings for the pier were not reviewed for this project, and no structural or hydrodynamic analysis was performed to verify the anticipated performance of this structure during future inundation events.

Figure 4-81: View of Pier 1 structural system

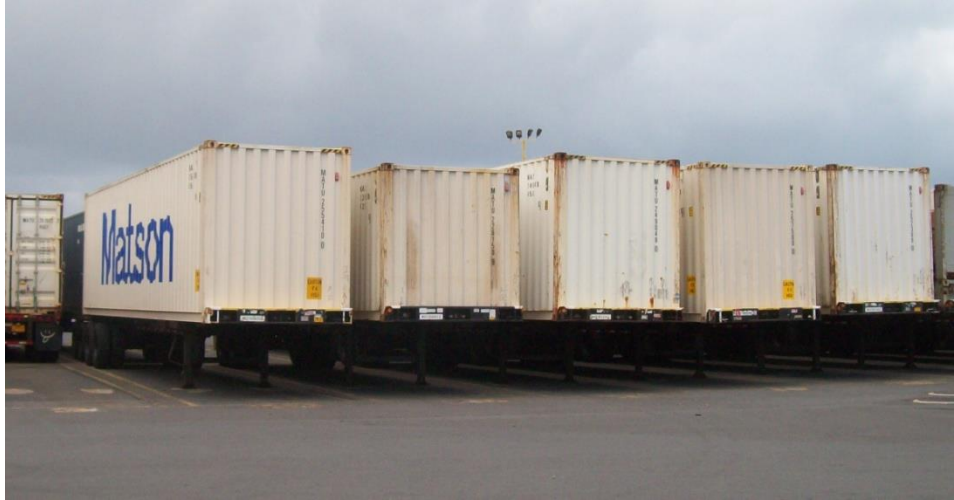
The main container storage areas are on Pier 1 and Pier 2 (Figure 4-76). Both areas are directly exposed to inundation due to storm surge or tsunami. Containers with hazardous contents are stored on chassis ready for removal to high ground in the event of a hurricane or tsunami warning (Figure 4-83). Others are stacked without restraint, so should be expected to float during a major inundation event (Figure 4-84). They will then become floating debris with the potential for striking structures and other harbor facilities and causing considerable damage. Many of the containers will be washed off the piers and potentially sink in the harbor basin or entry channel, reducing the available draft. This would be a major concern that needs to be resolved prior to allowing ships into the harbor after a hurricane or tsunami.

Figure 4-83: Chassis mounted containers on Pier 1 ready for removal to high ground

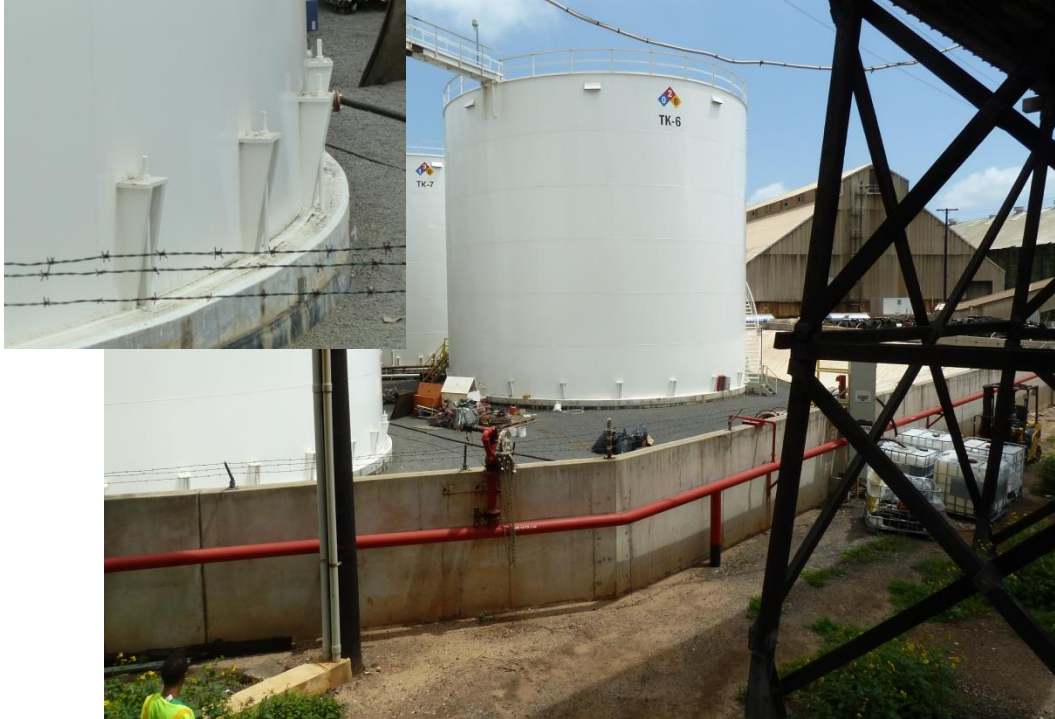
Two tank farms are located adjacent to Kahului Harbor (Figure 4-77). The first is a Tesoro fuel storage facility directly inland from the container storage yard on Pier 1 (Figure 4-85). The storage tanks are secured to concrete foundations by means of anchor bolts as shown in the insert in Figure 4-85. This will help to prevent uplift during inundation, but may not be able to resist the potential buoyancy of an empty tank with significant inundation. The relatively thin steel walls of empty tanks may also tend to buckle due to the external water pressure.

This facility is surrounded by a concrete wall varying in height from 8 to 10 feet. The top of the wall is therefore approximately 14 to 16 feet above MSL. This wall was presumably designed as a containment wall, so would be able to resist hydrostatic pressure due to storm surge, but may not be adequate to resist high velocity tsunami flow.

If the wall is overtopped by either storm surge and wave action, or tsunami inundation, the tanks will be subject to potential flotation, buckling, or impact from floating debris. Resulting fuel spills could lead to fires that can spread with the water flow. The current fire suppression system is located on the outside of the wall (horizontal red pipe in Figure 4-85) and is exposed to potential damage from debris strikes.

Figure 4-85: Tesoro fuel storage tank farm at Kahului Harbor

Although not part of the Kahului Harbor property, both of these fuel storage tank farms present a potential hazard to surrounding areas, including harbor property, if they are damaged during a coastal flooding event. Remediation against inundation would require an evaluation of the height of the containment walls relative to anticipated storm surge and tsunami flow depths. If the walls are not currently high enough to prevent inundation of the tank farm areas, then they can be replaced with higher walls. An alternative approach may be to leave the walls in their current condition but prevent buoyancy and tank wall buckling by maintaining the tanks at least half full. A retention fence should be added to the top of the containment walls to prevent floating containers and other large debris from reaching the tanks.

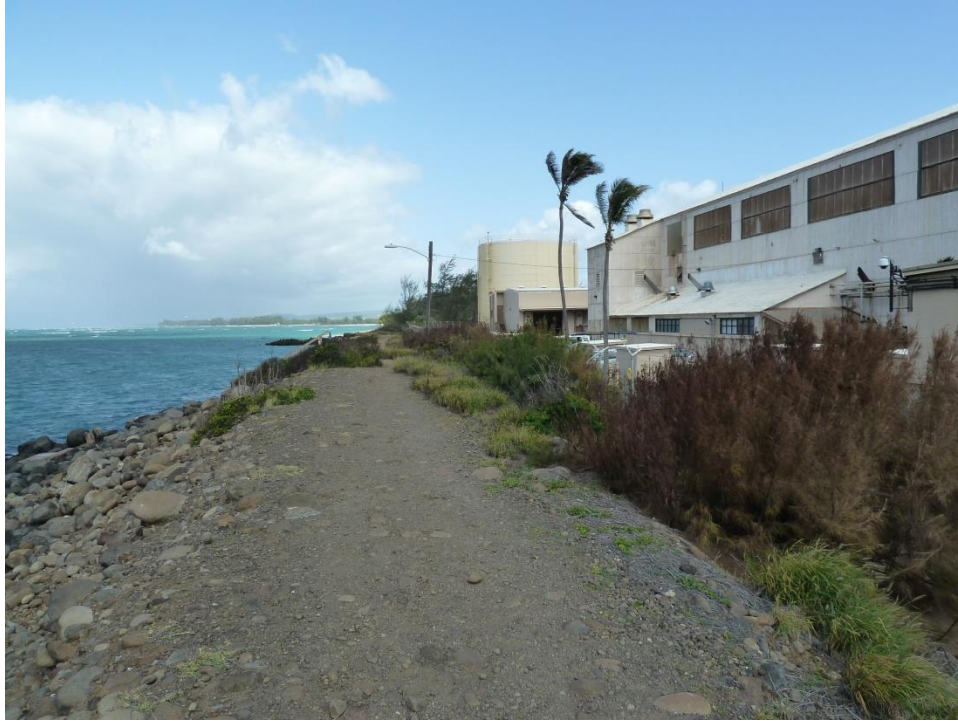
The second fuel storage facility is associated with the Kahului Power Station (Figure 4-86). Both the power station and tanks are protected from wave action by a berm with top elevation approximately 16 feet above MSL. The berm is built of earthen fill with the ocean face lined with boulders. The berm is not continuous around the power station and fuel storage area, so would not provide protection during a significant hurricane storm surge or tsunami inundation. The Kahului Power Station produces approximately 13% of the power generated on Maui (Wikipedia, 2014), but may be decommissioned in the future.

Figure 4-86: Kahului Power Station and fuel storage tanks behind earthen berm

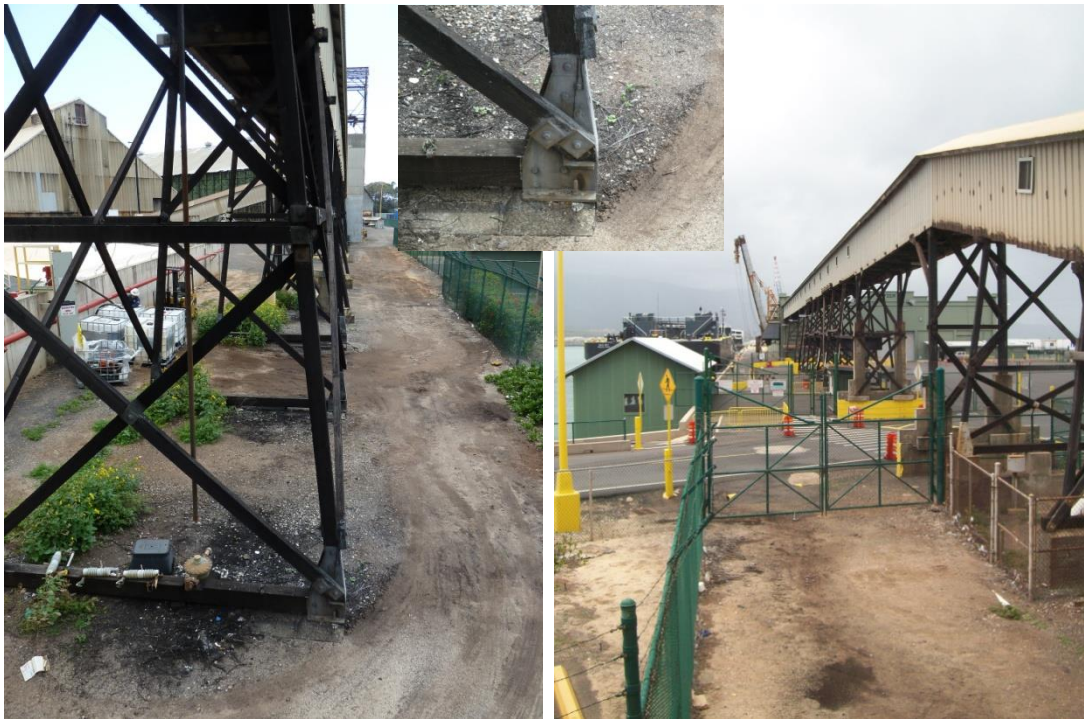
Kahului Harbor has a bulk handling system for loading sugar onto ships at Pier 1. The conveyor system is supported by timber trestles (Figure 4-87) leading to the loading facility in the warehouse on Pier 1. Although the trestle legs are well secured to their concrete foundations (inset in Figure 4-87), they are still susceptible to impact damage from floating shipping containers. Based on the number of trestles and their location relative to the shipping container storage yard, it should be assumed that there will be sufficient damage to make the bulk handling system inoperable after a major inundation event.

Figure 4-87: Bulk handling conveyor system for sugar export

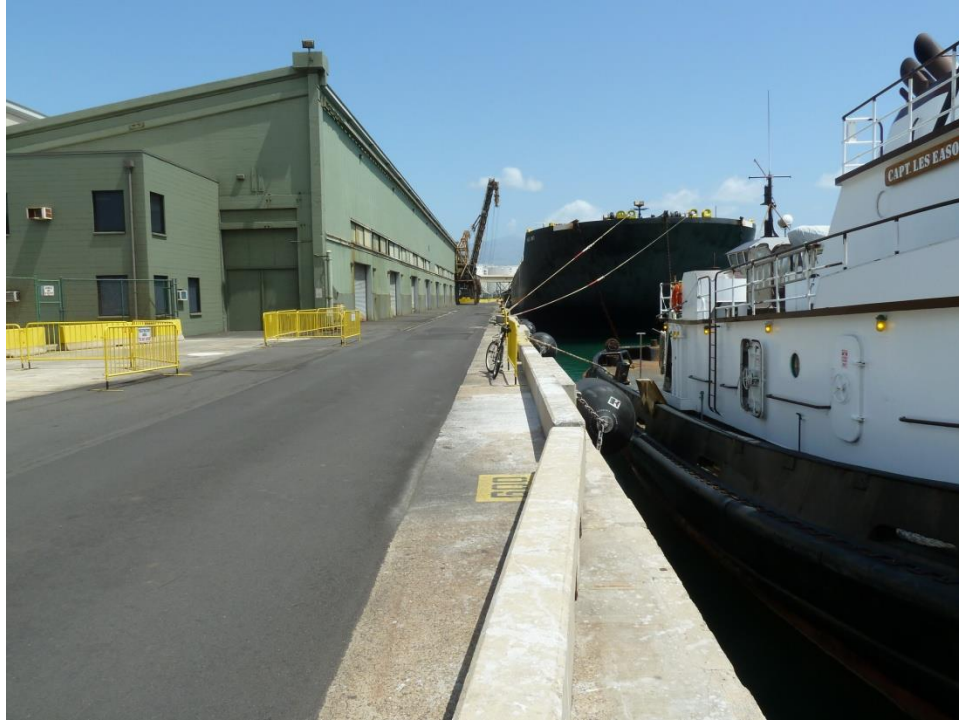
The only major warehouse in the harbor is on Pier 1 (Figure 4-88). It houses the sugar bulk loading system and services cruise ship passengers, but it is no longer used for pallet mounted material handling. The structure has not been evaluated for high velocity flow conditions, but it is likely that the main steel columns and roof structure would survive while the infill walls may be damaged (Figure 4-89). Roller doors, windows and any sheet metal cladding at the lower elevations would likely be damaged during a flooding event.

Figure 4-88: Warehouse on Pier 1

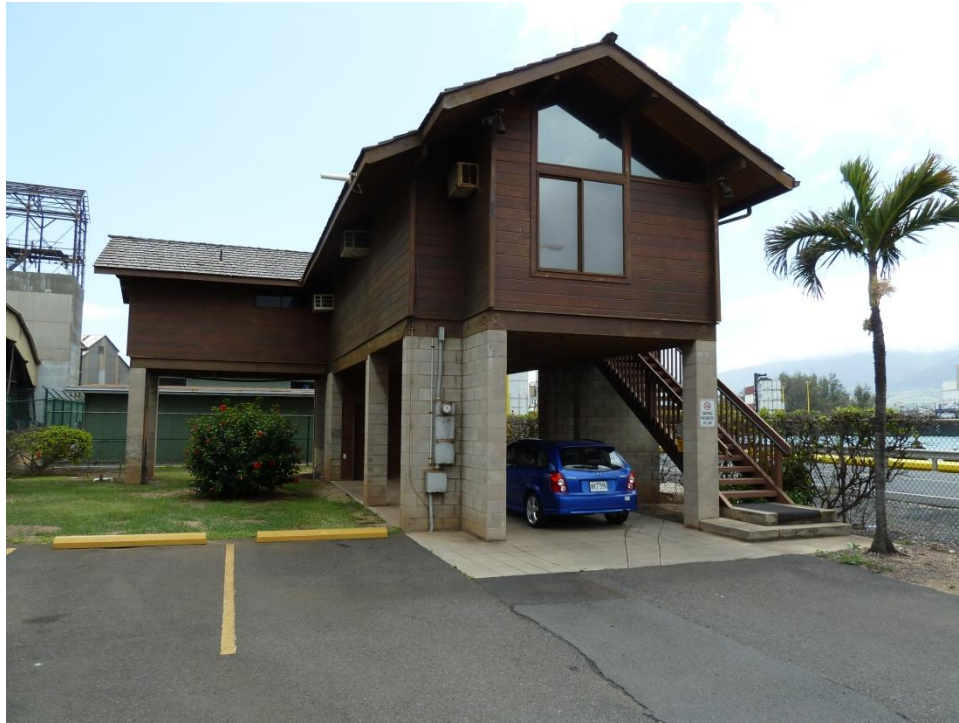
The harbor office building shown in Figure 4-90 is elevated 10 feet above grade, and approximately 14 feet above MSL. It was therefore not damaged during the Tohoku Tsunami inundation. It is not known if the masonry walls and columns supporting this

structure were designed for high velocity tsunami flow or hurricane wave loading, but elevation of the building will certainly provide better continuity of services after an event. This building should still be evacuated during a tsunami or hurricane warning.

Figure 4-90: Kahului Harbor office

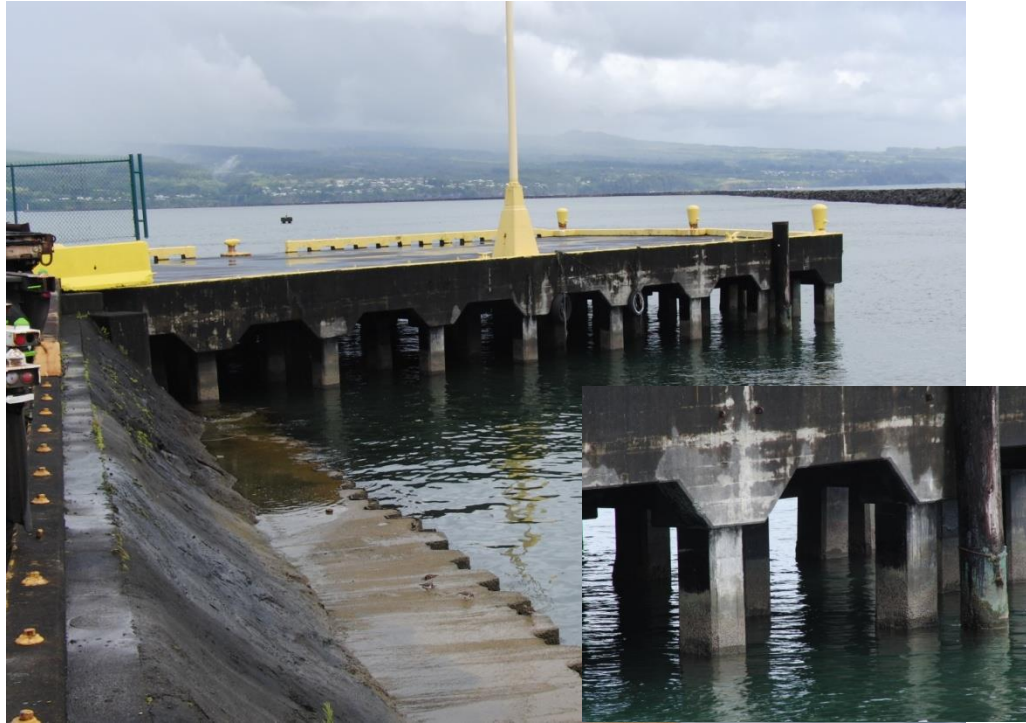
The newer Pier 1 construction (Figure 4-95) is anticipated to survive future inundation events. It is likely that Pier 2 and 3 (Figure 4-96), and the older portion of Pier 1, will also survive future inundation events, though contingency plans should incorporate possible collapse or damage to portions of these older piers.

Figure 4-95: Pier 1 newer construction with view of pile to deck connection (inset)

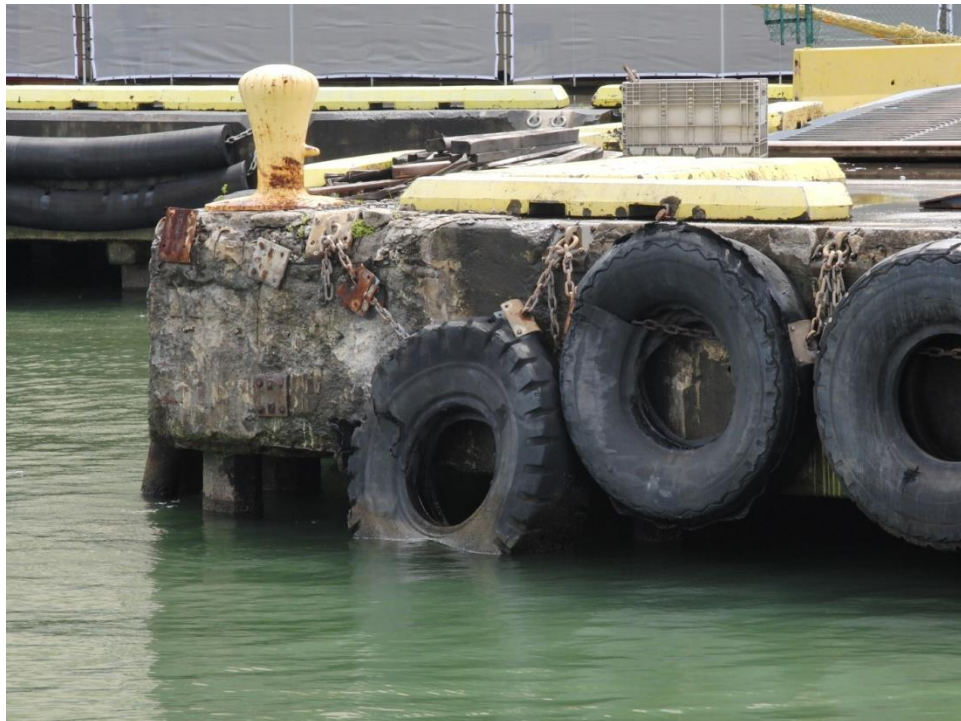
All three piers are partly supported on piles and partly on fill material. The pile supported piers are built integrally from driven piles to girder to deck slab, providing good resistance to potential hydrodynamic uplift. Piers 2 and 3, and portion of Pier 1, were constructed in the 1920s, while the end of Pier 1 is newer construction. Portions of Pier 2 deck slab have failed under forklift wheel loads, and the piers cannot support mobile cranes during an emergency.

Figure 4-96: Older pier construction

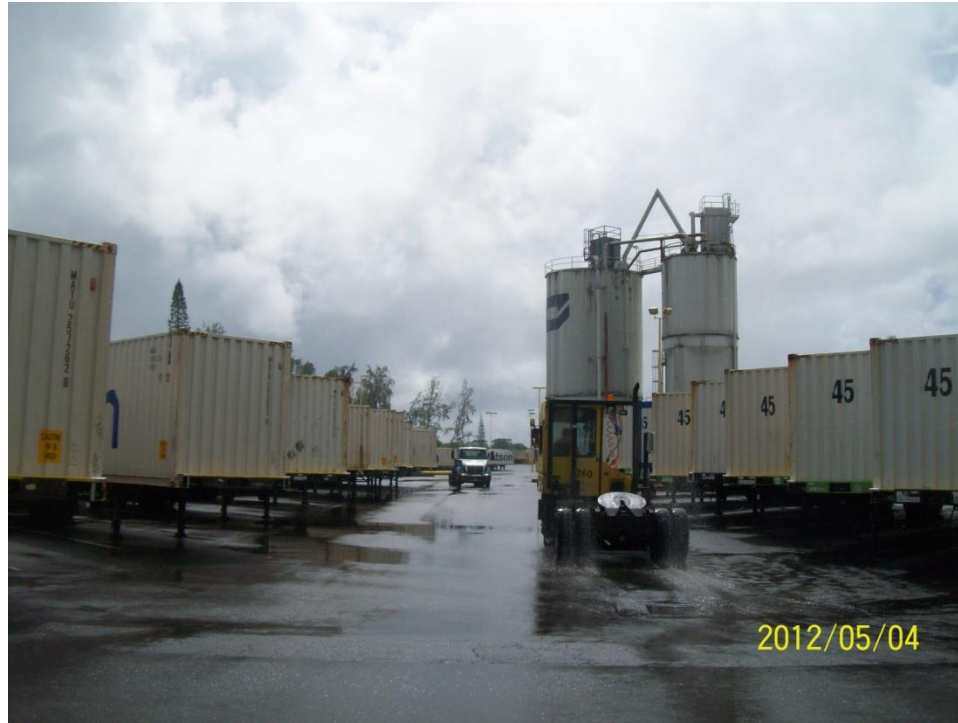
Containers are stored at various locations in the harbor, including in the large storage area adjacent to the fuel storage tanks shown in Figure 4-91. Containers with hazardous materials and perishable cargo such as food are stored on chassis for easy evacuation (Figure 4-97). Empty containers and those containing regular cargo are stacked in the storage and handling areas.

Figure 4-97: Shipping containers stored on chassis

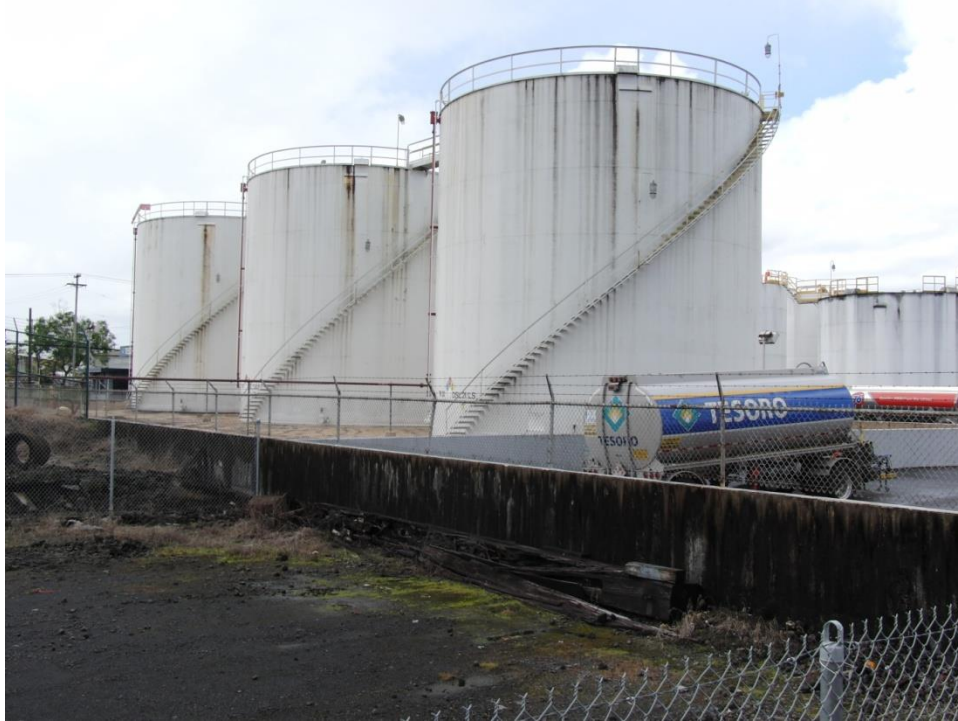
There are four fuel storage facilities adjacent to or near the Hilo Harbor. Containment walls of various heights surround the storage tanks, most constructed of concrete masonry unit (CMU) walls. Tesoro storage tanks are surrounded by a 4ft high CMU wall (Figure 4-98), while the Aloha storage tanks have a 5.5 ft high CMU containment wall (Figure 4-99). The Midpac storage tanks are surrounded by a 10 ft high reinforced concrete wall topped by 5 ft of CMU wall (Figure 4-99).

The tall reinforced concrete and CMU walls at the Midpac facility are likely strong enough to survive moderate velocity flow, however the lower CMU walls at the other storage tank sites should be expected to fail or suffer overtopping during a major inundation event.

Figure 4-98: Tesoro storage tank facility

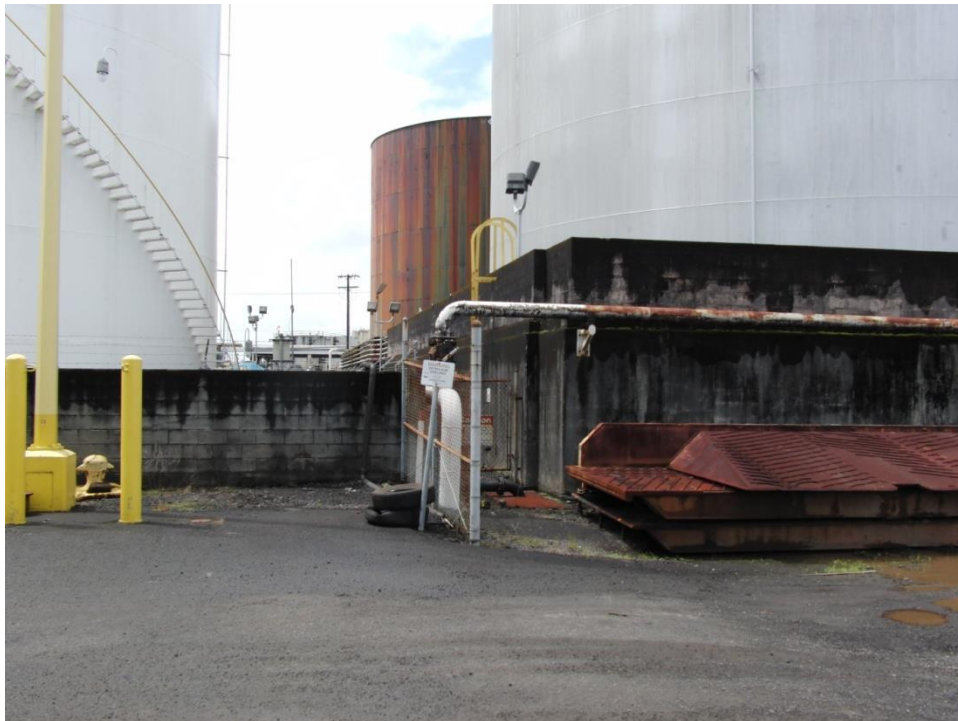
Figure 4-99: Aloha (left) and Midpac (right) storage tank facilities

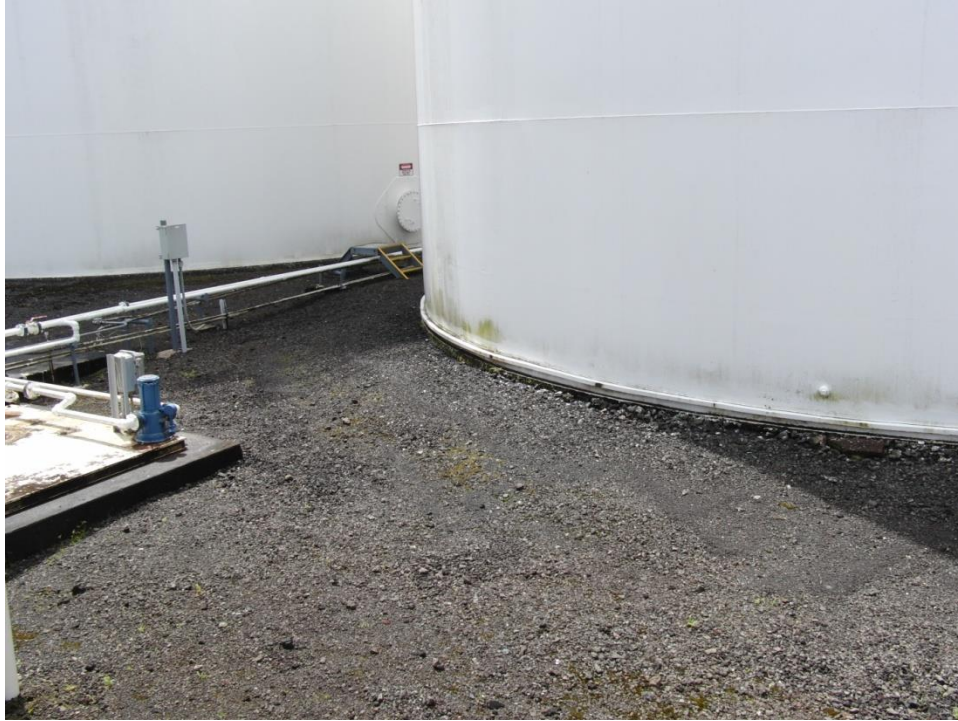
Many of the storage tanks are not secured to the ground (Figure 4-100), so they should be expected to float during inundation, resulting in damage to pipe connections and potential impact and puncturing of the tank wall.

Figure 4-100: Tank bases resting on concrete slab without uplift restraint

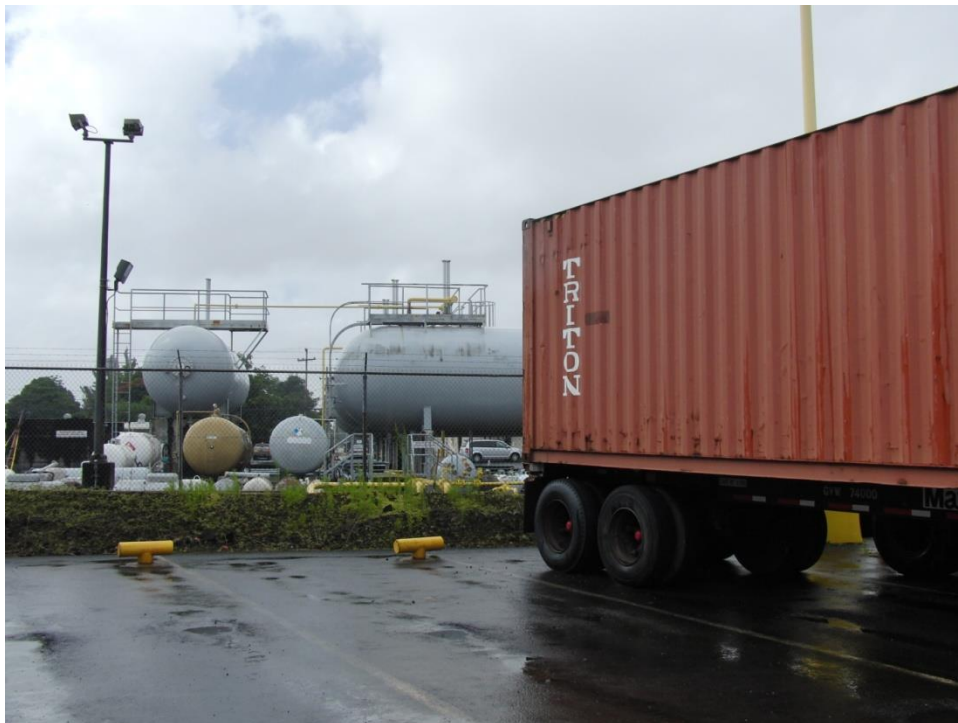
A gas storage facility adjacent to the container handling yard is also exposed to impact damage due to floating debris (Figure 4-101).

Figure 4-101: Gas storage facility adjacent to shipping container yard

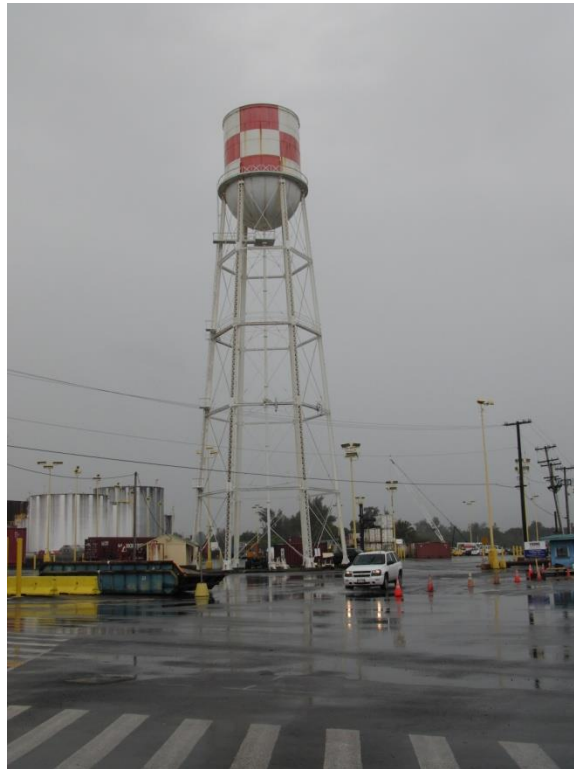
Due to Pier 1 shed modifications occurring within Hilo Harbor, the steel truss-supported water tank is being evaluated for its purpose and use. Potential damage to the support legs or bracing from debris impact could create a falling hazard (Figure 4-102).

Figure 4-102: Unused water tower

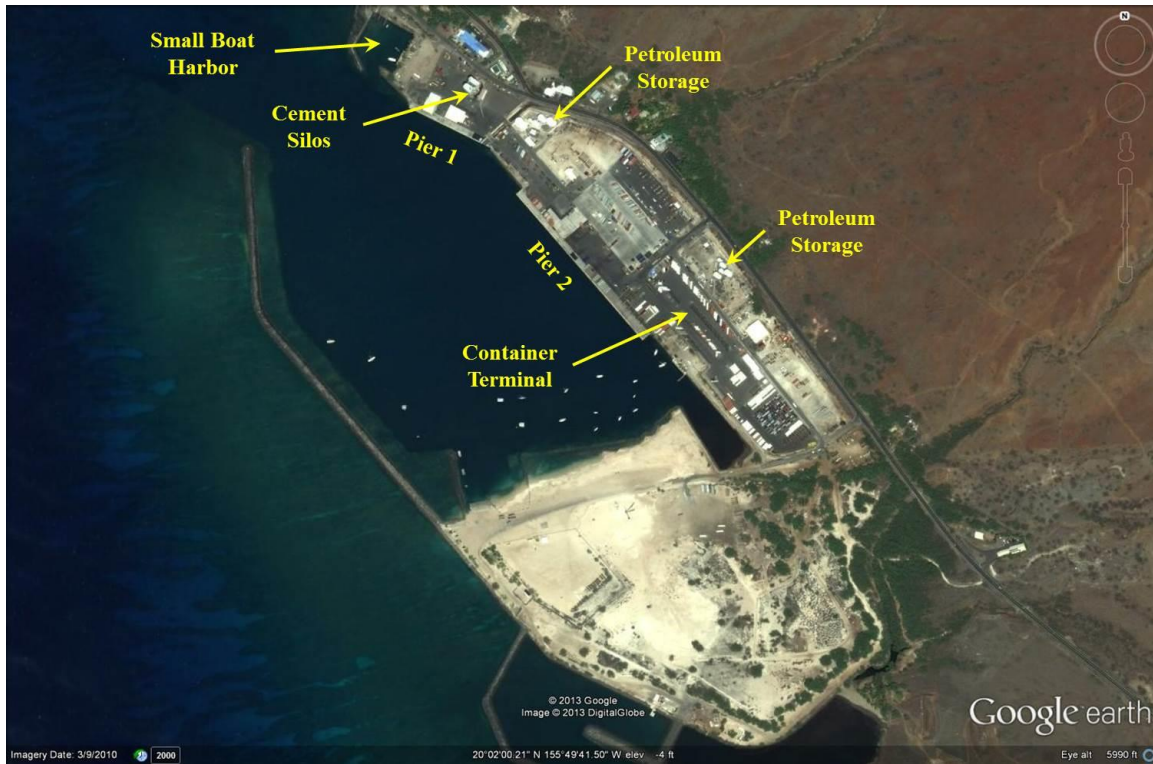
Figure 4-103: Kawaihae Harbor, Hawaii County

Pier 1 is the oldest pier while Pier 2 consists of two sections built at different times (Figure 4-103). Pier 1 was damaged during the Kiholo Bay earthquake in 2006 and was out of commission for some time while repairs were made. It may be anticipated to experience damage during future tsunami or hurricane events.

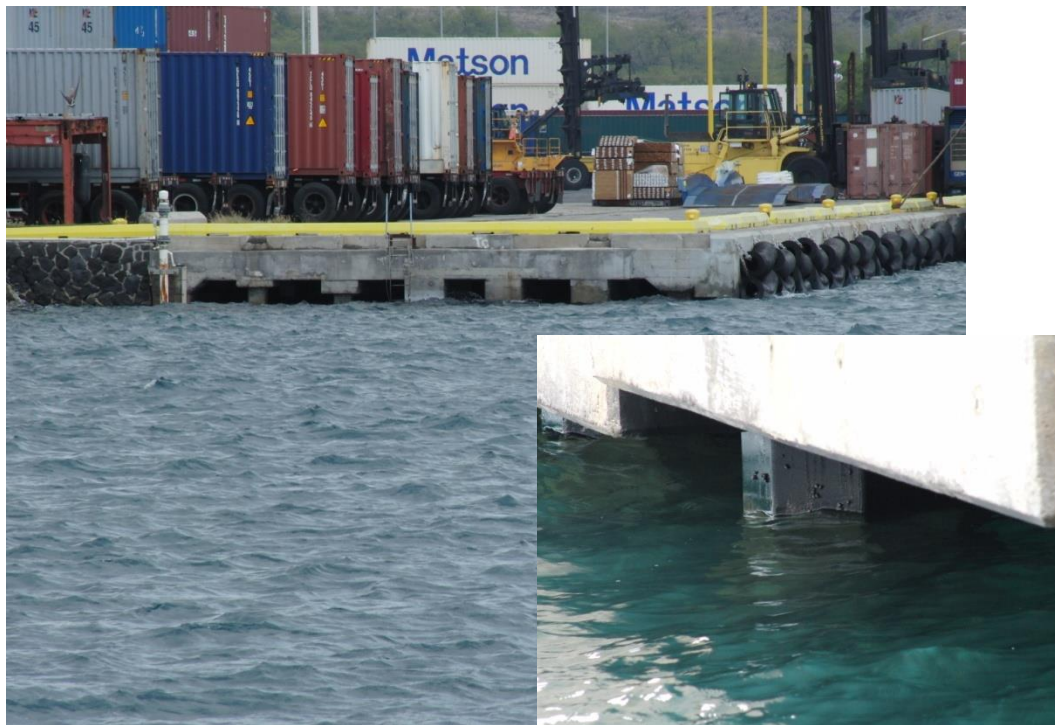
Pier 2 is a more robust construction (Figure 4-107) and would be expected to survive a major inundation event without significant damage.

Figure 4-107: Pier 2 - concrete deck on piles (inset)

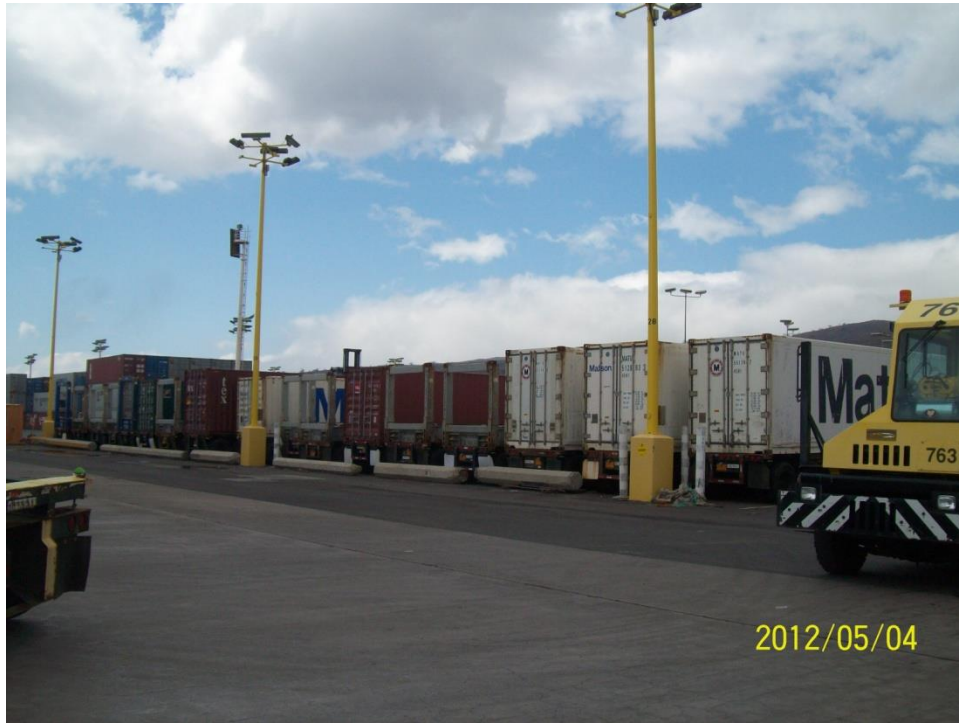
Containers are stored adjacent to Pier 1. Containers with hazardous materials are stored on chassis for easy evacuation (Figure 4-108). Empty containers and those containing

Figure 4-108: Chassis mounted containers in storage area

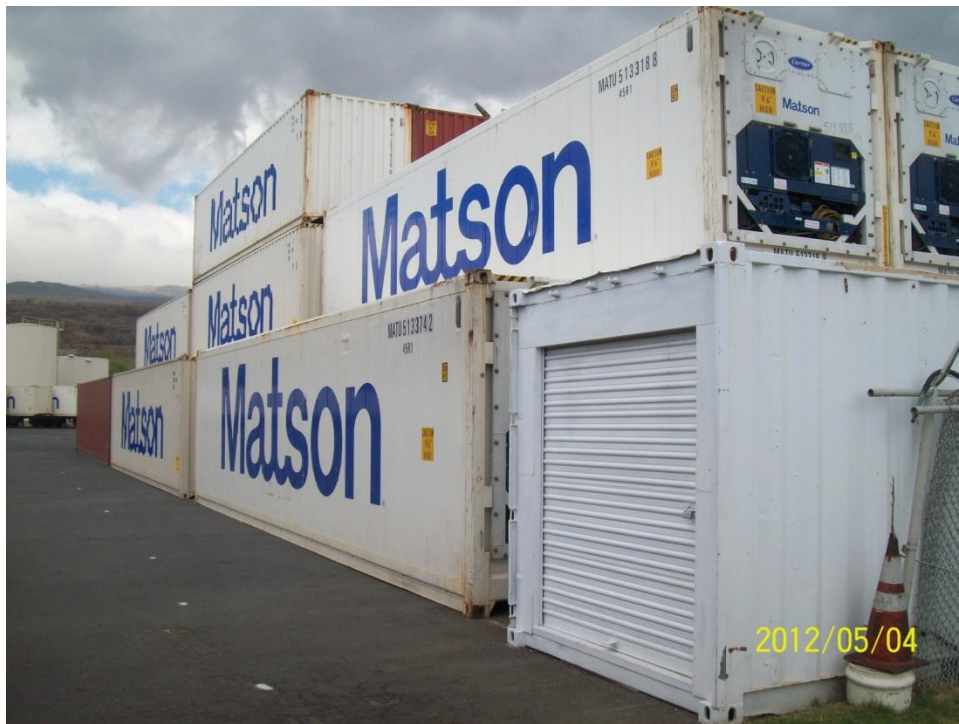
regular cargo are stacked in the storage and handling areas (Figure 4-109), but are unstacked and packed against each other during a disaster warning.

Figure 4-109: Stacked containers

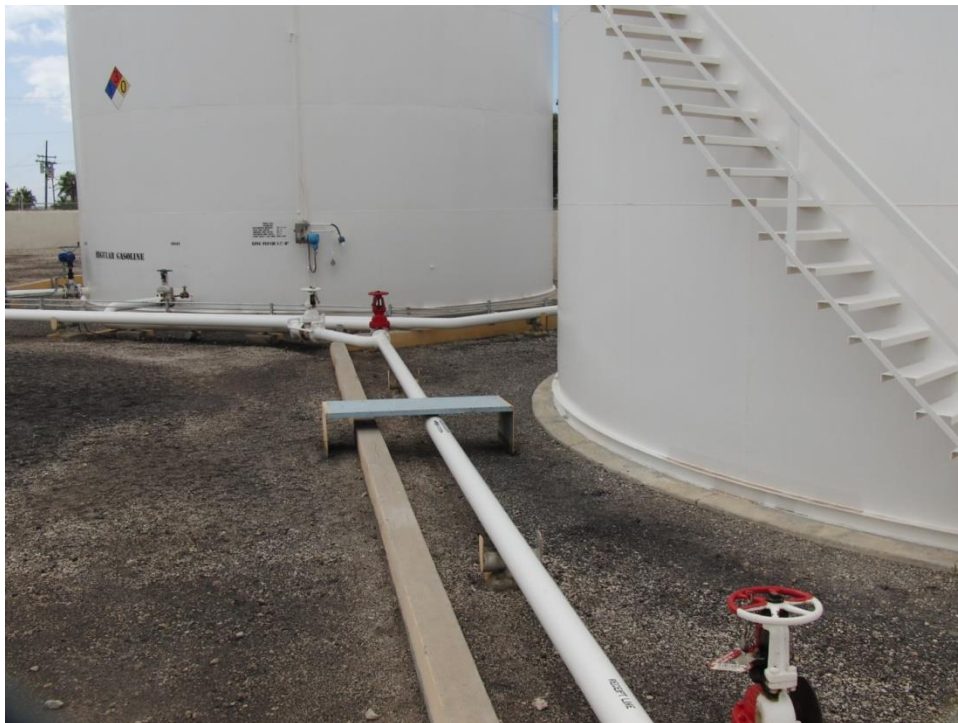
There are two fuel storage yards at Kawaihae Harbor, both of which are adjacent to container storage areas (Figure 4-110 and Figure 4-111). The storage tanks are filled by a barge every 4 weeks. The 5 foot high containment wall is designed for the contents of the largest tank plus 25 year rainfall. The tanks are located at an elevation of approximately 5 feet, and therefore the top of the wall is approximately 10 feet above MSL (Figure 4-112). The tanks are not connected to the concrete foundations, so inundation of the tank farm could lead to floatation and damage of the piping connections (Figure 4-113).

Figure 4-113: Base support and piping in Midpac tank farm

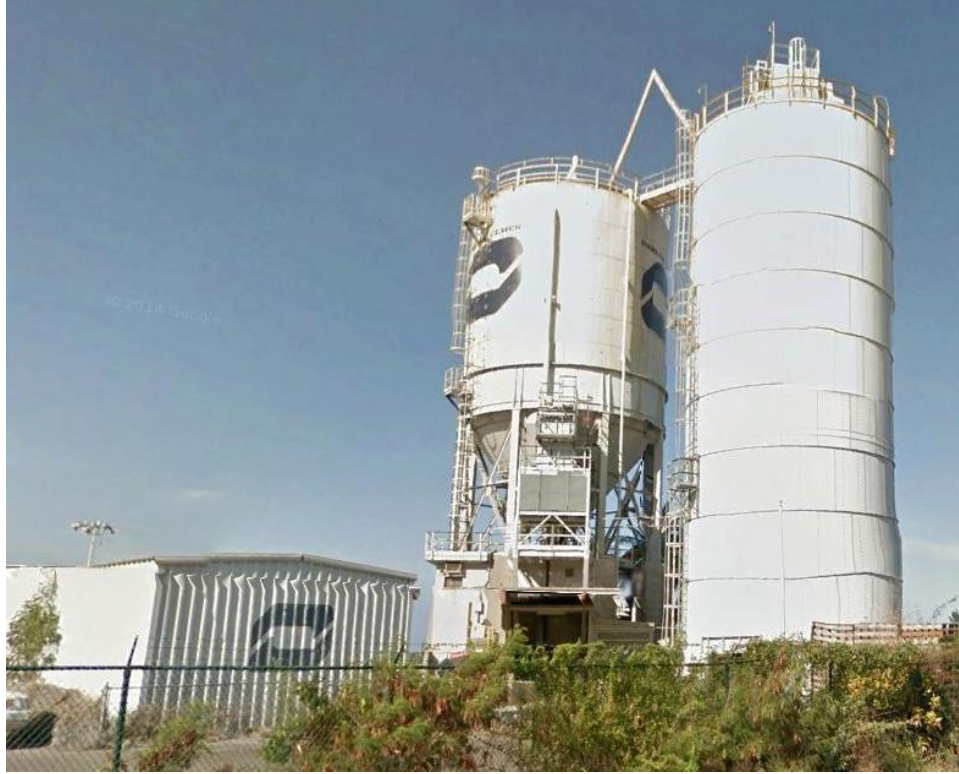
The only bulk handling facility at Kawaihae Harbor is the cement delivery and storage (Figure 4-103 and Figure 4-114). Loss of this facility could impact construction during

the critical early construction phase after a disaster. Alternative cement delivery systems, such as super-sacks, are available that could be used on a temporary basis if necessary. The elevated nature of the cement silos and the sturdy construction should provide improved resistance to damage, though the piping systems may need repair after an inundation event.

Figure 4-114: Cement Silos at Kawaihae Harbor
